# Post-Construction Report for the Lower Three Runs Integrator Operable Unit Upper Subunit (U)

SRNS-RP-2023-00109

Revision ~~0~~1 Redline

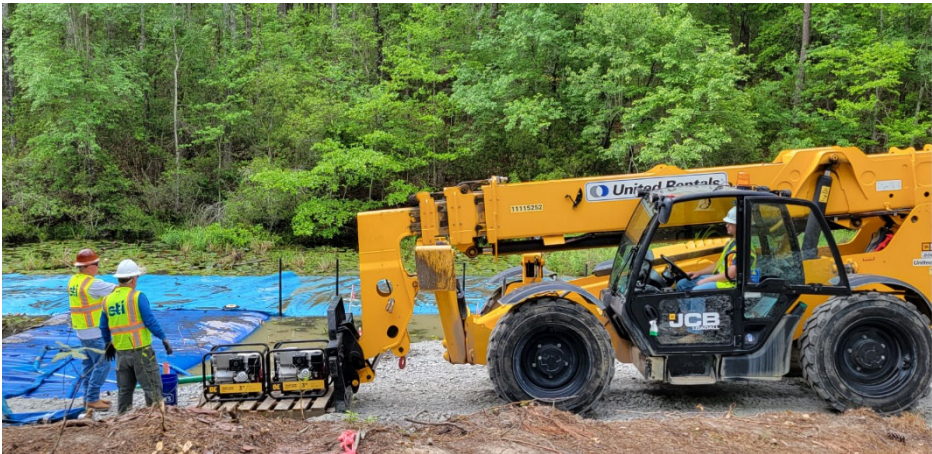
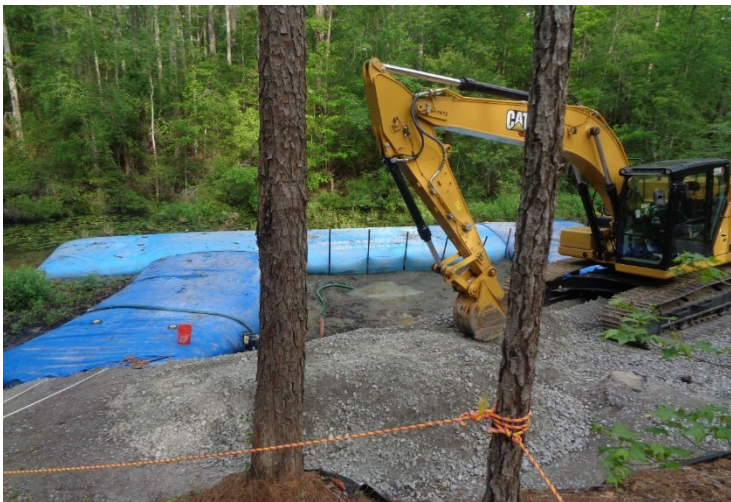
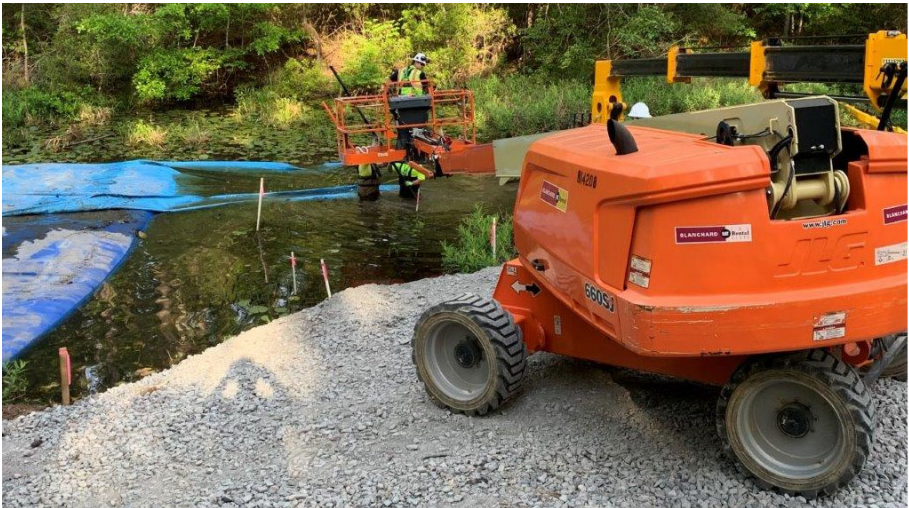
Figure 10. Photos of Equipment - Telehandler

Table 3 identifies the general equipment types used during remedy implementation. Photos of several pieces of equipment are provided in Figure 10.

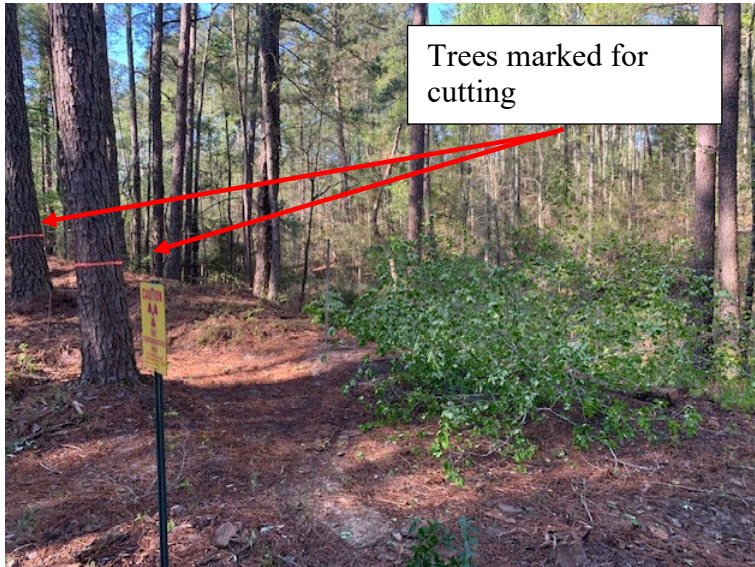
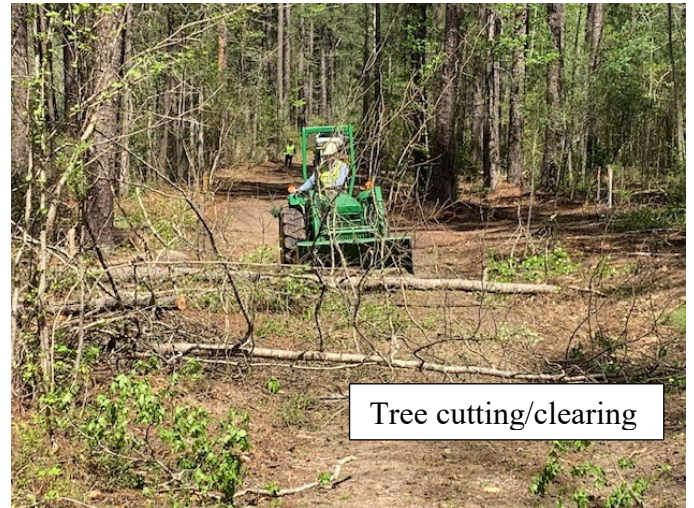
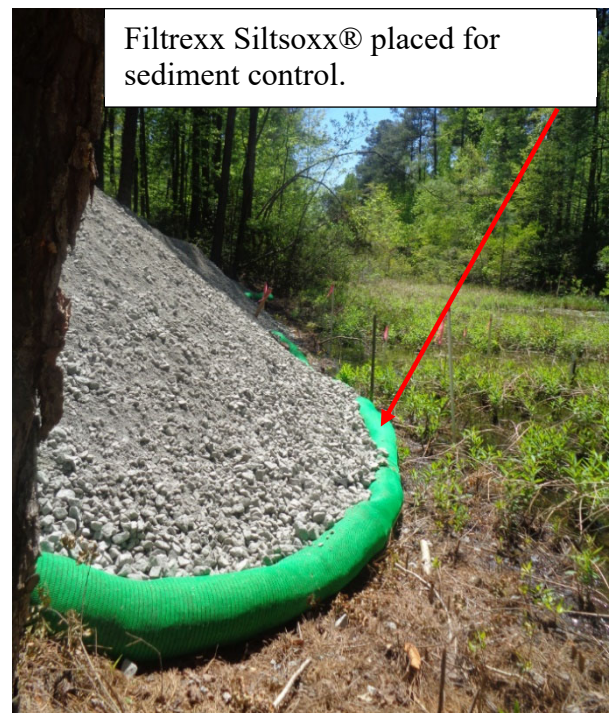
**Figure 11. Tree Clearing and Placement of Stone for Working Platform**

Initial land clearing was performed to allow access to the R-Area Discharge Canal and to establish a working platform for the excavator. Trees were cut above grade and pushed to the side. No grubbing was performed so there was minimal disturbance to the soil. Filtrexx Siltsoxx® was used as the edge of the canal to mitigate migration of soil to the canal (Figure 11).

The subcontractor prepared an access path and working platform along the bank of the canal consisting of a non-woven geotextile fabric covered by approximately 12 loads of stone (rip rap and #57 stone). The platform has approximate dimensions of 30 ft by 40 ft to permit parallel tracking along the excavation footprint.

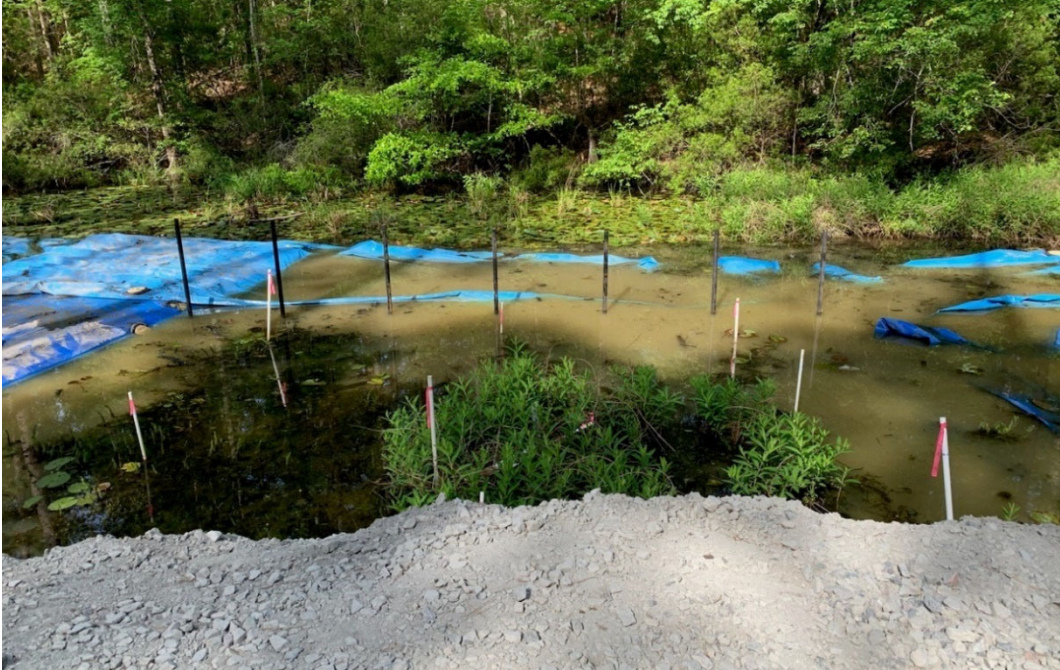
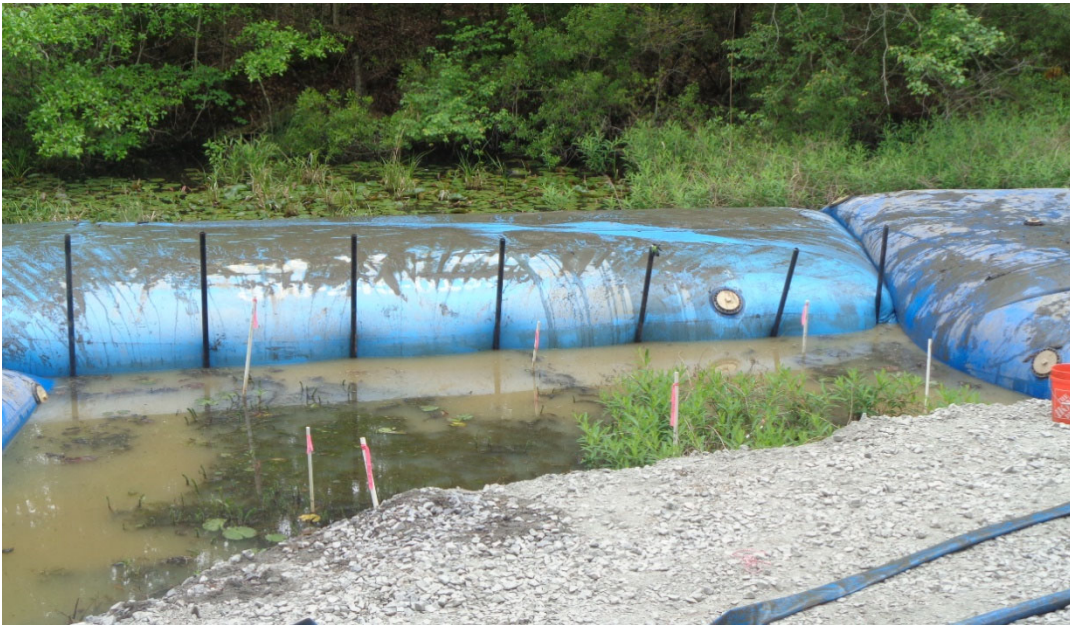
**Figure 13. Cofferdam Construction Using Aqua Barriers**

Aqua Barrier Layout Prior to Inflation

Aqua Barriers Inflated with Canal Water

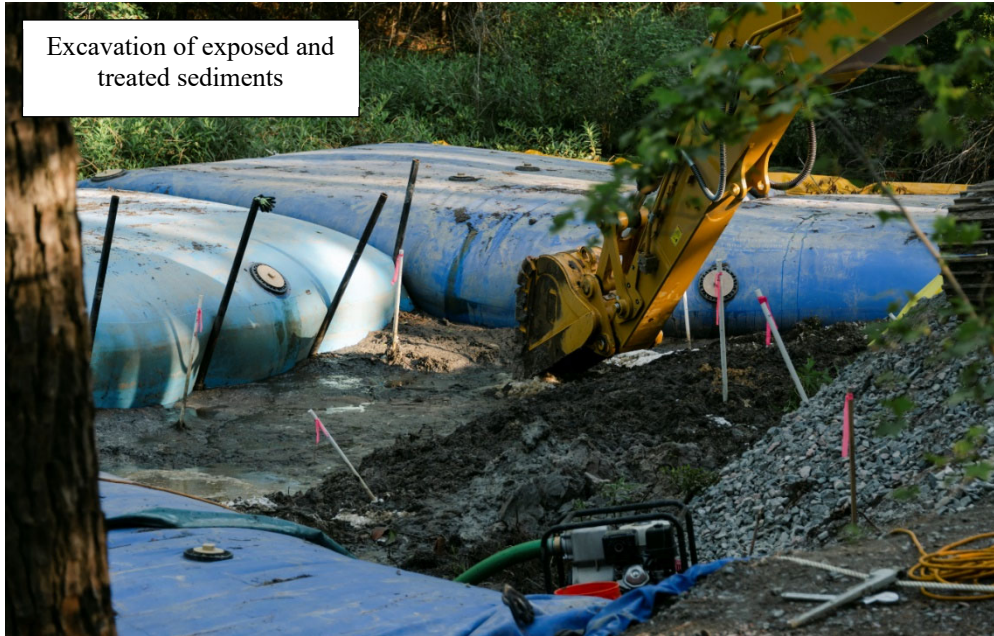
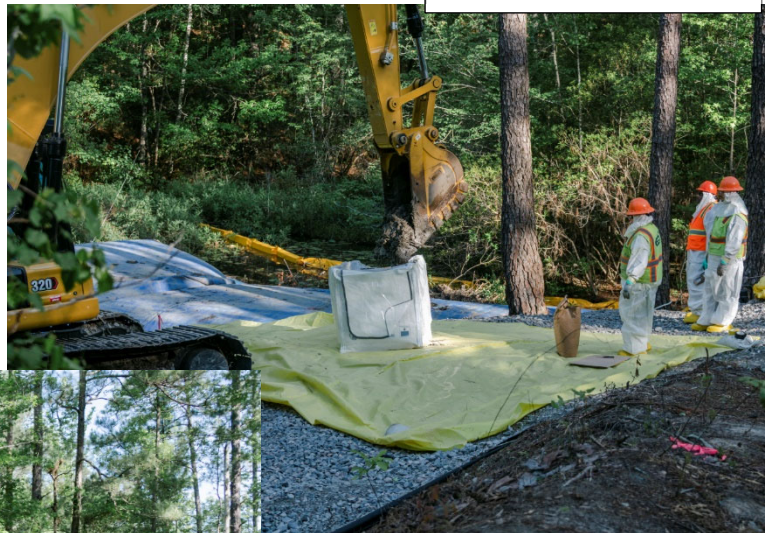
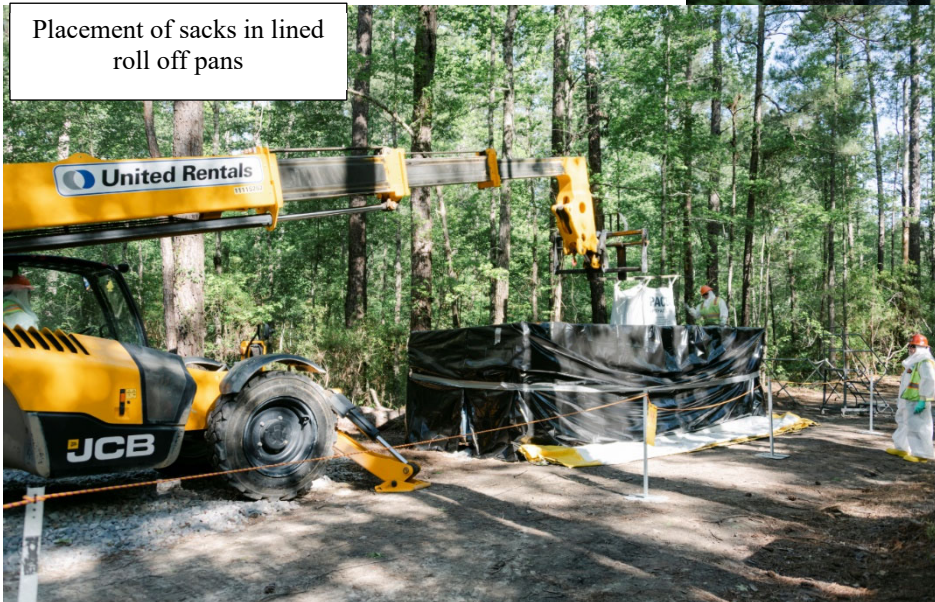
Figure 15. Excavation of R-Area Discharge Canal Sediments

The roll off containers were covered to prevent rainwater infiltration and then staged in a paved parking area near the former entrance to the R-Area reactor perimeter fence. After the project was completed, the roll off pans were shipped to the SRS LLWF in E-Area for disposal.

Excavation of exposed and treated sediments

Placement of sediments in 1 cy double line sacks

Placement of sacks in lined roll off pans

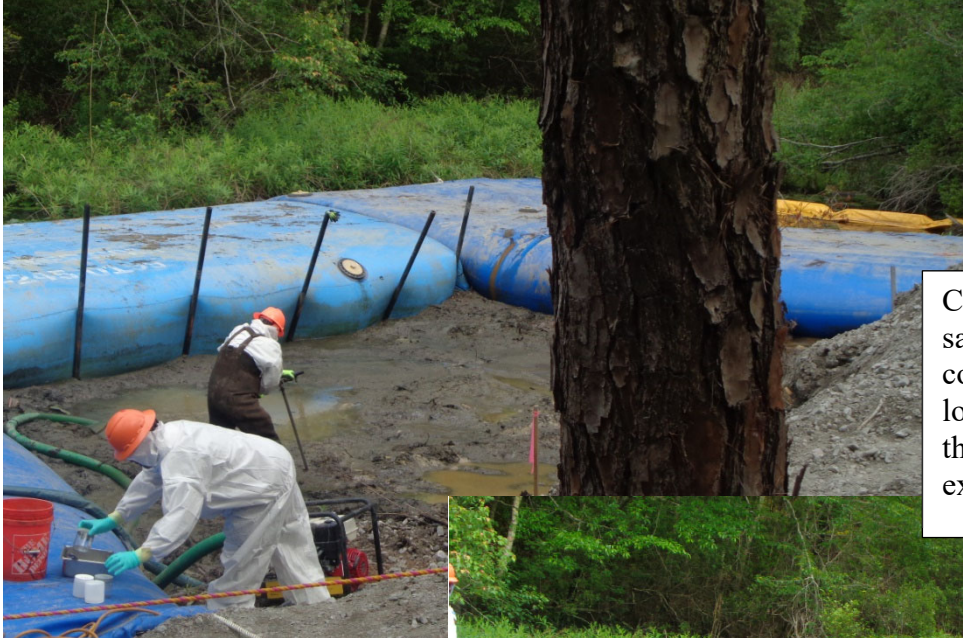
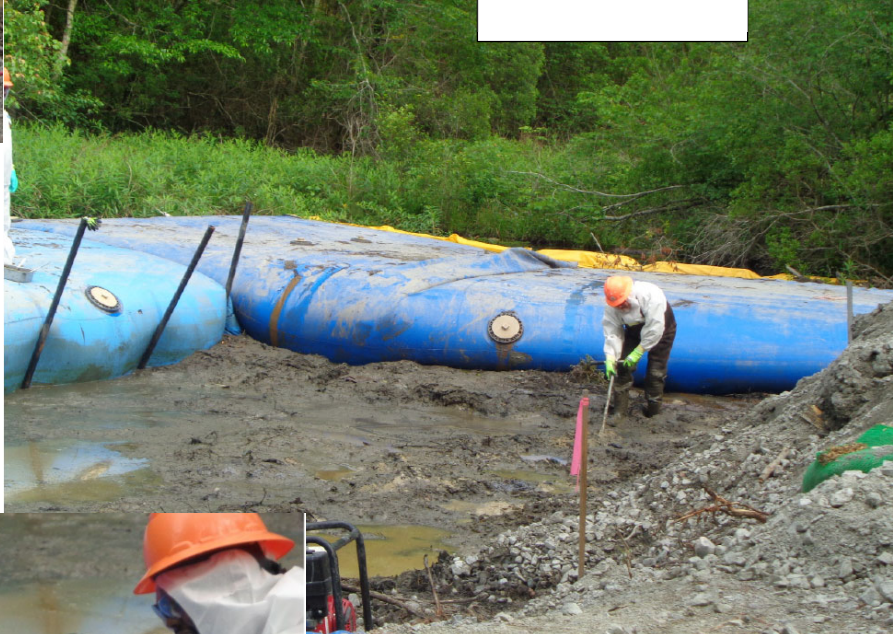
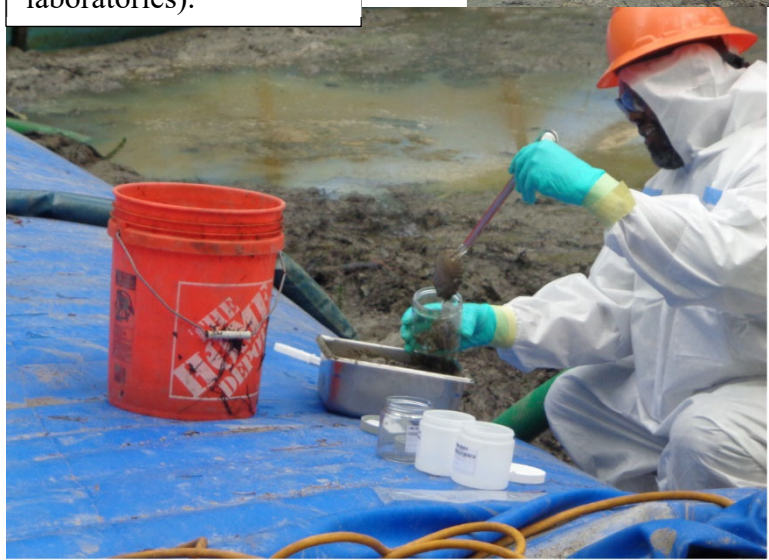
**Figure 16. Confirmation Sampling**

Confirmation samples were collected from 5 locations within the 500 ft<sup>2</sup> excavation area.

The sediment samples were then composited and packaged for shipping to GEL and TAL (offsite laboratories).

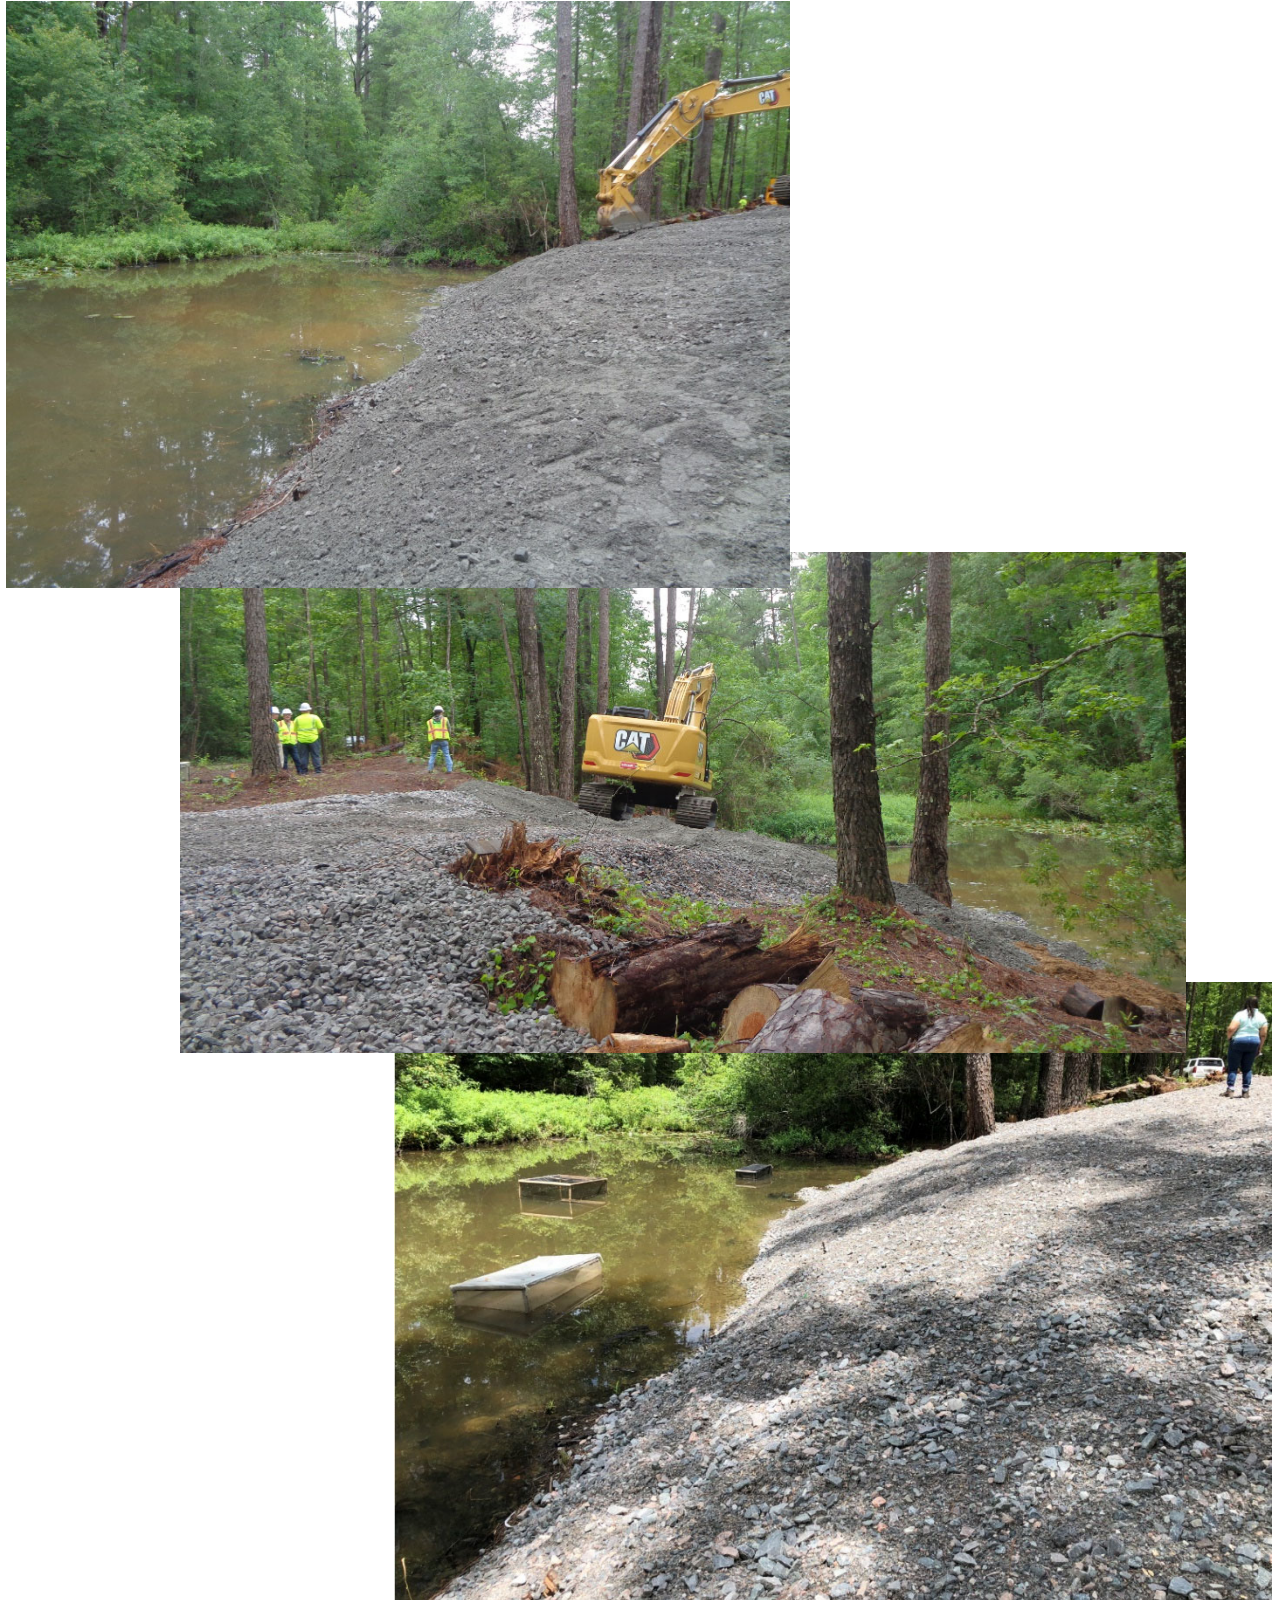
**Figure 18. Final Grading and Final Acceptance Inspection**

the design requirements. A final acceptance inspection for the R-Area Discharge Canal excavation and access gate installation was held on May 25, 2023, and SRNS approved the site conditions. A final acceptance inspection for the LUC access warning sign installation was held on July 17, 2023, and SRNS approved the site conditions.

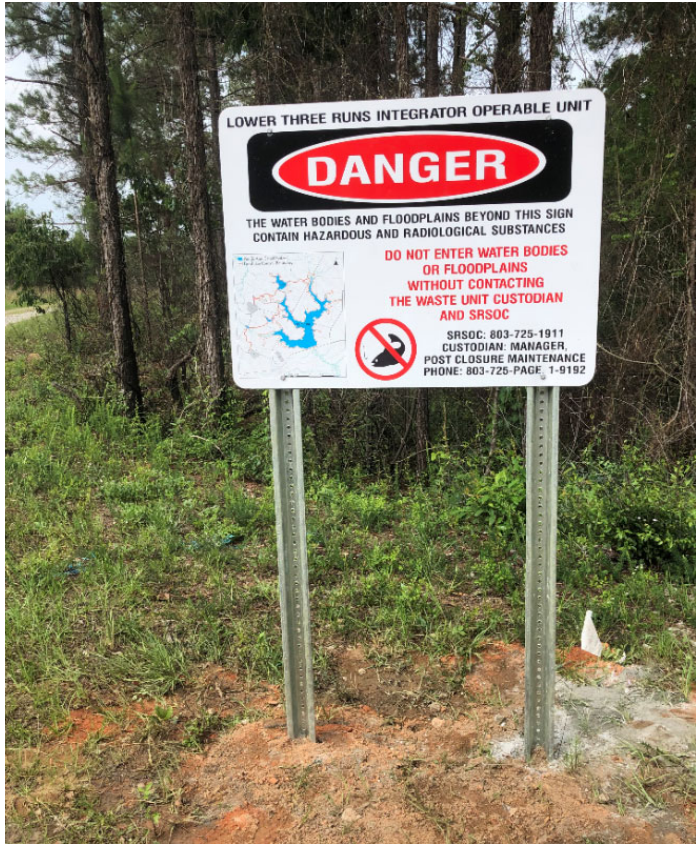
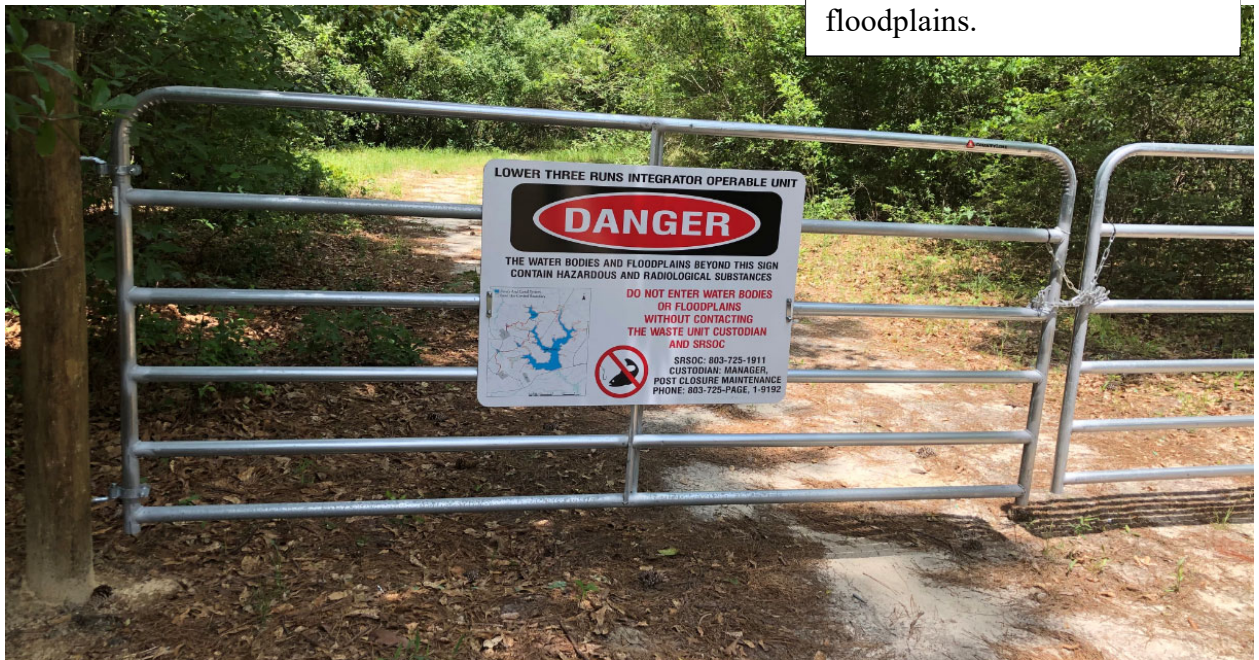
Figure 20. Access Control Warning Signs (typical)

51 Signs were installed on posts at access points to the LTR IOU waterbodies and floodplains.

4 Signs were installed on gates: 2 at access points to the LTR IOU waterbodies and floodplains.
