## Decommissioning Project Final Report Building 683-D, Chlorine Unloading and Storage

*Prepared for*  
U.S. Department of Energy  
*and*  
Savannah River Nuclear Solutions LLC  
Aiken, South Carolina

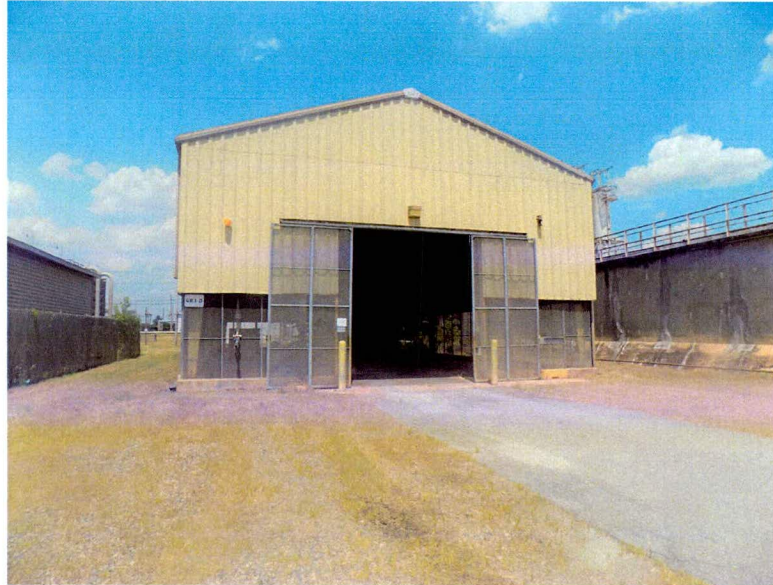
Figure A-1. Building 683-D (Looking East) Before

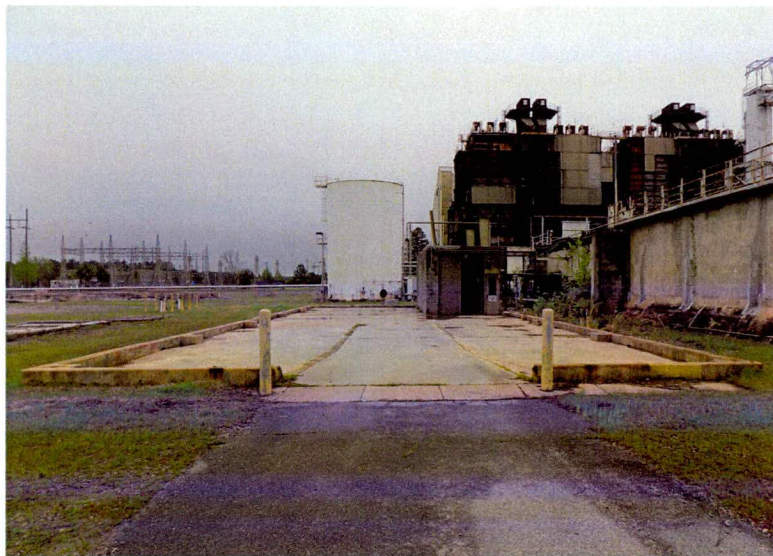
Figure A-2. Building 683-D (Looking East) After Partial Decommissioning by CRO

The 683-D steel building was removed intact by CRO for reuse or resale.

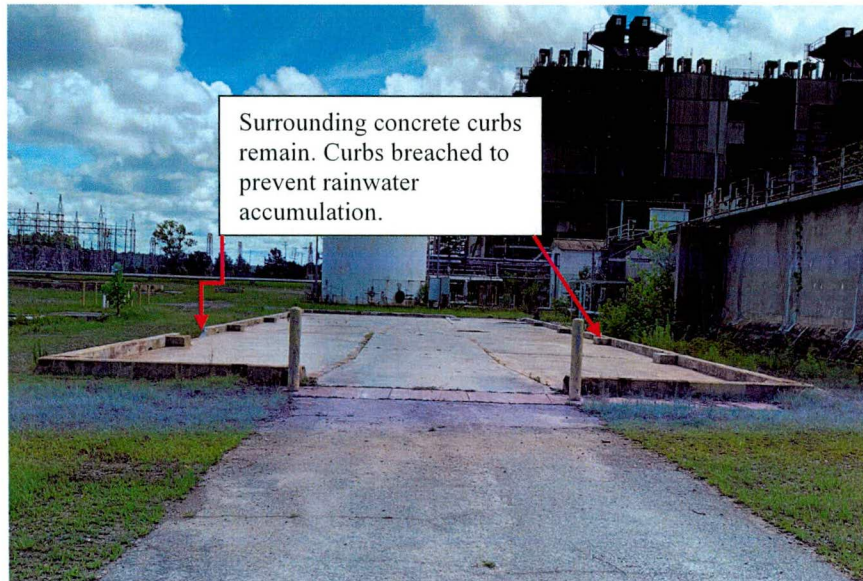
Figure A-3. Building 683-D (Looking East) After Final Decommissioning

The 683-D steel building was D&R down to the concrete slab by CRO. The remaining decommissioning activities were completed by CTI and Associates, Inc. The masonry chlorination room located on the southeast corner of the slab was demolished down to the slab. All appurtenances, the ancillary sea-lands, Handi-House, and metal tracks were D&R to grade, concrete slab, or concrete pedestals, as applicable. The concrete slab and pedestals were verified to be free of equipment, structure, rubble, waste, and debris. All interfacing utilities were isolated, disconnected, and plugged. Resulting holes were plugged and grouted. Building 683-D and its ancillaries were D&R and the remaining concrete slab and concrete pedestals have been left in place and remain left in place.

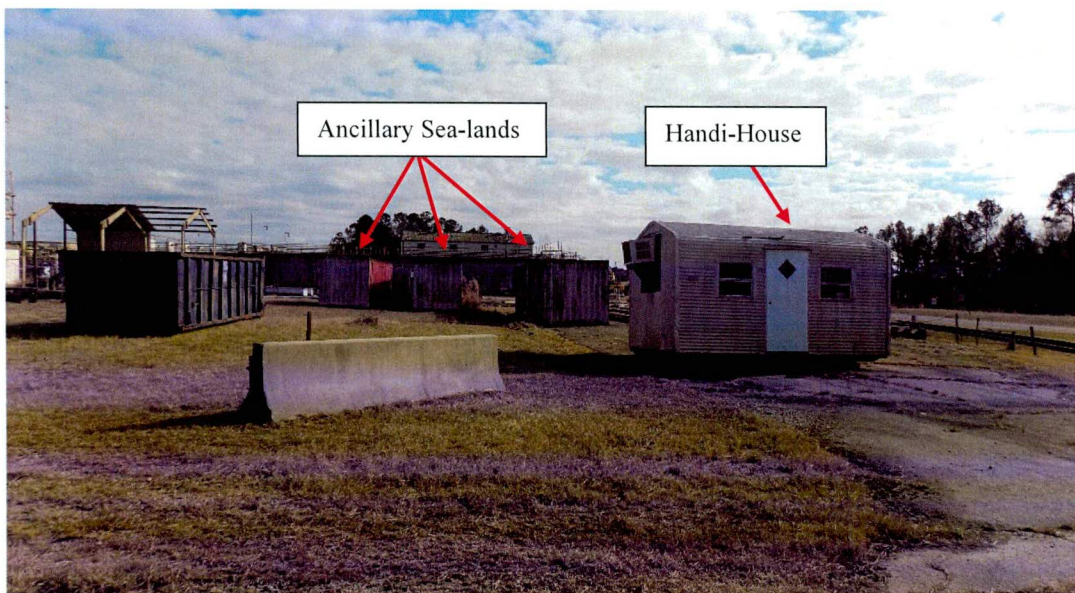
Figure A-4. Ancillary Sea-lands and Handi-House (Looking South) Before

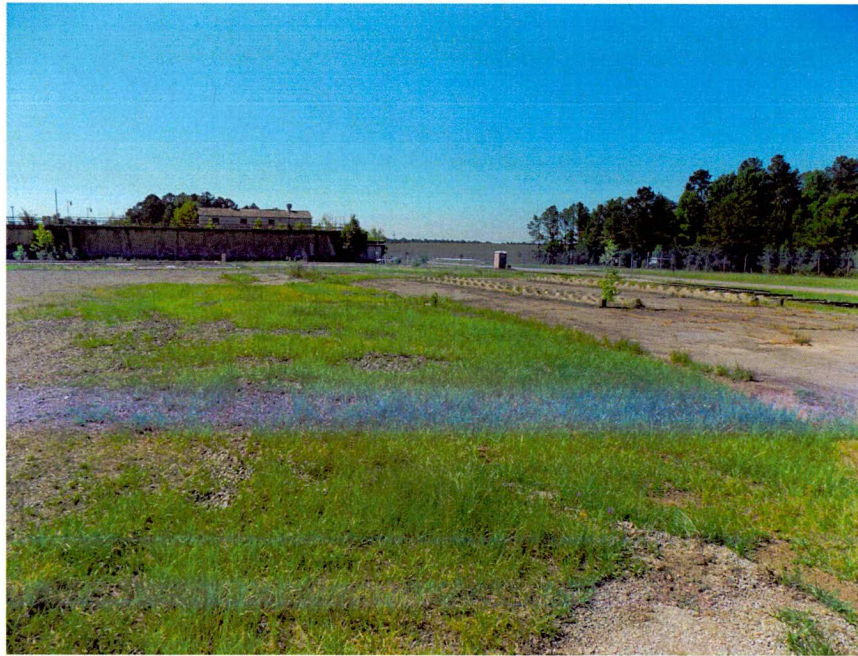
Figure A-5. Ancillary Sea-lands and Handi-House (Looking South) After

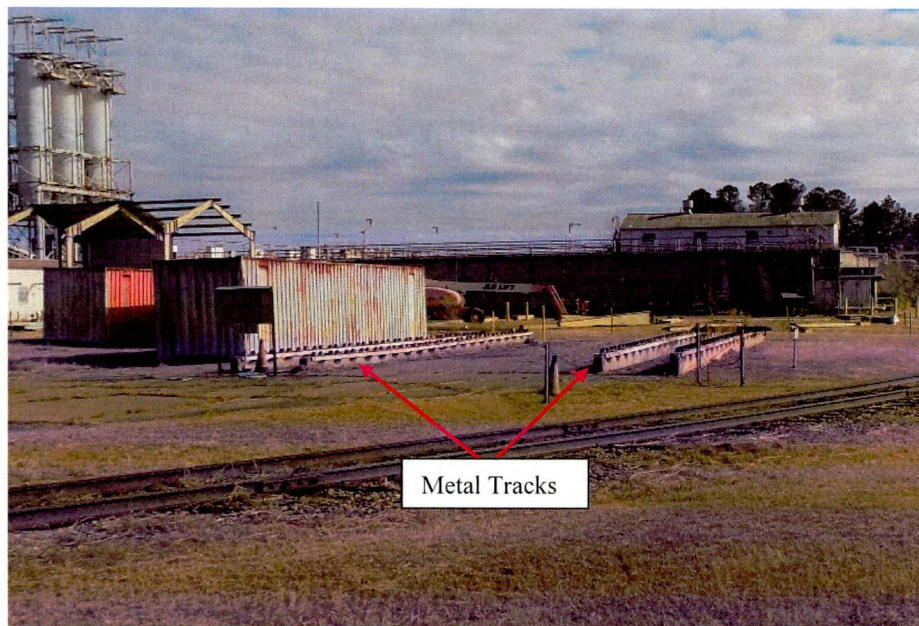
Figure A-6. Ancillary Metal Tracks (Looking Southeast) Before

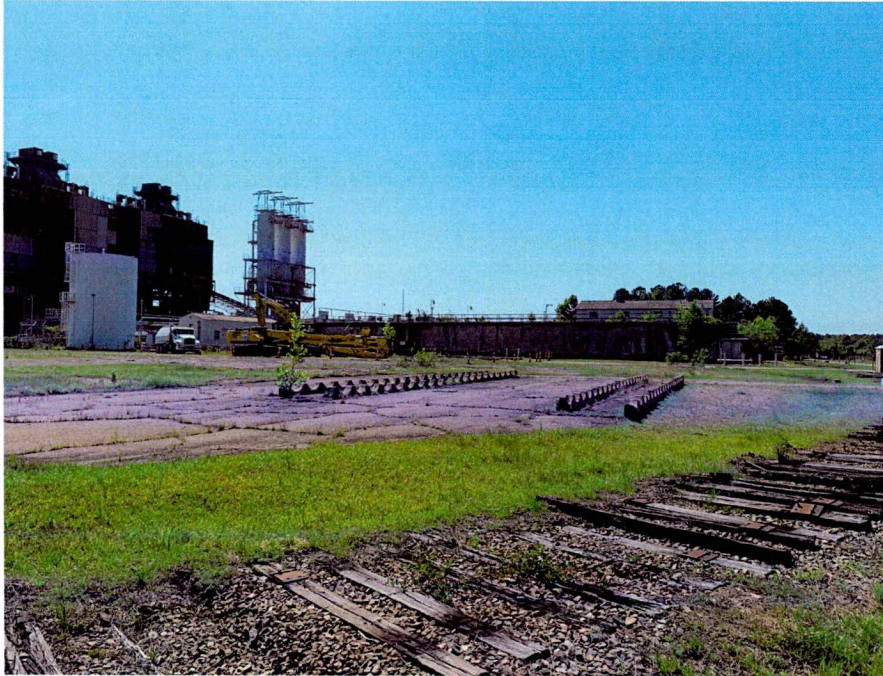
Figure A-7. Ancillary Metal Tracks (Looking Southeast) After
