Facility Decommissioning Evaluation Building 720-F, Central Alarm Station

This is a Simple Model Decommissioning per Facility Disposition Manual 1C

Introduction

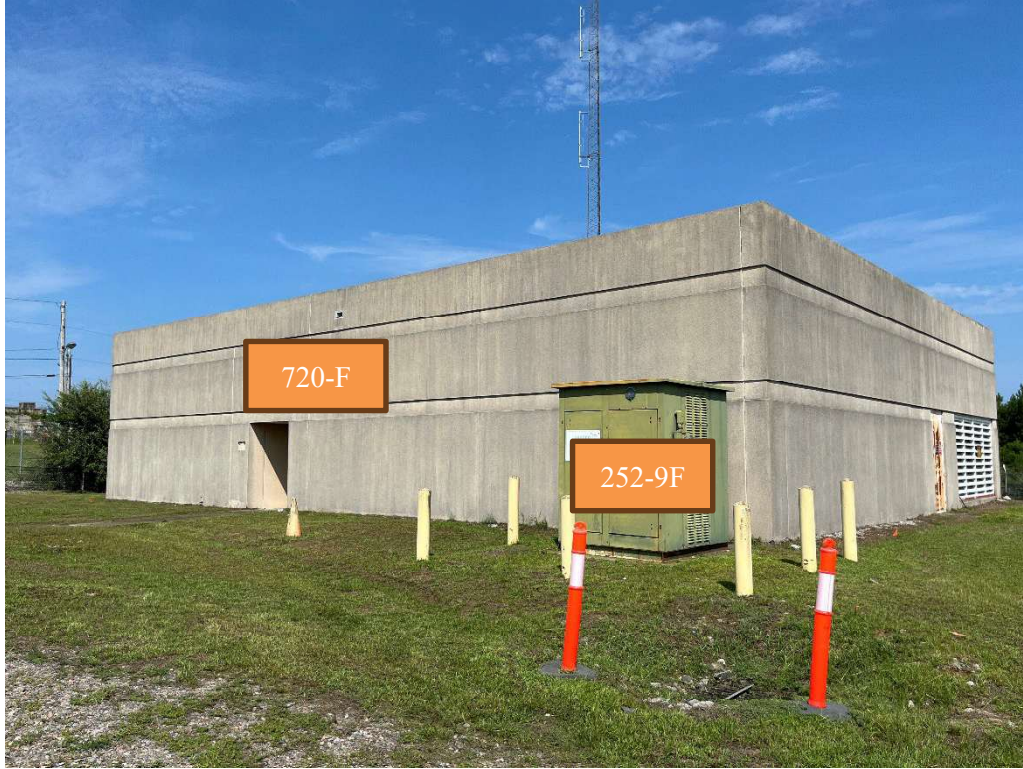
Figure 2: Photograph of 720-F and 252-9F taken from Southeast.

Building 720-F, CAS, provided F-Area (Figure 1) with intrusion detection and access control per the Electronic Safeguards & Security System (E3S). Building 720-F is a 3,913 square foot, single-story structure (Figure 2). It was built in 1989 on a concrete slab. The building is a steel-framed structure consisting of an interior of cement masonry block walls, drop acoustical ceiling tiles, and accessible floating floor panels in the computer and control rooms and electrical rooms (Figure 3). The exterior has a stucco finish and built-up roofing. The control room and computer room supported the E3S system. The structure contains old equipment which has been abandoned-in-place such as a mechanical compressor or items to support the E3S system and climate control that are all deactivated and are set to be removed during decommissioning work and prior to demolition. Final hazard removal actions (including removing the deactivated equipment) will be done to facilitate demolition with heavy equipment. The building contains a minimum 6-inch-high wall surrounding the diesel generator to prevent spillage of oil/grease or water into E3S/computer rooms or outside (Figure 3 – top right) as well as a sump in the northeast corner near the deactivated diesel generator (Figure 4) (Reference 2).

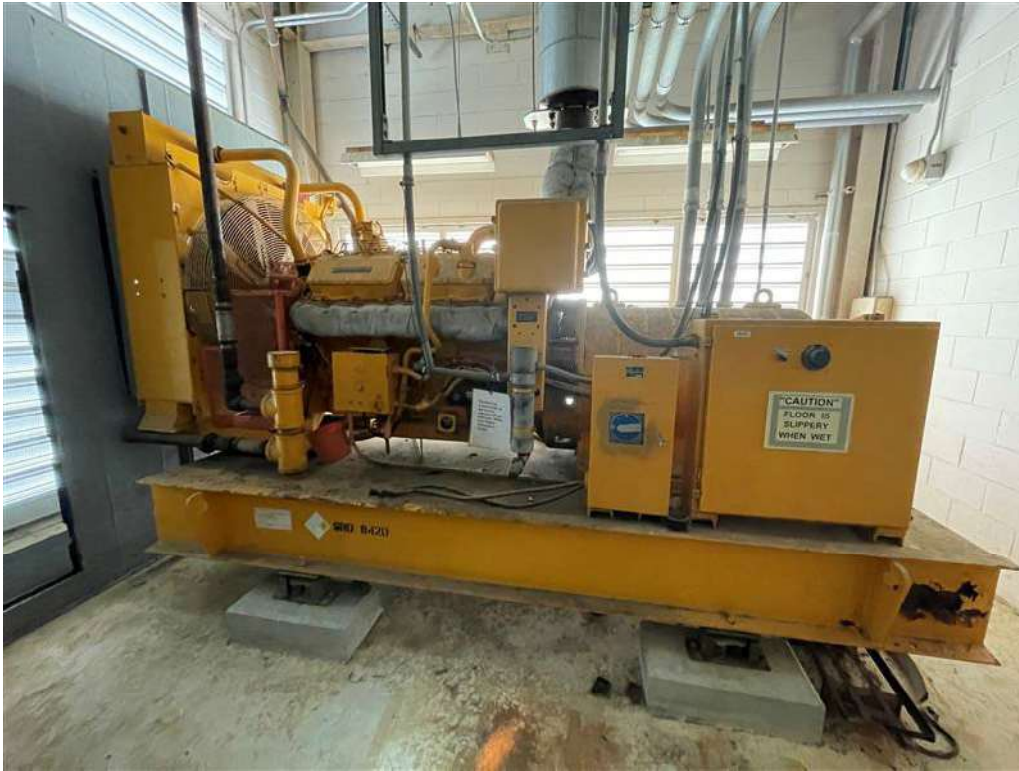
Figure 4: Diesel Generator within 720-F.

The service inlet used for refueling the diesel generator is located outside of the northeast corner of 720-F (Figure 3). This area included an external mini containment dyke designed to contain any spills that might occur during the refueling process along with a valve designed to capture spills or release rainwater. Spills would have been managed through the ORPS/SIRIM (Occurrence Reporting and Processing System/Site Item Reportability and Issue Management) database. No records of spills to the surrounding area outside of 720-F were identified in that database during research to prepare this FDE. The stained concrete will be treated with a surfactant during the decommissioning process and prior to Final Acceptance Inspection.

Contents emptied from the diesel generator sump will be pumped, typically into a 330-gallon tote tank, and characterized before disposition in accordance with the sample results. The disposition path and volume of rainwater will be discussed in the DPFR.

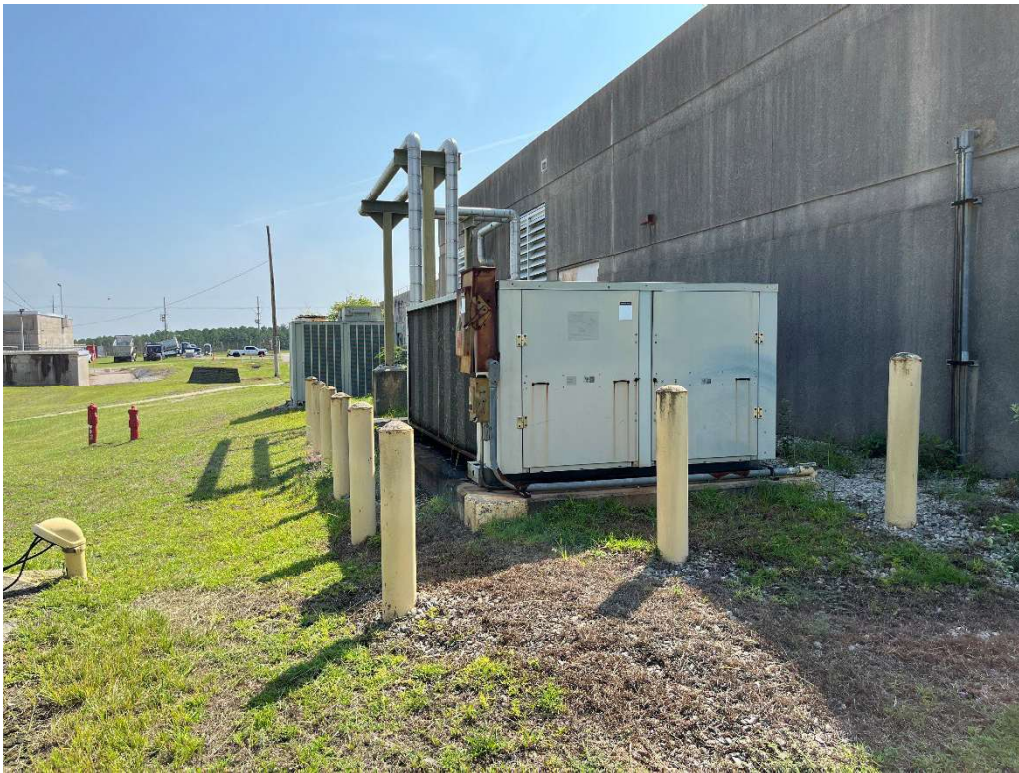
Figure 5: North Side of CAS Featuring the A/C Units and Slabs.

- Secondary Transformer 252-9F, a small transformer located on a concrete pad outside the south-east corner of Building 720-F,
- • 2 heating, ventilation, and air conditioning (HVAC) Units located on concrete pads north of Building 720-F, and
- A radio tower located on a concrete pad outside the north-west corner of Building 720-F.
