**SUBJECT:** Facility Decommissioning Evaluation, Building 690-N, Process Heat Exchanger Repair Facility (G-FDE-N-00013, Revision 2, May 2019), Savannah River Site's Responses to Regulatory Comments on the Revision 1 Document, Human Health Risk Screening Evaluation for 690-N Ford Building (U) (SDD-2019-00030, April 2019), and the Characterization Report for Building 690-N (Ford Building) and Ancillary Equipment and Facilities (SDD-2014-00054, Revision 1, August 2014)

**SRS Responses to SCDHEC Comments on the  
Facility Decommissioning Evaluation (FDE), Process Heat Exchanger Repair Facility  
(Ford Building), Building 690-N, G-FDE-N-00013, Revision 1, dated August 7, 2009**

# Process Heat Exchanger Repair Facility (690-N) Facility Decommissioning Evaluation (FDE)

# Process Heat Exchanger Repair Facility (690-N) (aka Ford Building)

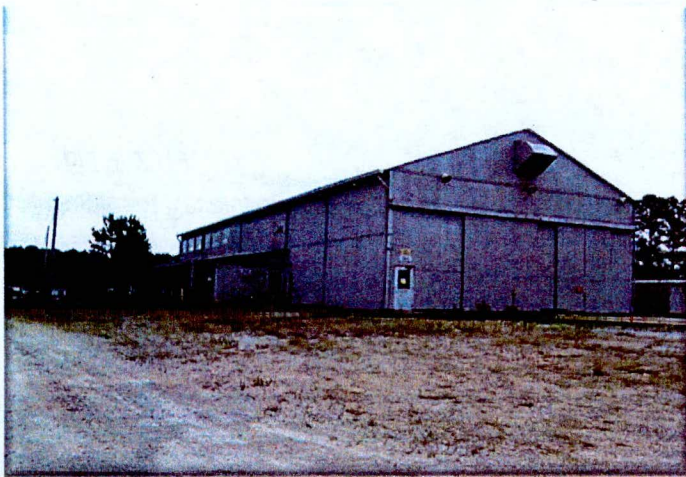
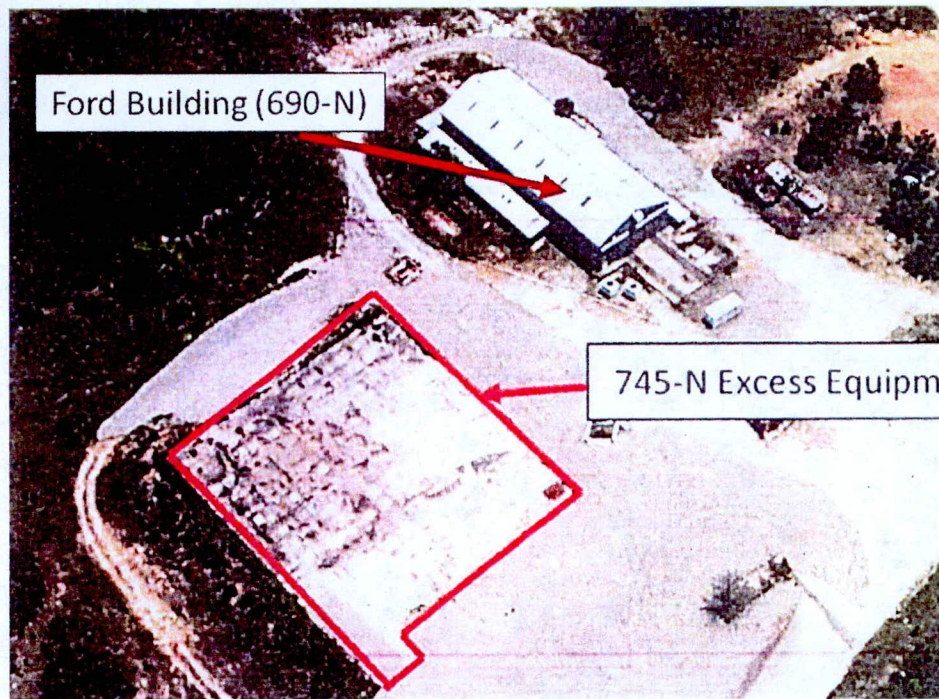
Approximate date of photo: 2015

- Building constructed in early 1950s for testing of Ford-company motor control packages for control rod drive mechanisms.
- To prepare for maintenance repair/rework of reactor heat exchangers, Ford Building (690-N) facility enlarged and a sealed inner liner structure with HEPA filtered HVAC system (Heat Exchanger Repair Shop) added. Constructed from 1964 to 1966.

- Facility used for maintenance repair/rework of radiologically contaminated heat exchangers from 1966 to 1982.
- New heat exchangers procured; Ford Building (690-N) used for final assembly and testing of new, clean heat exchangers from 1982 to late 1980s.

- Equipment and supplies stored in Ford Building (690-N) from late 1980s to early 1990s.
- Ford Building (690-N) used for repair of one K-Reactor Heat Exchanger in mid-1990s.

- **Stored equipment removed in 1998 and cleanup of Ford Building (690-N) initiated.**
  - Two epoxy coatings applied to floor of Heat Exchanger Repair Shop room in 1998 to seal residual PCB and radioactive contamination; third coating added in 2009.

- **Mechanical and electrical isolation (cold and dark) of Ford Building (690-N) completed in 2012**
- **Enhanced characterization performed in 2014; minimal contamination found in concrete floor slab, soils beneath slab, and Heat Exchanger Repair Shop room**

- **Administrative Plan:**
  - *Decommission Ford Building (690-N) structure under Integrated Sample Model*
  - *Include Ford Building (690-N) post-decommissioning remnant (building slab) in N-Area Waste Unit Closures*

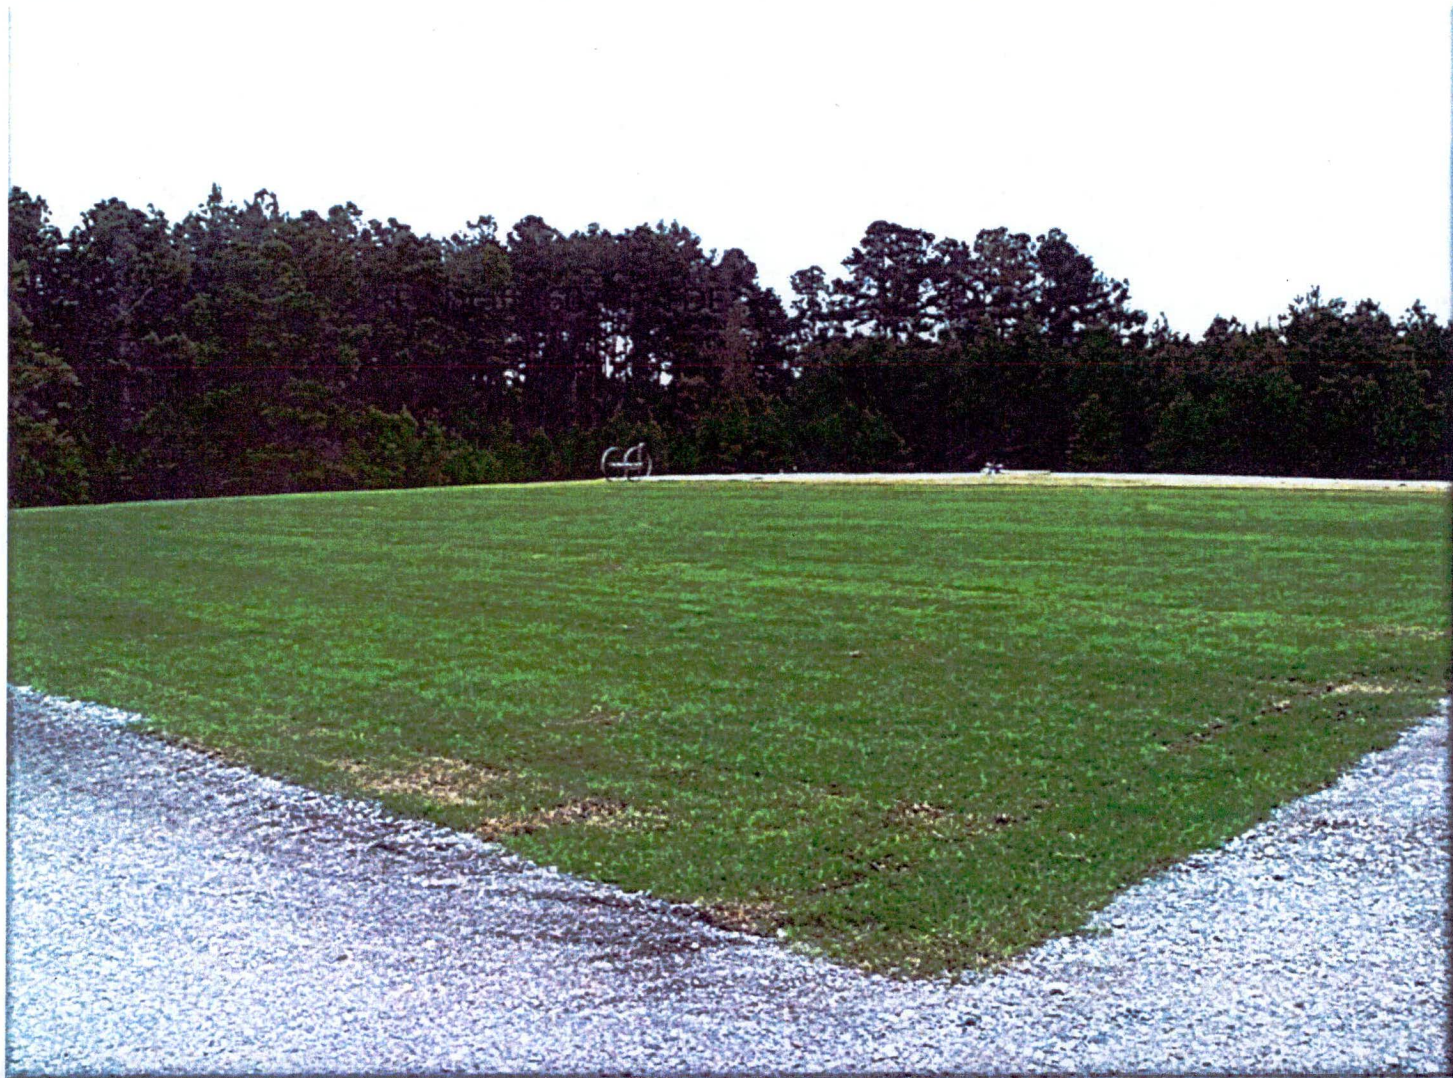
## Excess Equipment Yard (745-N)

- Excess Equipment Yard (745-N) pad constructed in 1958 as slab of hangar-style building for clean equipment storage.
- Building later demolished, 24,000 ft<sup>2</sup> pad retained. Pad used for storage of reactor process heat exchangers (repaired or awaiting repair).

- All 49 heat exchangers on Excess Equipment Yard (745-N) pad characterized, removed, and dispositioned to SRS Solid Waste Burial Ground in 2011-2012.
- Pad cracked under weight of large crane and 100 ton heat exchangers.

- Surface contamination found during sampling related to condensation leakage; pad was removed to eliminate risk of contaminant migration to soil.
  - Soil beneath pad sampled and area determined uncontaminated *per SRS-RCO procedures*.

- **Administrative Plan: Include in N-Area Waste Unit Closures**

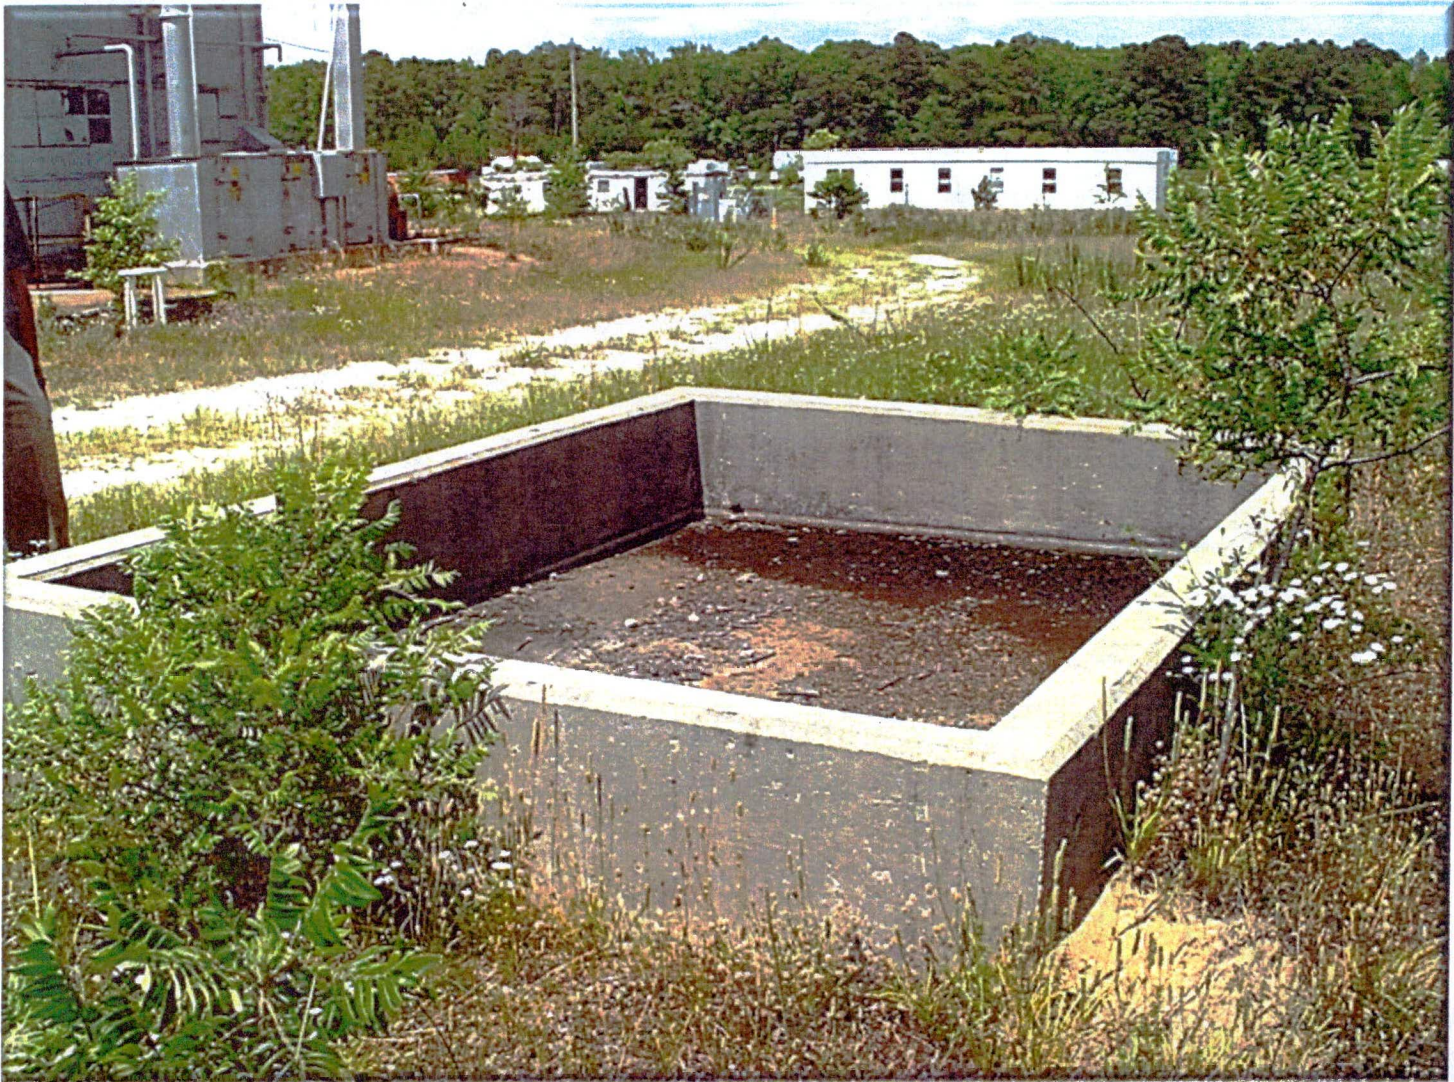
# Fuel Oil Tank Concrete Containment Dike

- Fuel Oil Tank supplied fuel oil to Ford Building (690-N) boiler.
  - Fuel Oil Tank and fuel oil piping to Ford Building (690-N) removed in 2006.
  - Remnant facility includes concrete basin.
  - No evidence of spills/leakage or visible cracks in containment dike.
  - No visible stains outside containment dike perimeter.
- 
- **Administrative Plan:**
    - *Decommission by cleaving containment dike to prevent accumulation of rainwater*
    - *Include post-decommissioning remnant (concrete structure) in N-Area Waste Unit Closures*

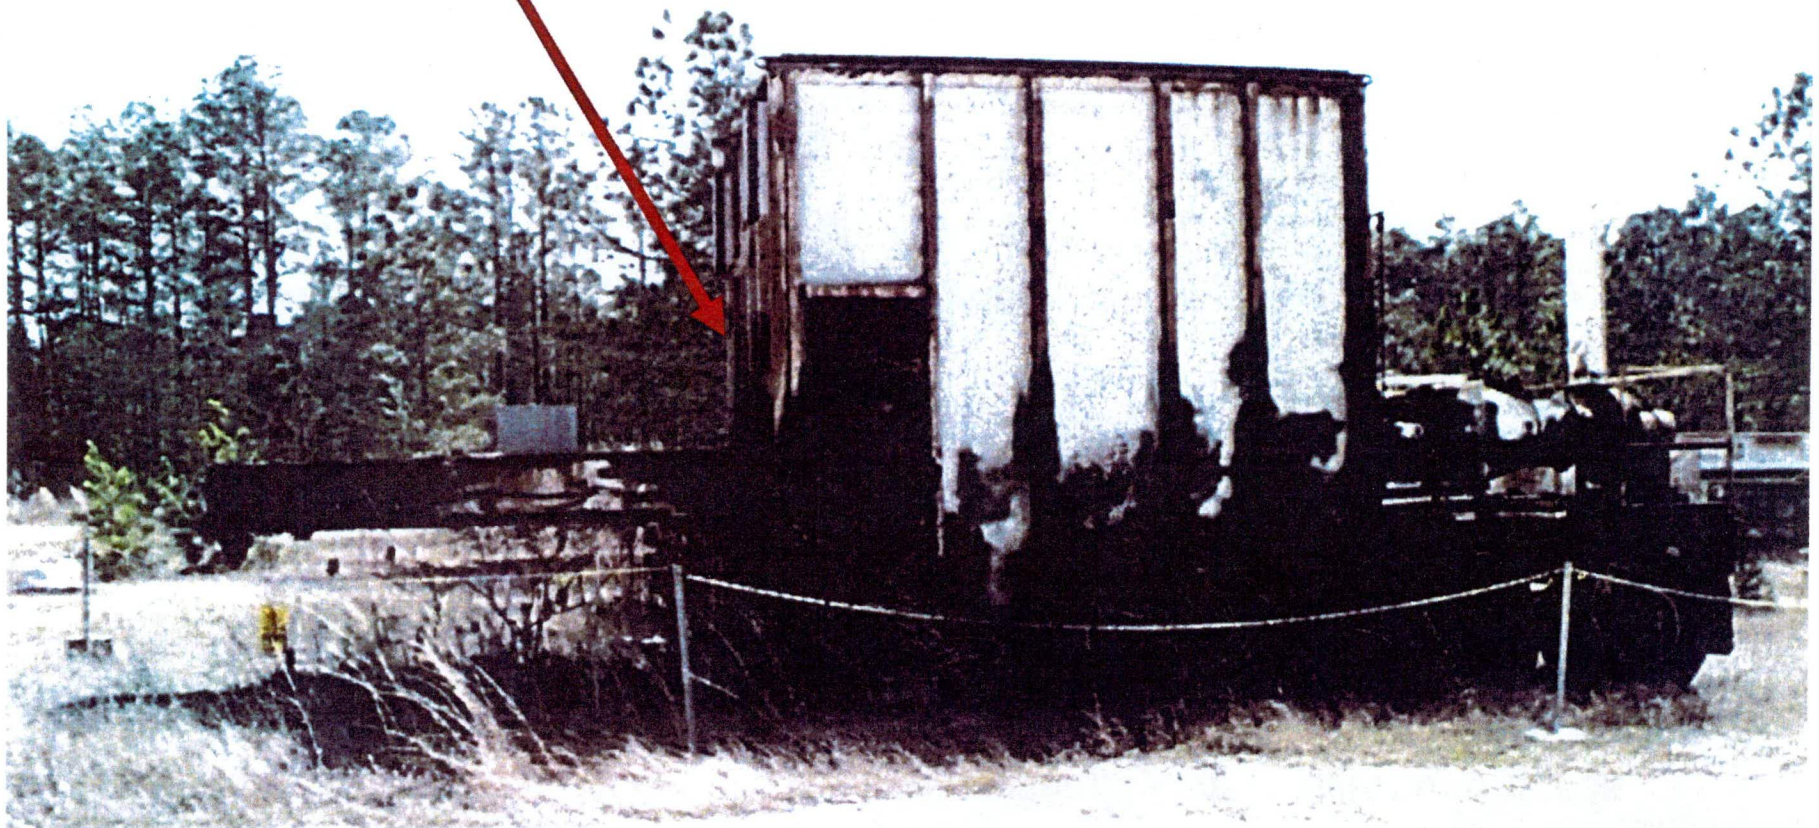
Portable Deionizer Trailer (690-1G)

- Portable equipment item used to clean disassembly basin water at process reactor buildings.
  - Trailer contains vessels, equipment, and HEPA system.
  - Never used as part of any process in or associated with Ford Building (690-N) (not a Ford Building [690-N] ancillary structure).
  - Rad Screen Results: either non-detect or trace amounts of activity in both pre-filter and HEPA filter samples; prefilter sample exceeded RCRA metal limit for lead (Pb) only and HEPA filter sample indicated no RCRA limit exceedances.
- 
- *Administrative Plan: To Be Dispositioned As Portable Equipment Item Separate from Ford Building (690-N)*

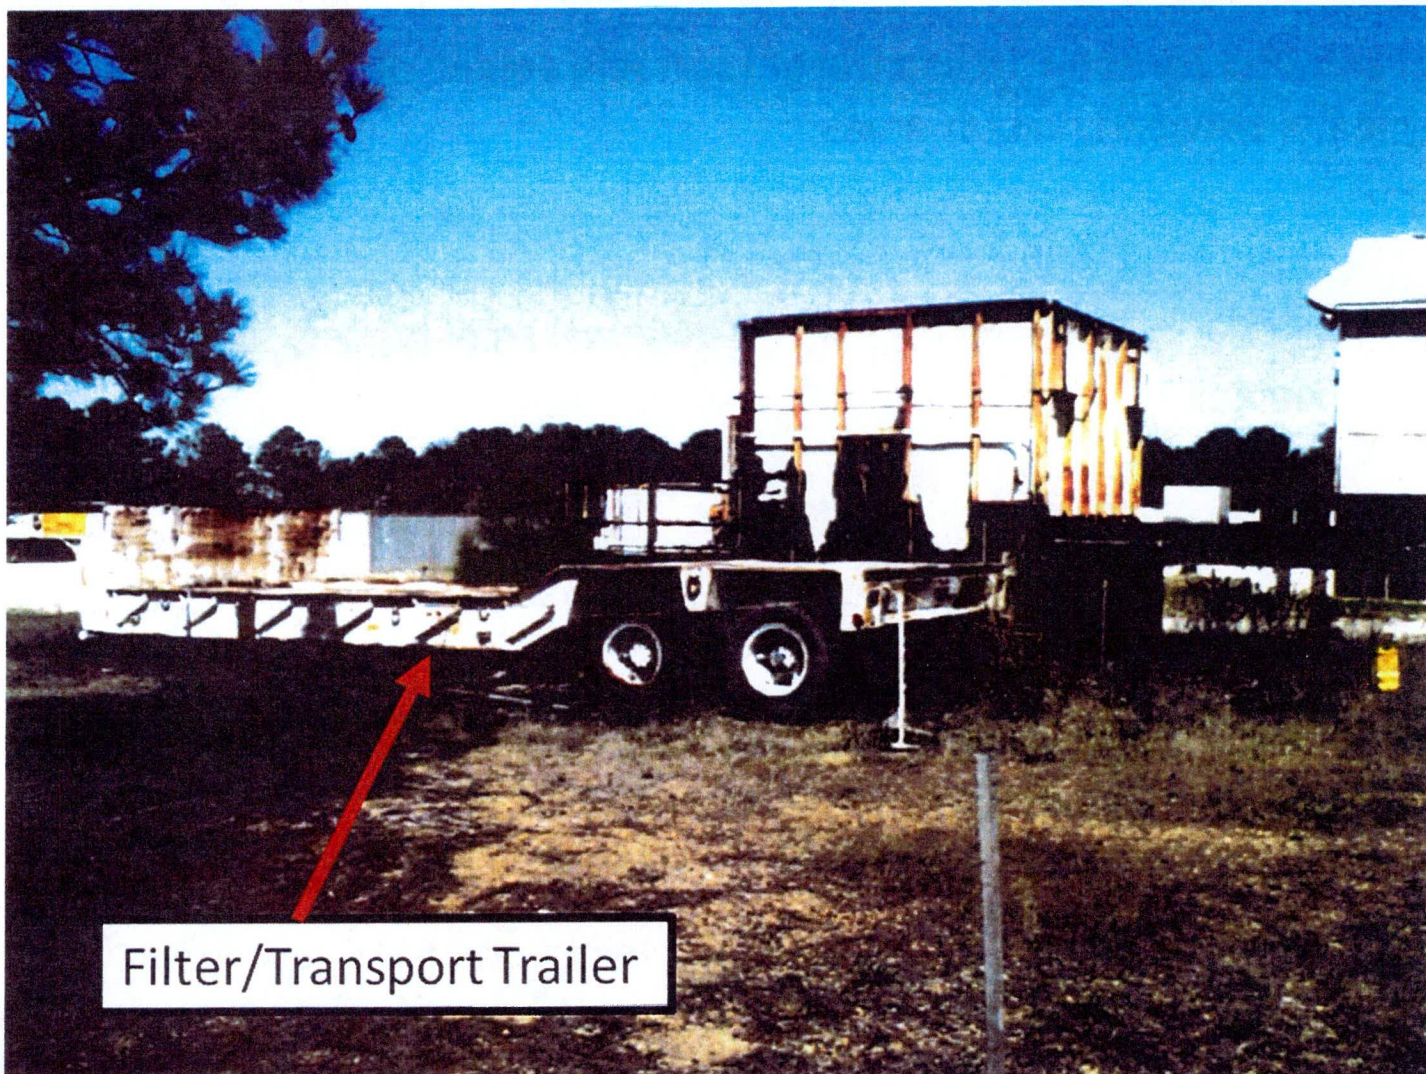
Filter/Transport Trailer

- Model 845-DLS low-boy flatbed trailer (portable equipment item) used to haul heavy loads between reactor areas.
  - Never used as part of any process in or associated with Ford Building (690-N) (not a Ford Building [690-N] Ancillary Structure).
  - Radiological Survey: Non-detect for radiological activity; field lead (Pb) tests were non-detect.
  - Dispositioned to SRS Solid Waste Burial Ground.
- 
- *Administrative Plan: Complete—Dispositioned to Burial Ground*

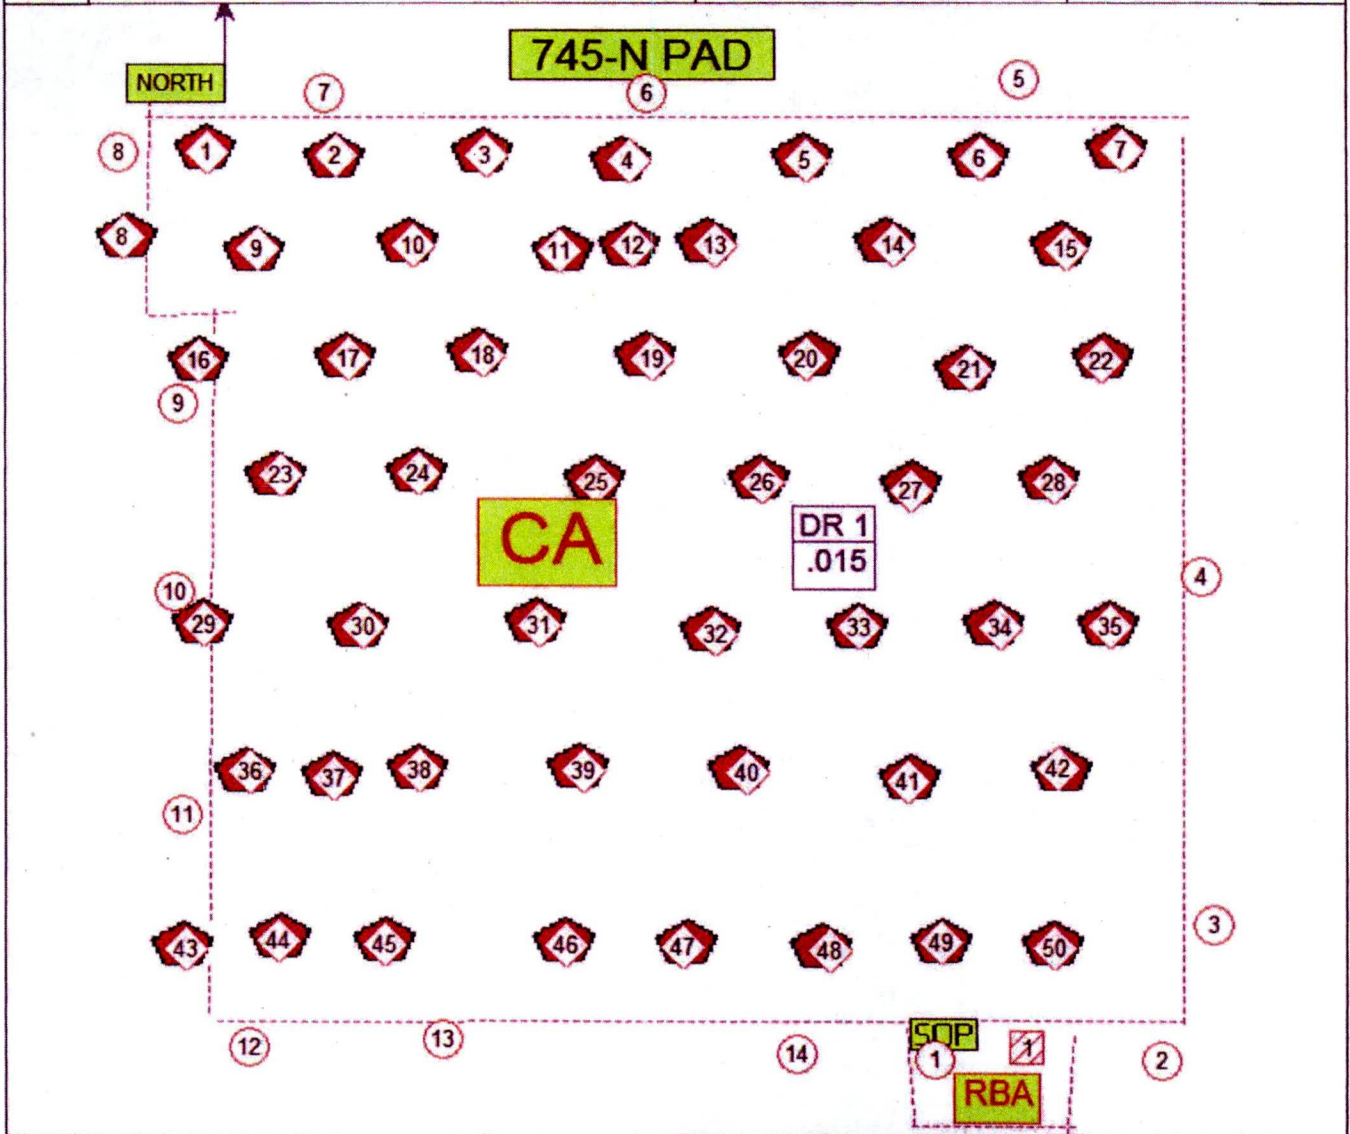
Map: 1 BLANK MAP Survey #: DDSG-M-20150714-1 Date/Time: 07/14/2015 07:30

Type: Other - Roll Back Survey

Unless otherwise noted, dose rates in mrem/hr.

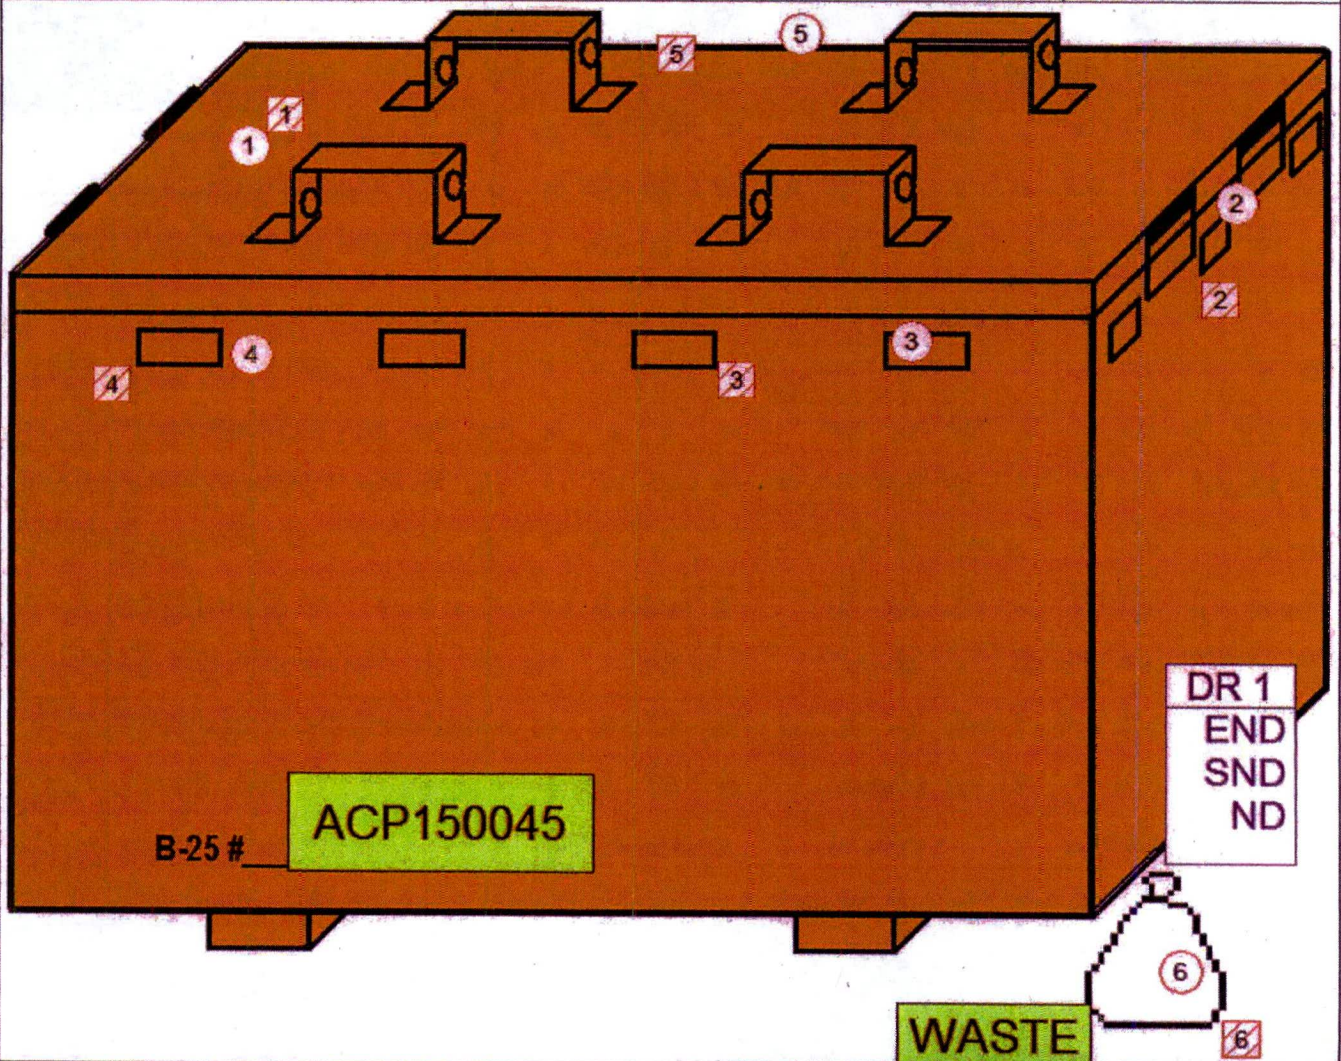
Map: 4 SINGLE B25 001 Survey #: DDSG-M-20150714-1 Date/Time: 07/14/2015 07:30

Summary of Highest Readings (All available values may not be listed)	
Smears	Air Samples & Wipes
6) <20 DPM/100 cm <sup>2</sup> α	Wipe 6) ND DPM/Wipe α
6) <200 DPM/100 cm <sup>2</sup> β/γ	Wipe 6) ND DPM/Wipe β/γ
6) <1000 DPM/100 cm <sup>2</sup> Tritium

Unless otherwise noted, dose rates in mrem/hr.

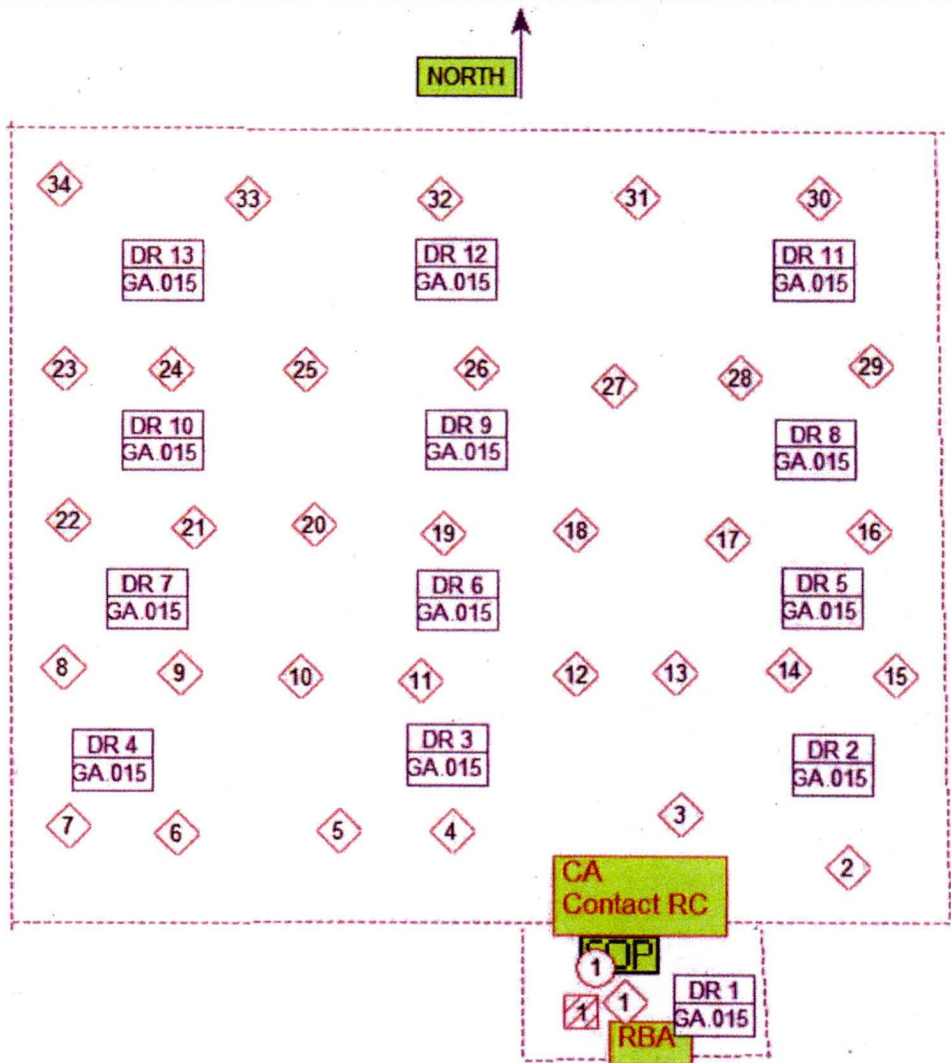
BLANK MAP Survey #: DDSG-M-20150713-1 Date/Time: 07/13/2015 07:15

Summary of Highest Readings (All available values may not be listed)	
Smears	Air Samples & Wipes
1) <20 DPM/100 cm <sup>2</sup> α 1) <200 DPM/100 cm <sup>2</sup> β/γ	Wipe 1) ND DPM/Wipe α Wipe 1) ND DPM/Wipe β/γ

Unless otherwise noted, dose rates in mrem/hr.
