Facility Decommissioning Evaluation Building 484-15D, D-Area Storage Building

This is a Simple Model Decommissioning per Facility Disposition Manual 1C

This Evaluation has been prepared in accordance with requirements found in Facility Disposition Manual 1C, Procedure 502, "Preparing Decommissioning Decision Documents". The scope of this evaluation is for Building 484-15D in D-Area which is further described in the next section.

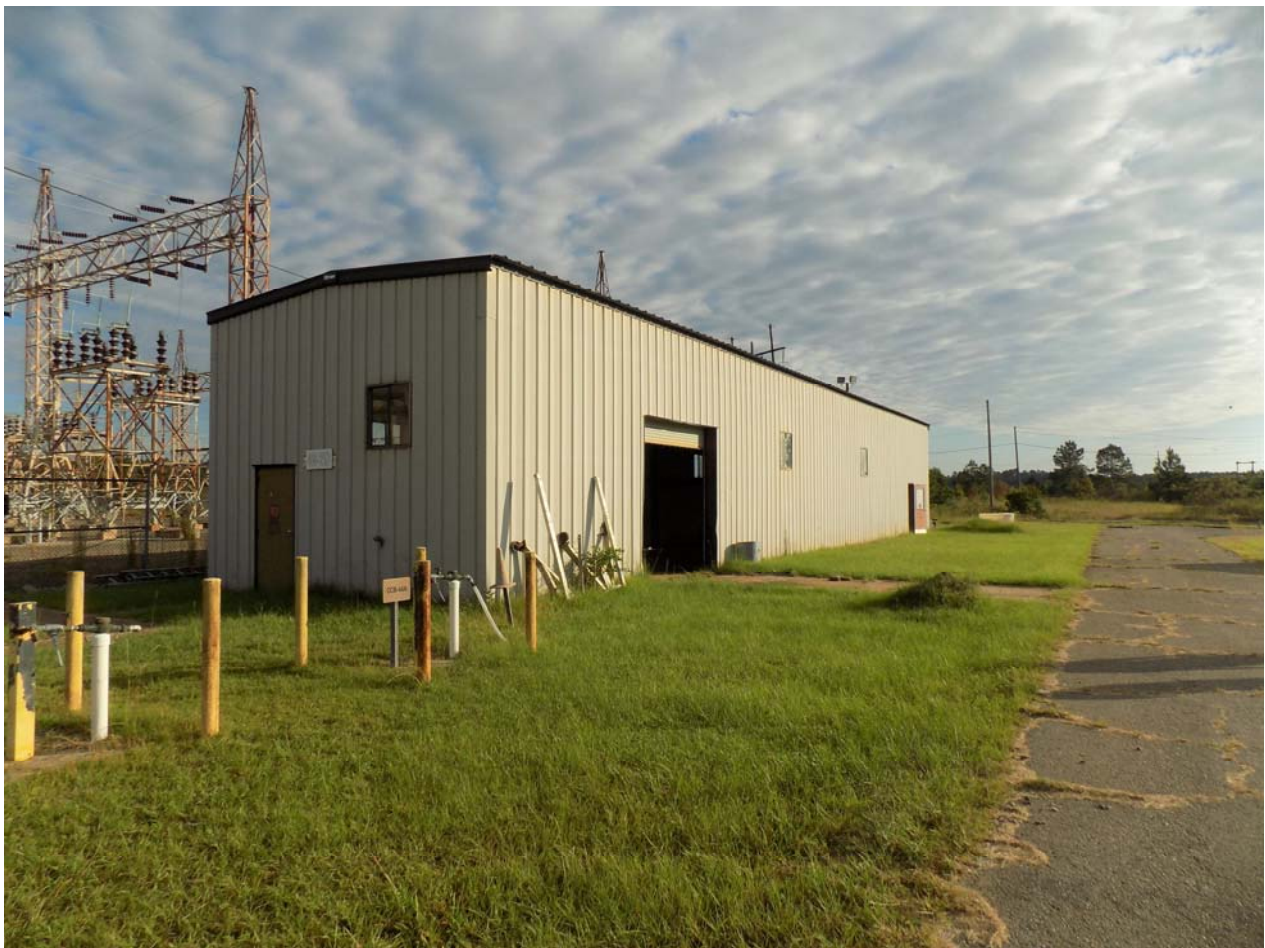
Building 484-15D is a steel frame structure with metal roof and skin, sitting on a concrete slab. The ceiling and walls in the interior of the structure are insulated with white plastic-backed, fiberglass insulation. The structure itself is approximately (~) 100 feet (ft) by 20 ft and ~20-ft tall. The building's electrical service has been deactivated (disconnected and air gapped), rendering the building cold & dark, refer to "Deactivation Project Final Report Building 484-D Powerhouse and Ancillary Buildings", V-PCOR-D-00042 (Reference 6). No other utilities were provided to the structure. Figure 1 is a picture of the building. Figures 2 and 3 are a layout of the building and a layout of the area in which the building is located, respectively. The building has a laydown yard associated with it. The structure was erected post-1987.

Figure 1. Building 484-15D, D-Area Storage Building

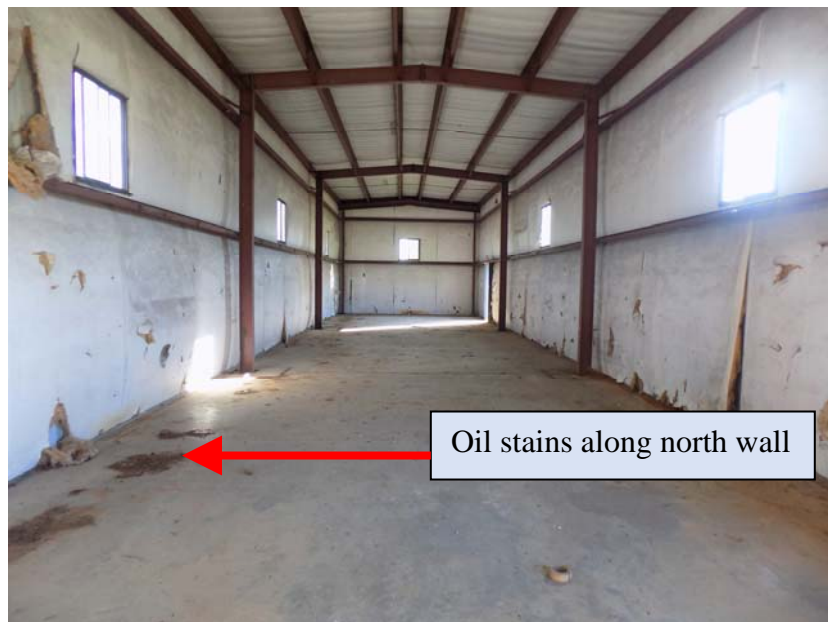
The concrete slab is stained in several places within the structure. The staining is limited in extent and is primarily along the north wall, indicating small quantities of release. Further, no evidence could be seen that the leaks may have migrated outside the confines of the slab. The slab is in good condition and has maintained its integrity. Further, there are no drains or sumps for the structure. Figure 4 provides a picture of stained concrete along the north wall of the facility.

Figure 4. Building 484-15D, D-Area Storage Building Slab Stains

Review of the FFA, the SRS ORPS/SIRIM database and SRS spill files reveal no records of spills having occurred outside of the 484-15D structure. Staining of concrete within the structure indicates that some small spills occurred. The nature and location of the staining indicate that the source of the material that caused the stains was likely oil or other common petroleum product leak. Staining was limited to within the structure. The leaks were apparently small and were limited to the concrete slab within the structure. No evidence of contamination of soil outside the structure was noted. Stains on the concrete will be cleaned with BioSolve® or equivalent surfactant during decommissioning.
