## Facility Decommissioning Evaluation Building 484-5D, D-Area Powerhouse Storage Building

This is a Simple Model Decommissioning per Facility Disposition Manual 1C

Figure 1. Building 484-5D Powerhouse Storage Building

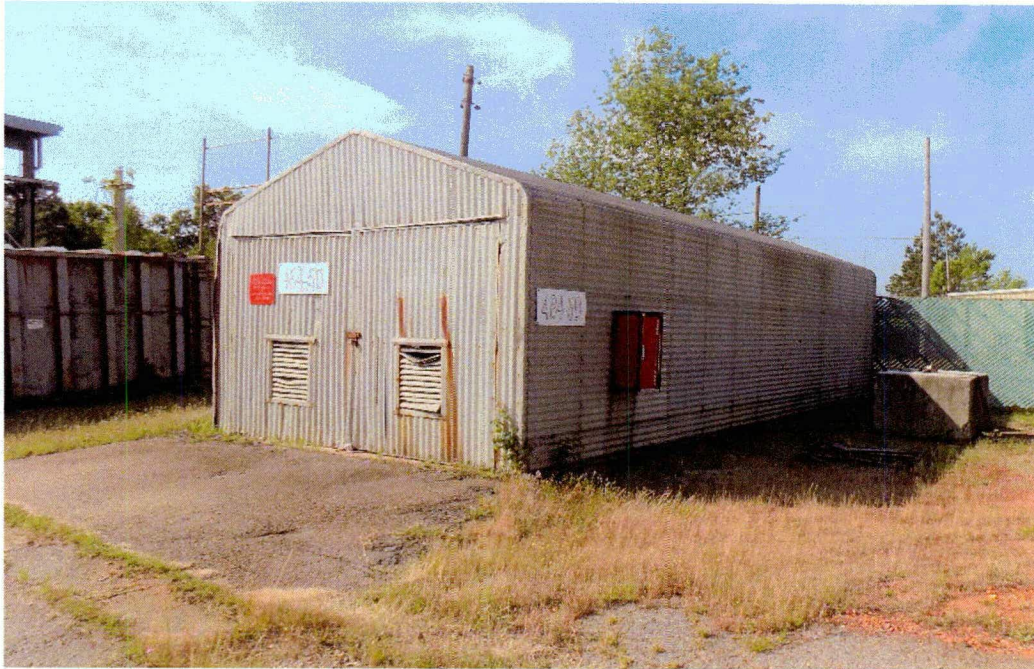
Building 484-5D was erected on site circa 1980. The structure is an aluminum tube-frame structure with a corrugated aluminum skin. The structure is attached to a concrete slab. The structure itself is approximately 12' X 30', with a non-partitioned interior. The structure has double, swinging doors at its front for access. Refer to Figure 1 for a picture of the structure, Figure 2 for a layout of the structure, and Figure 3 for surrounding structures.
