## Facility Decommissioning Evaluation Building 717-3D, D-Area Welding Shop

**This is a Simple Model Decommissioning per Facility Disposition Manual 1C**

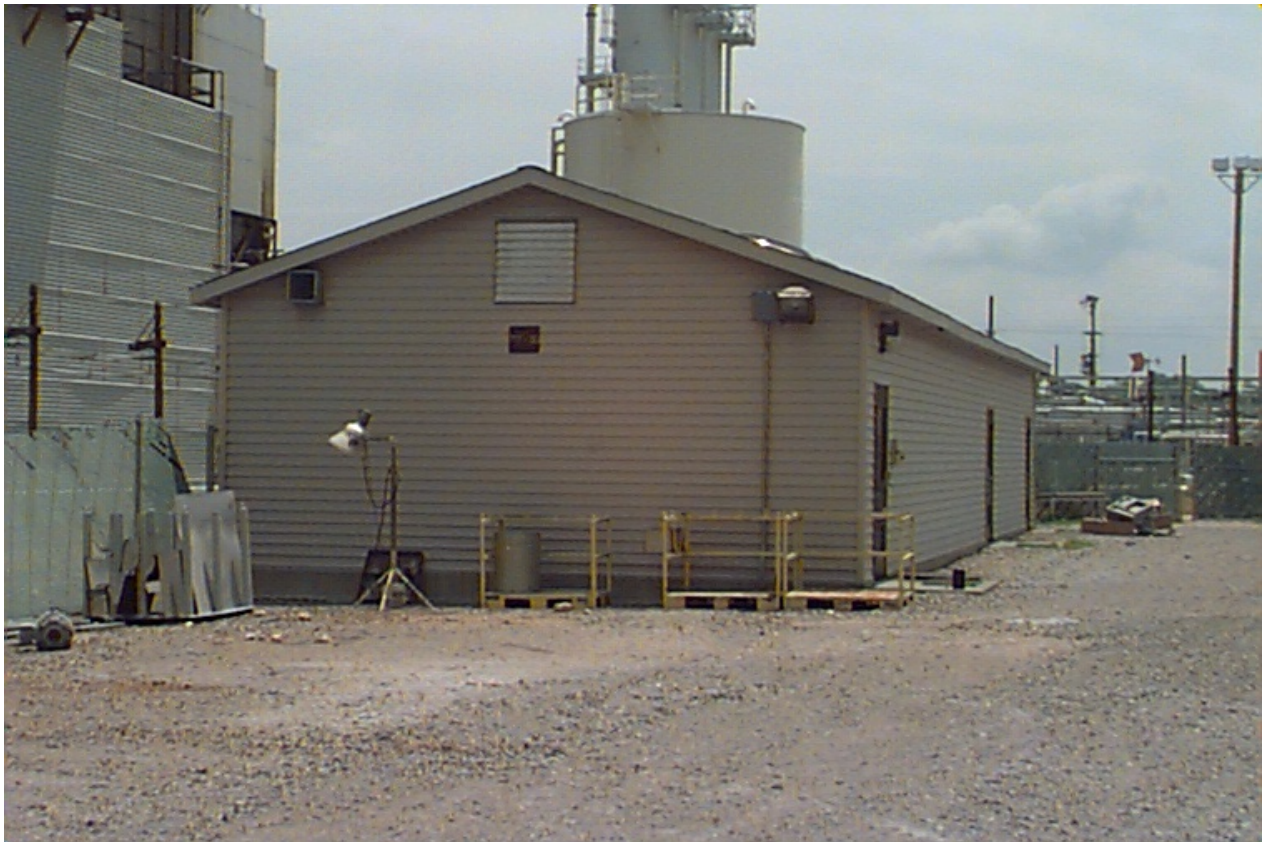
**Figure 1. Building 717-3D, D-Area Storage Facility**

Building 717-3D (Figure 1) is located on the north end of 400-D Area of the Savannah River Site (SRS) in South Carolina. The location of the building relative to surrounding structures can be seen in Figure 2. Building 717-3D is currently a storage building. Within a few years of construction, the building was converted to storage space. The building was constructed in 1991 to serve as a welding shop. The building is approximately 26.5' by 73.5' and 14' high at the peak of the roof, giving it approximately 1,900 ft<sup>2</sup> of floor space. The building is light steel frame construction with insulated walls and ceiling. Vinyl siding, wood and composite materials (non-asbestos) are also included in the construction. The roof of the structure is asphalt shingle. The flooring is tile on concrete, for the most part. The rest is plain concrete. The layout of the structure can be seen in Figure 3. The building had electricity supplied, which has since been cut off and isolated. There was no domestic water or sewer supplied to the structure. The building was provided with a speaker from the area's public address system. The building has a small sump in the center of the largest room in the building (south end). The sump is covered with a metal grate. Figure 4 shows the sump with the grating cover removed.

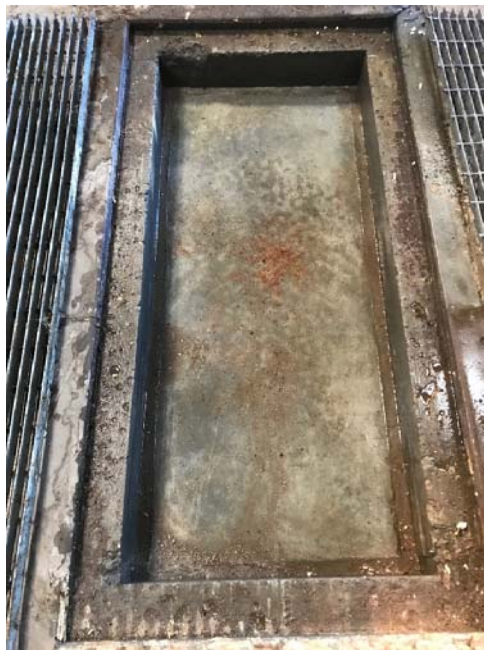
#### **Figure 4. Sump (with grating cover removed)**

The only sump in the facility is the 64” long x 28” wide x 5-3/4” deep sump in the center of the largest room (south end). The sump is covered by metal grating. There are no readily apparent stains on the slab of the structure or within the sump. Further, there are no observed cracks or loss of integrity in the slab or inside the sump.
