# **Scoping Summary for the ECODS N-1 (NBN), Central Shops Scrap Lumber Pile (631-2G), and Building 690-N, Process Heat Exchanger Repair Facility (Ford Building) Operable Unit (U)**

**(RFI/RI Work Plan Characterization)**

**SRNS-RP-2019-00764**

**December 2019 (Final)**

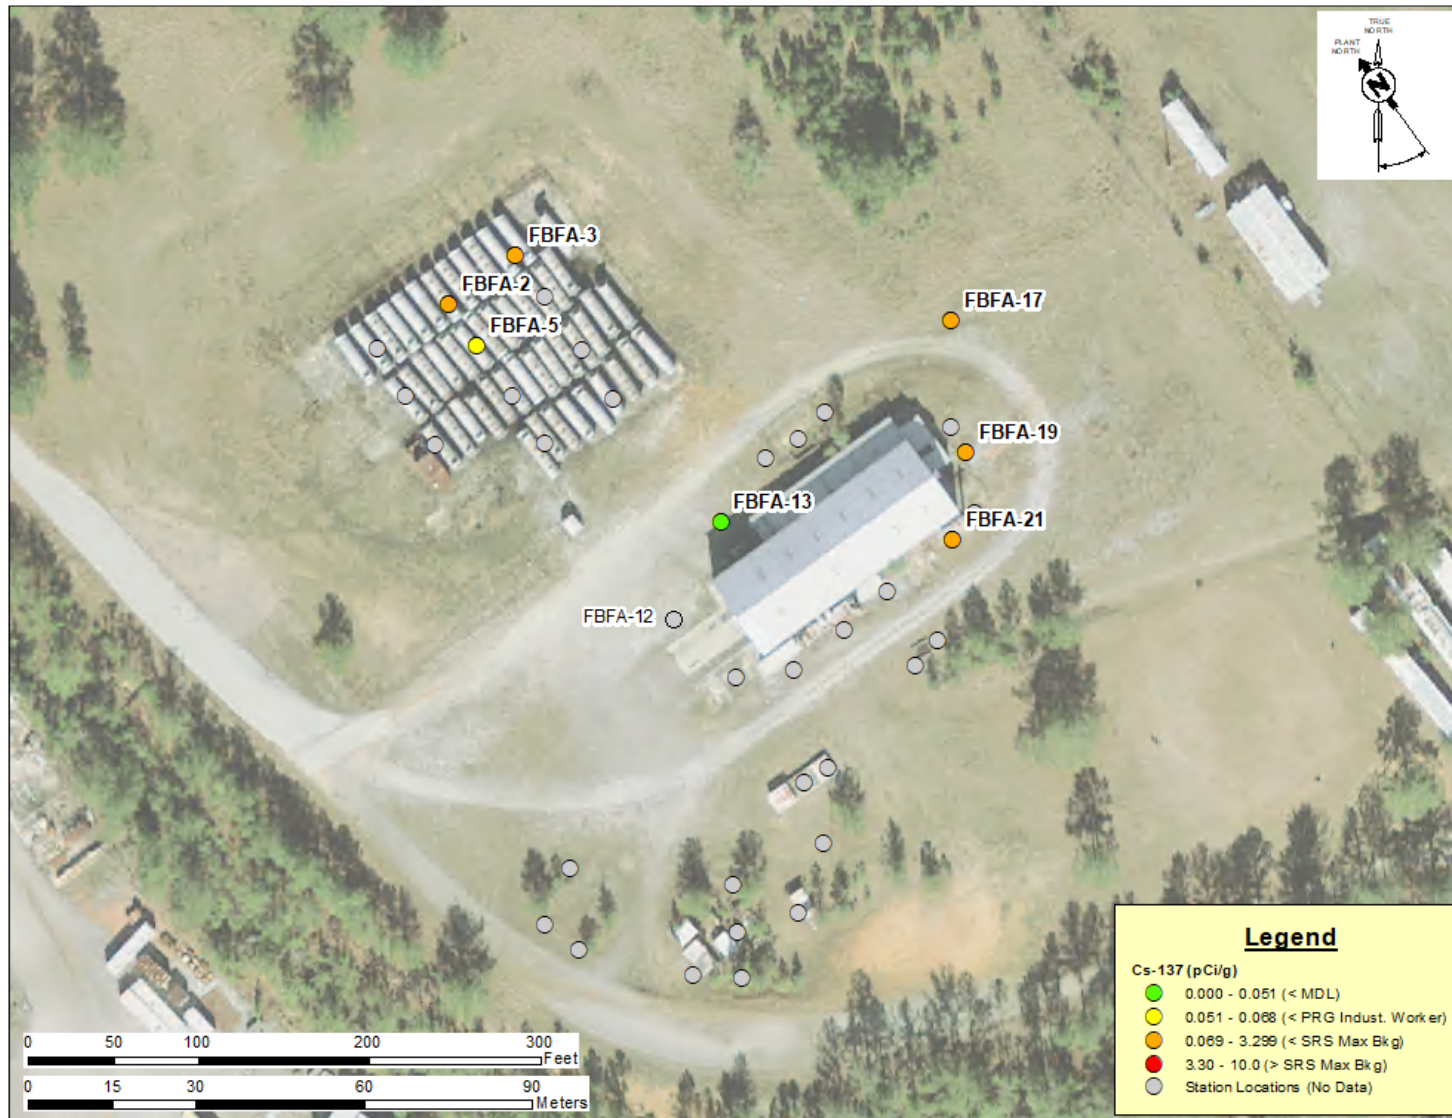
Figure 23. Ford Building (690-N) Nonvolatile Beta Results (> SRS Max Background) Surface Soil (0-1 ft)

Figure 24. Ford Building (690-N) Nonvolatile Beta Results (> SRS Max Background) Surface Soil (0-1 ft)

characterization effort exceeded the nonvolatile beta trigger limit (50 pCi/g) for additional beta-emitting radionuclide analyses (Figure 23). However, ten of the samples were selected for gamma spectroscopy analyses because the maximum nonvolatile beta result was 48.0 pCi/g and the presence of Cs-137 in soils is possible based on the results of the 2014 concrete sample data from inside the Ford Building (690-N). The maximum Cs-137 concentration in surface soil for the 2019 gamma spectroscopy analyses is 0.153 pCi/g (Figure 24), and all the deeper interval soil samples were below detection for Cs-137.
