SUBJECT: Savannah River Site's Responses to the Regulatory Comments on the Facility Decommissioning Evaluations for Building 484-4D, Powerhouse Maintenance Facility (G-FDE-D-00037, Revision 0, November 13, 2019), Building 484-12D, D-Area Storage Building (G-FDE-D-00038, Revision 0, November 18, 2019), Building 484-7D, D-Area Storage Building (G-FDE-D-00039, Revision 0, November 13, 2019), Building 683-D, Chlorine Unloading and Storage (G-FDE-D-00040, Revision 0, November 13, 2019), Building 454-D, D-Area Diesel Fuel Tank (G-FDE-D-00041, Revision 0, November 13, 2019), Building 484-13D, D-Area Storage Building (G-FDE-D-00042, Revision 0, November 18, 2019), and Building 484-15D, D-Area Storage Building (G-FDE-D-00043, Revision 0, November 18, 2019) Simple Model

**SRS Responses to U.S. Environmental Protection Agency
Comments on the Facility Decommissioning Evaluations for the
Facility Decommissioning Evaluations for Building 484-4D, Powerhouse Maintenance Facility
(G-FDE-D-00037, Revision 0, November 13, 2019), Building 484-12D, D-Area Storage Building
(G-FDE-D-00038, Revision 0, November 18, 2019), Building 484-7D, D-Area Storage Building
(G-FDE-D-00039, Revision 0, November 13, 2

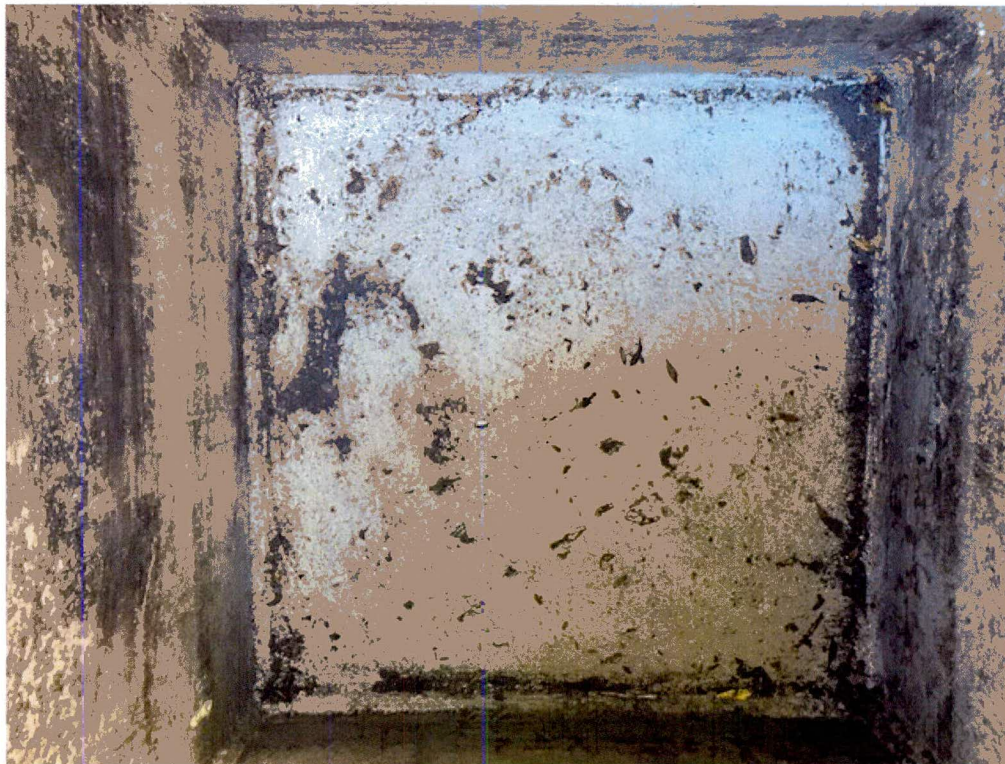
photographed (see below for photos). DOE believes the sumps' condition warrants Simple Model decommissioning for 454-D. No change to the FDE is proposed

454-D Sump Interior (March 2020)

Response. Clarification. Based on interviews/conversations with D-Area Operations personnel, a filter leak on the transfer pump in 454-D occurred resulting in a minor leak that was confined to the diked area and the sump. These same interviews/discussions revealed that any leaks that may have occurred at 454-1D did not result in any oils/stains reaching the 454-1D sump; there is only evidence of minor leaks confined to the pad/containment structure which were immediately cleaned up. In both instances, there was no evidence of spills outside the containment areas. During the 2012 to 2014 timeframe deactivation of facilities was taking place throughout the D-Area complex. In 2014, as part of the deactivation of 454-D and

454-1D, residual surface stains due to minor spills within the dike area of 454-D and the concrete pad/dike area of 454-1D were pressure washed. The sumps of both facilities were inspected, pressure washed, and filled with rock. Since the February 27, 2020 walkdown, the rock have been removed from the sumps and the sumps re-inspected. Also see above SRS response to EPA Response to DOE COMMENT RESPONSES 2. No change to the FDE is proposed.

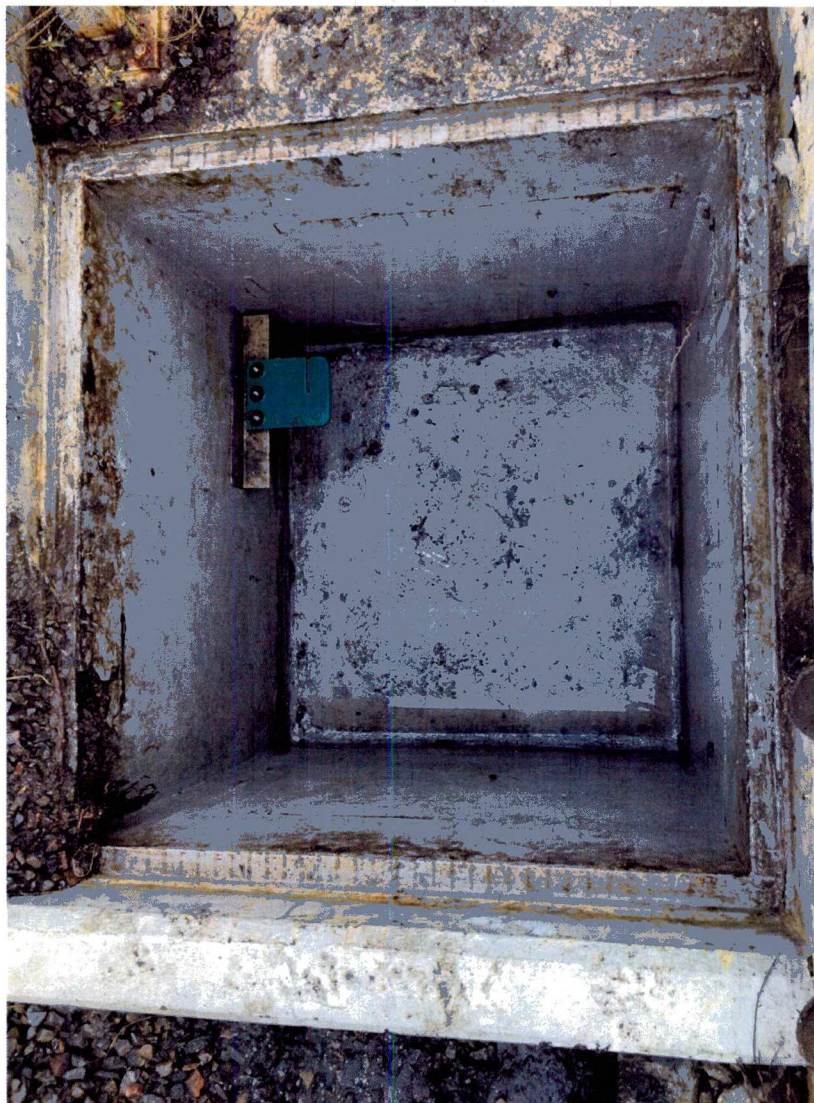
454-1D Sump Interior (March 2020)

Response. Clarification. Please see the SRS response to EPA Response to DOE COMMENT RESPONSES 2) and to EPA Comment 5b. Based on interviews/conversations with D-Area Operations personnel, no oils/stains reached the 454-1D sumps and there is no evidence of spills outside the containment areas. The sumps of 454-D and 454-1D were inspected and pressure washed in 2014 and reinspected in March 2020. No change to the 454-D Diesel Fuel Tank Facility FDE is proposed.

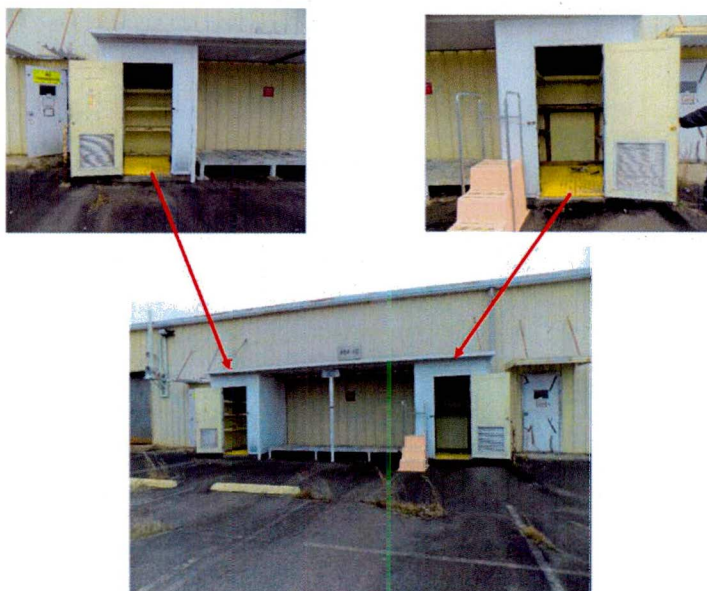
Response. Agree. Figure 2 provides interior and exterior views of the two small storage buildings and the covered area. No change to the FDE is proposed.

Figure 2. Interior and Exterior Views of 484-4D Storage Buildings

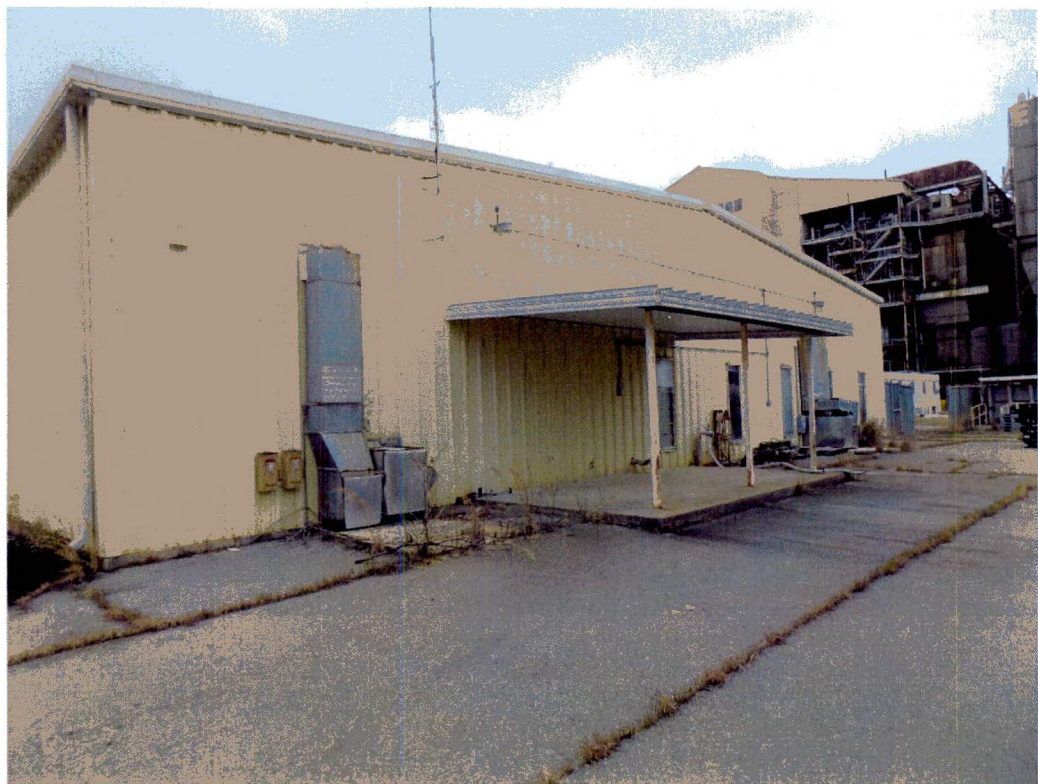
Response. Agree. Figure 3 provides a photograph of the small covered area on the east side of Building 484-4D. No change to the FDE is proposed.

Figure 3. Photograph of Small Covered Area on East Side of Building 484-4D

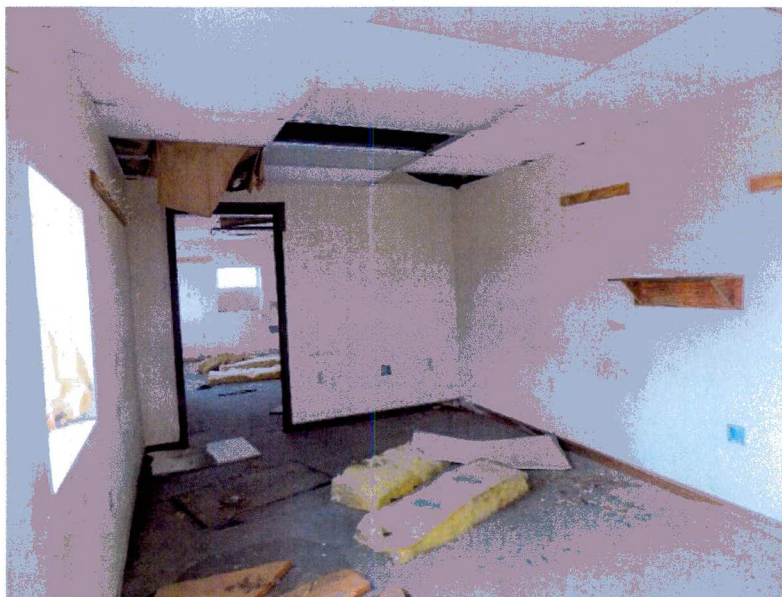
Response. Agree. Figures 4 and 5 provide pictures of the Office Area and Garage Area of 484-12D, respectively. No change to the 484-12D FDE is proposed.

Figure 4. Office Area of 484-12D

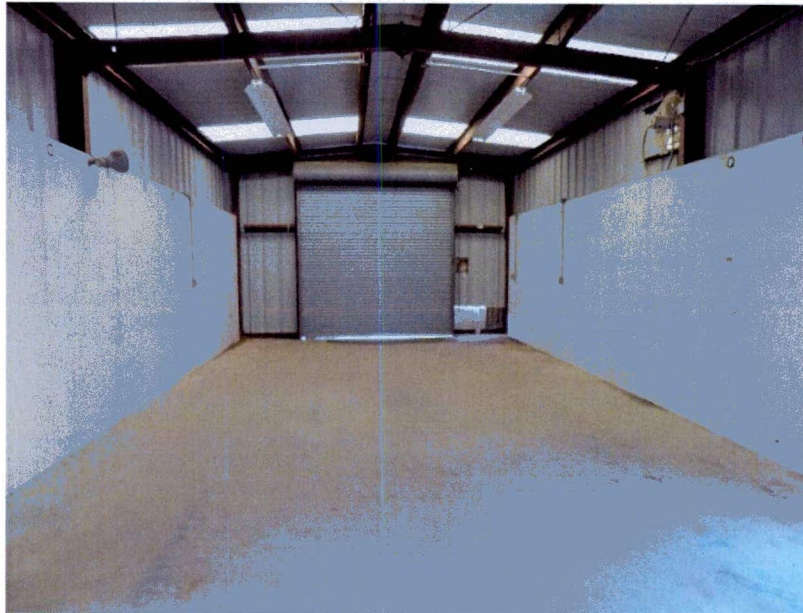
Figure 5. Garage Area of 484-12D

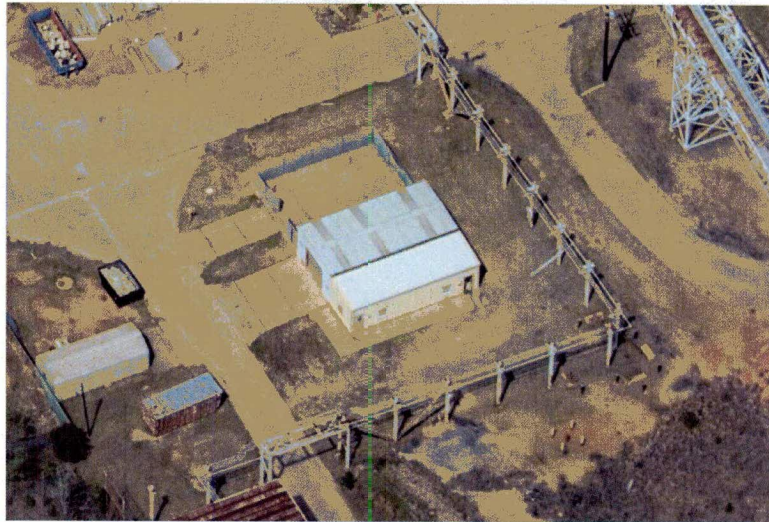
Figure 6. Aerial View of 484-12D Laydown Yard

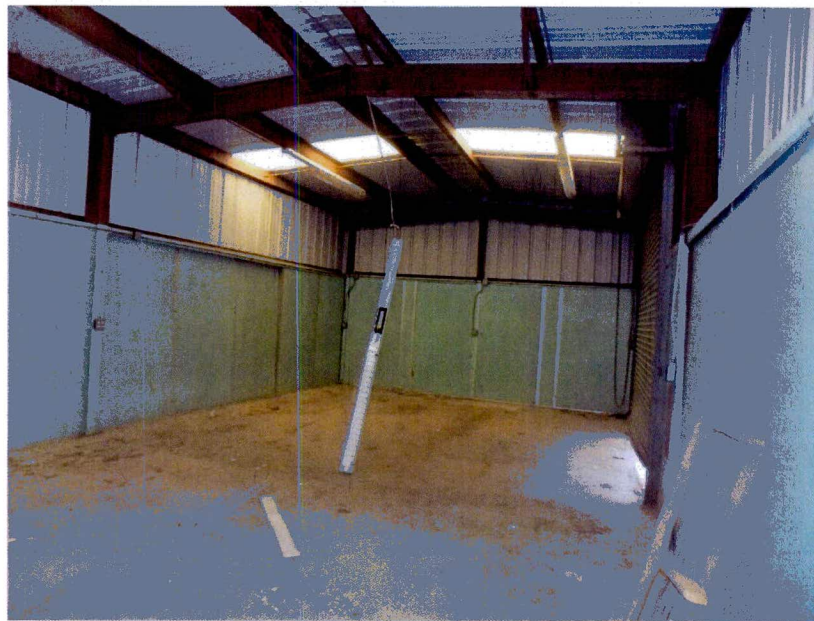
Response. Agree. The interior view of Building 484-7D is shown in Figure 8. No change to the FDE is proposed.

Figure 8. Interior View of Building 484-7D

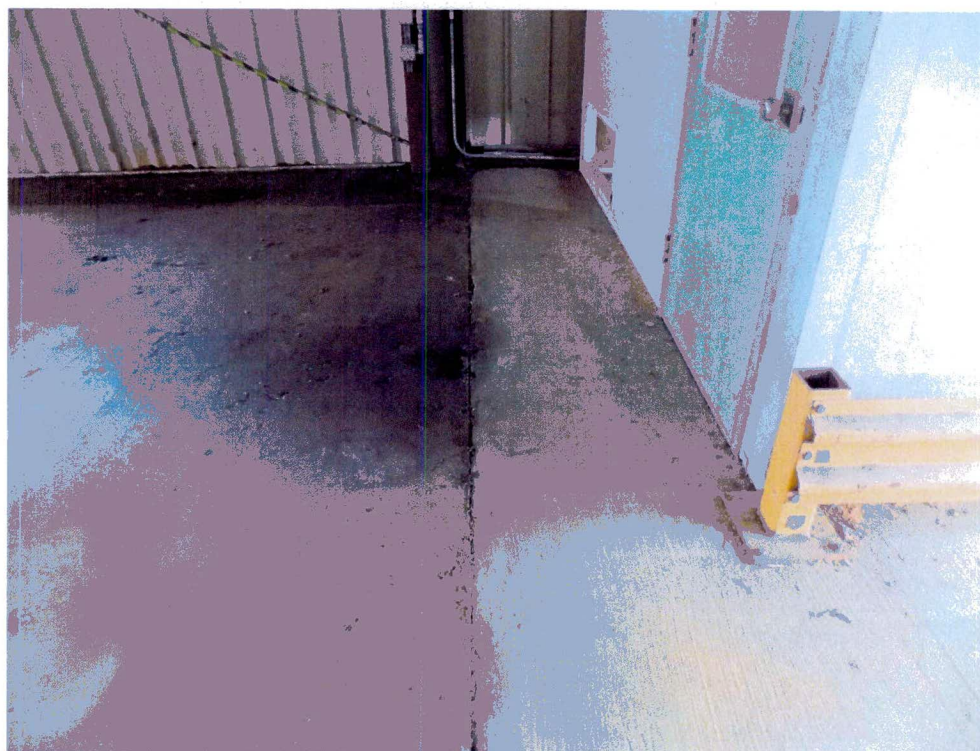
Response. Figure 6 was inadvertently omitted from the final version of the FDE. The figure is shown below. No change to the FDE is proposed.

Figure 6. Building 484-13D, D-Area Storage Building Floor Stain

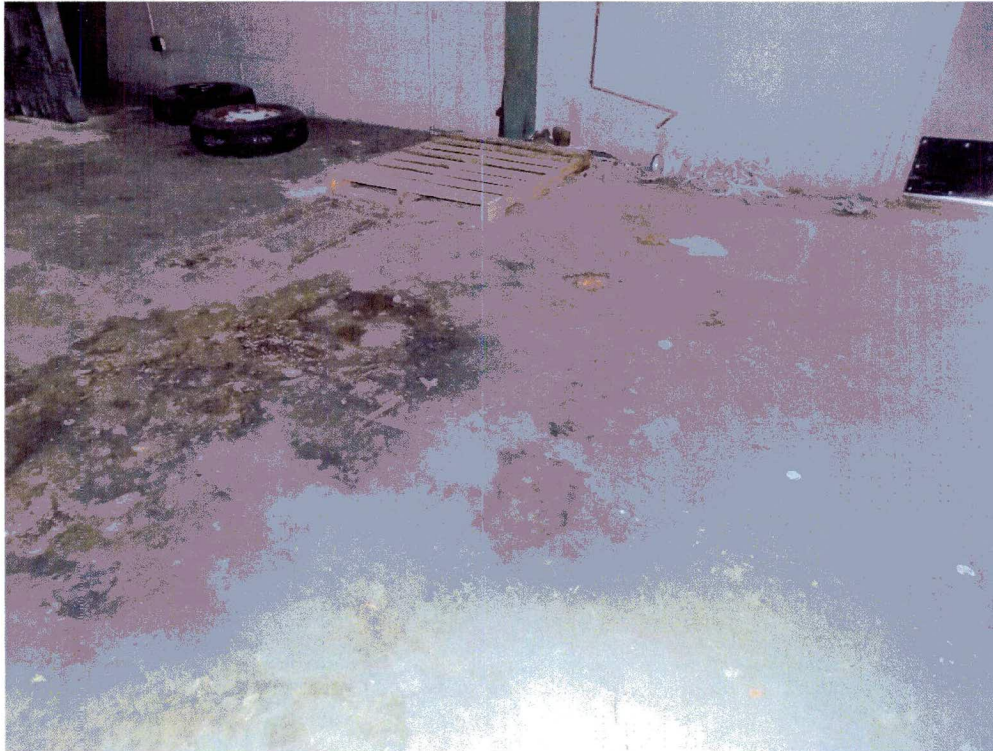
Response: Agree. See Figures 1 and 2 below. No change to the FDE is proposed.

Figure 1. Stained Concrete Near East Door

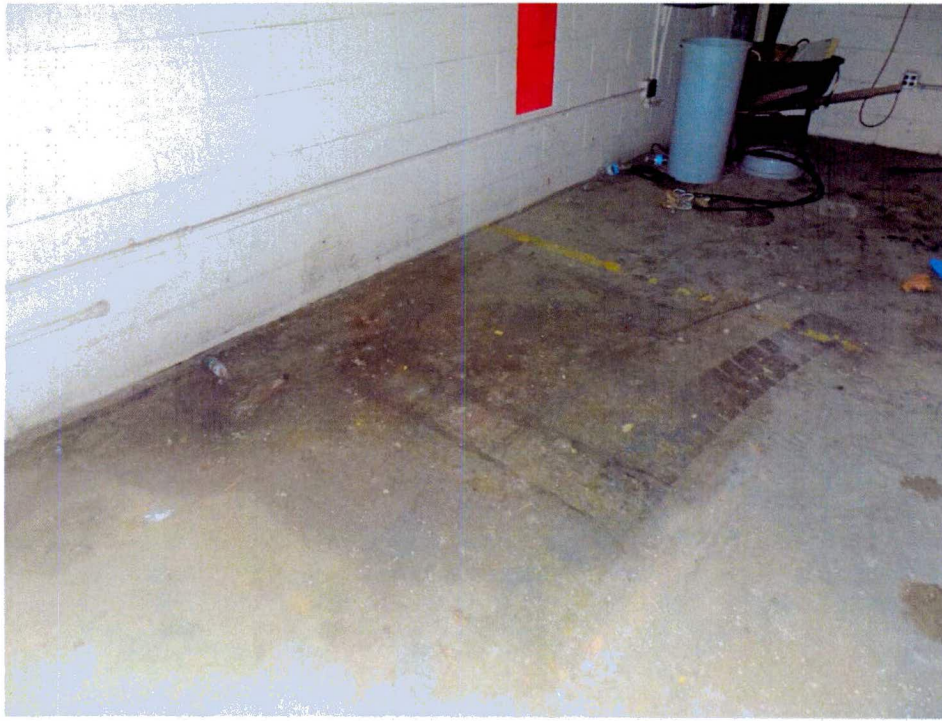
Figure 2. Stained Concrete Near Wall Perpendicular to South Wall

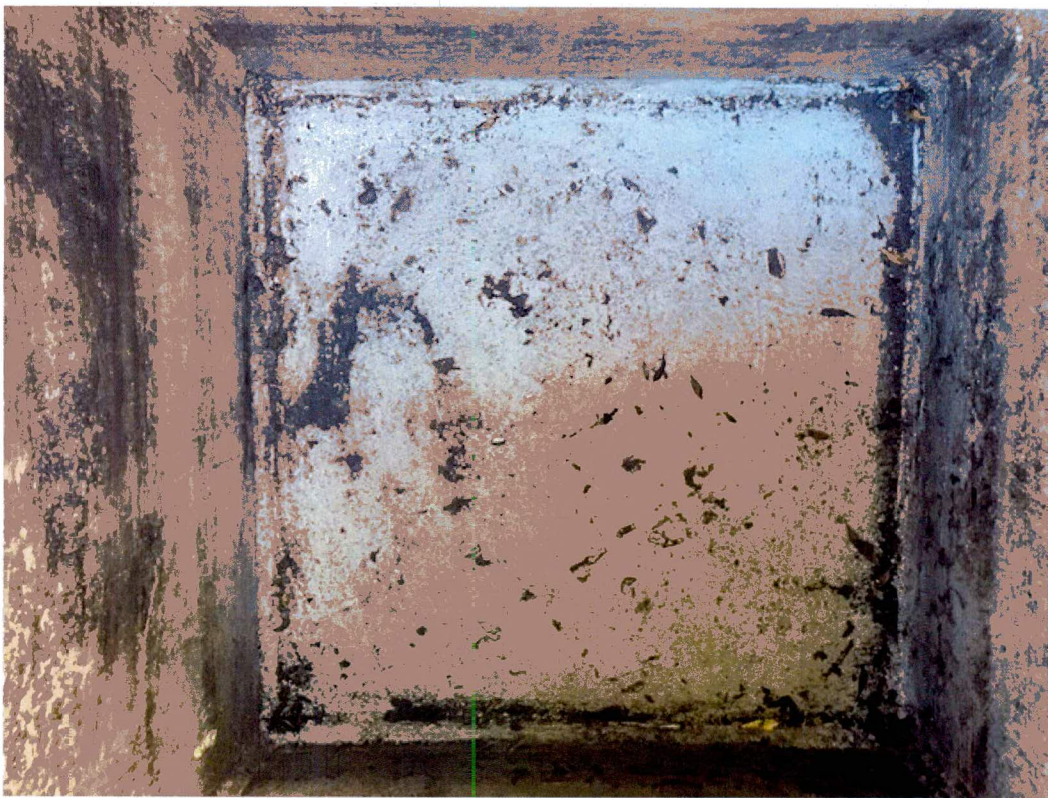
Response: Clarification. The integrity of the sump was not compromised during the operation of the facility based on the review of operating records, spill reports, interviews with the operating organization and a March 2020 inspection of the current state of the sump. (see photos below). The facility was a fuel storage area and managed during its operation in accordance with all regulatory requirements and standards up until its shutdown. During the 2012 to 2014 timeframe, deactivation of facilities was taking place throughout the D-Area complex. In 2014, as part of the deactivation of 454-D and 454-1D, residual surface stains within the dike area of 454-D and the concrete pad/dike area of 454-1D were pressure washed. The sumps of both facilities were inspected, pressure washed, and filled with rock. A walkdown of the facilities was performed on February 27, 2020, at which time the rock-filled sumps in 454-D and 454-1D were not visually accessible, and their condition and subsurface release potential could not be assessed. DOE believes that if the sumps had been visually accessible during the walkdown, their integrity, condition, and potential for release would not have created uncertainty. The rocks were removed from the sumps in March 2020 and the sumps have been re-inspected and photographed (see below for photos). DOE believes the sumps' condition warrants Simple Model decommissioning for 454-D. No change to the FDE is proposed

454-D Sump Interior (March 2020)

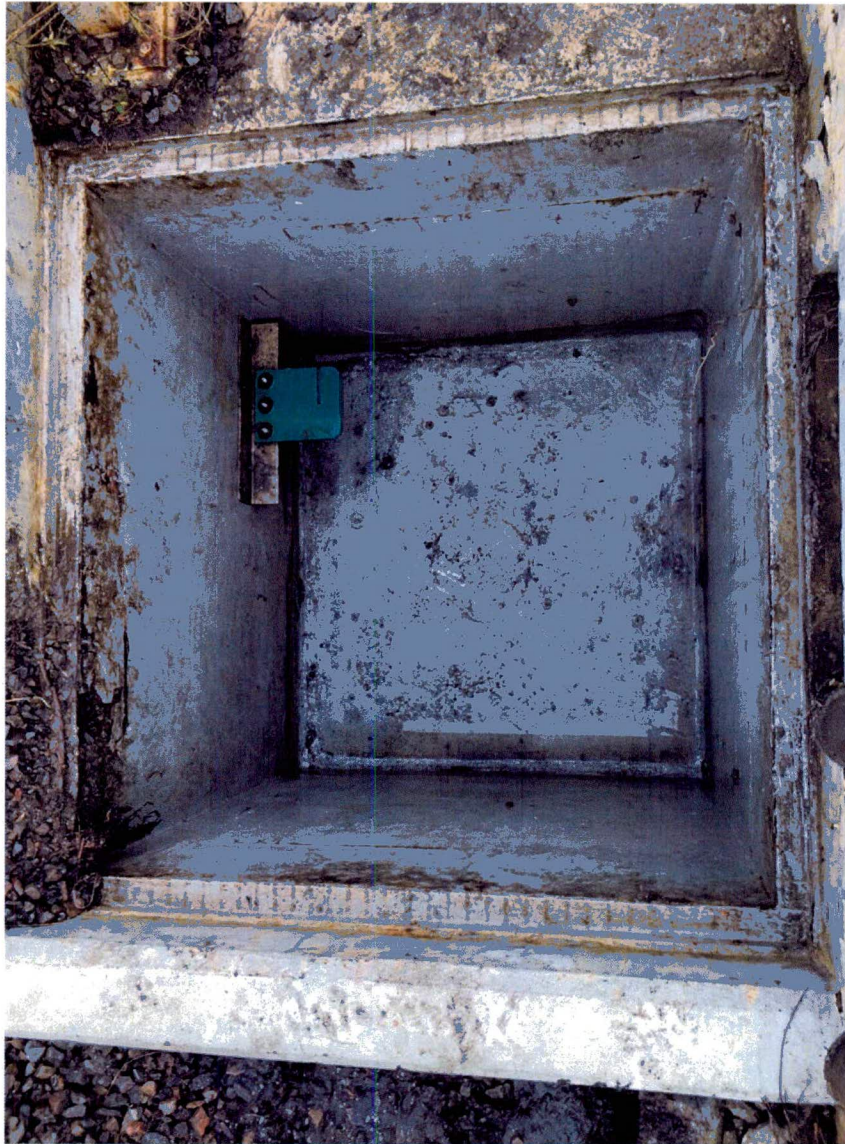
454-1D Sump Interior (March 2020)

Response: Clarification. Interviews/discussions with D-Area Operations personnel revealed that any leaks that may have occurred at 454-1D did not result in any oils/stains reaching the 454-1D sump. Minor leaks were confined to the pad/containment structure at the truck off-loading station and were immediately cleaned up. No change to the FDE is proposed.
