# **Post-Construction Report for the Wetland Area at Dunbarton Bay in Support of Steel Creek Integrator Operable Unit (U)**

**SRNS-RP-2020-00003**

**October 2020**

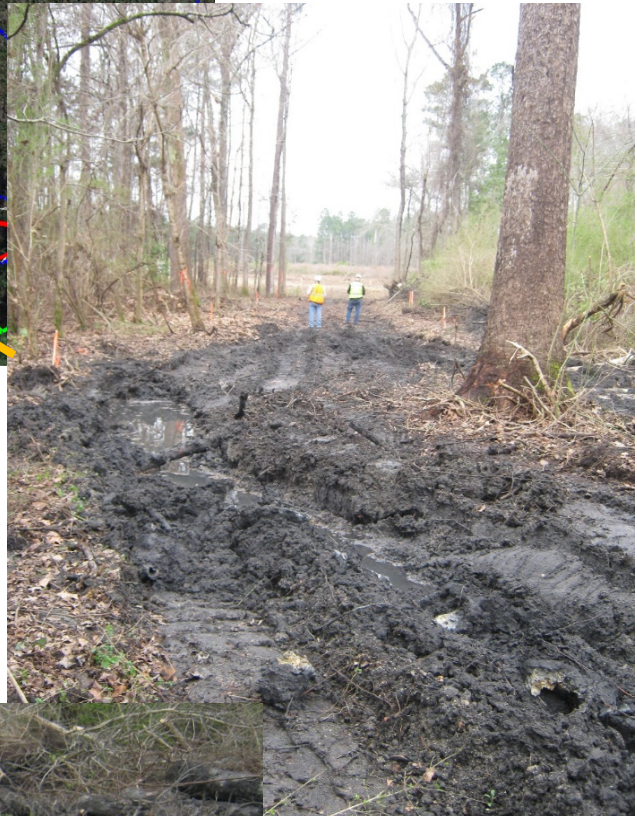
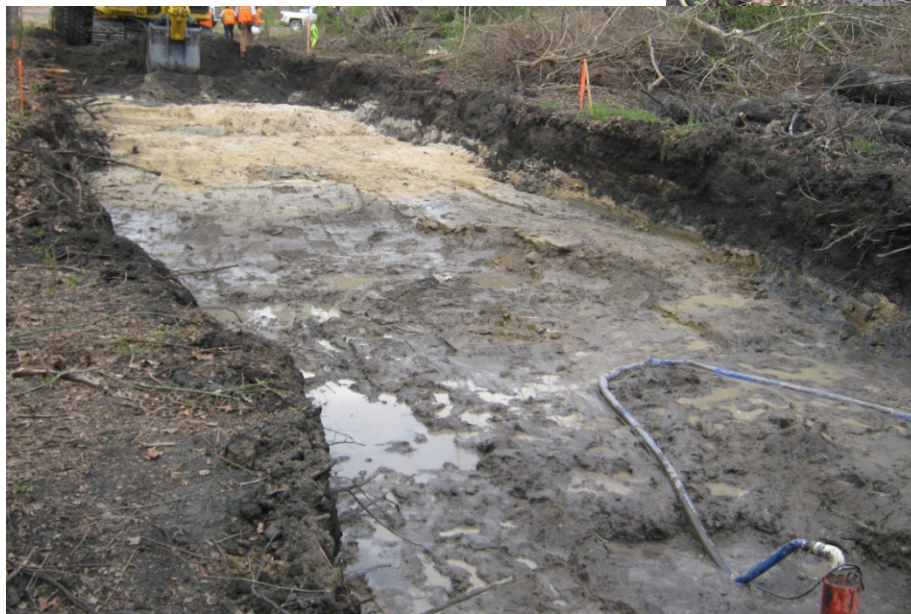
**Figure 4. SARA Western Access Corridor – Additional Ash**

Photo on the right shows additional ash found in the access corridor on the western side of the SARA. The photo below shows excavation of the ash between the Limits of Ash and Limits of Disturbance boundaries.

During the installation of the access corridors on the east and west sides of the SARA, additional ash was found outside of the limits of ash boundary as identified on the design drawings. Along the western corridor, this additional ash was excavated between the limits of ash and limits of disturbance (Figure 4). The excavated ash was stockpiled in the NARA and aerated prior to disposal in Three Rivers Landfill. The western corridor was the primary access path for heavy equipment into the SARA, and because the subgrade was found to be a saturated clay material, stabilization with large stone, fabric, backfill and smaller stone was required. Within the eastern corridor, ash found between the limits of

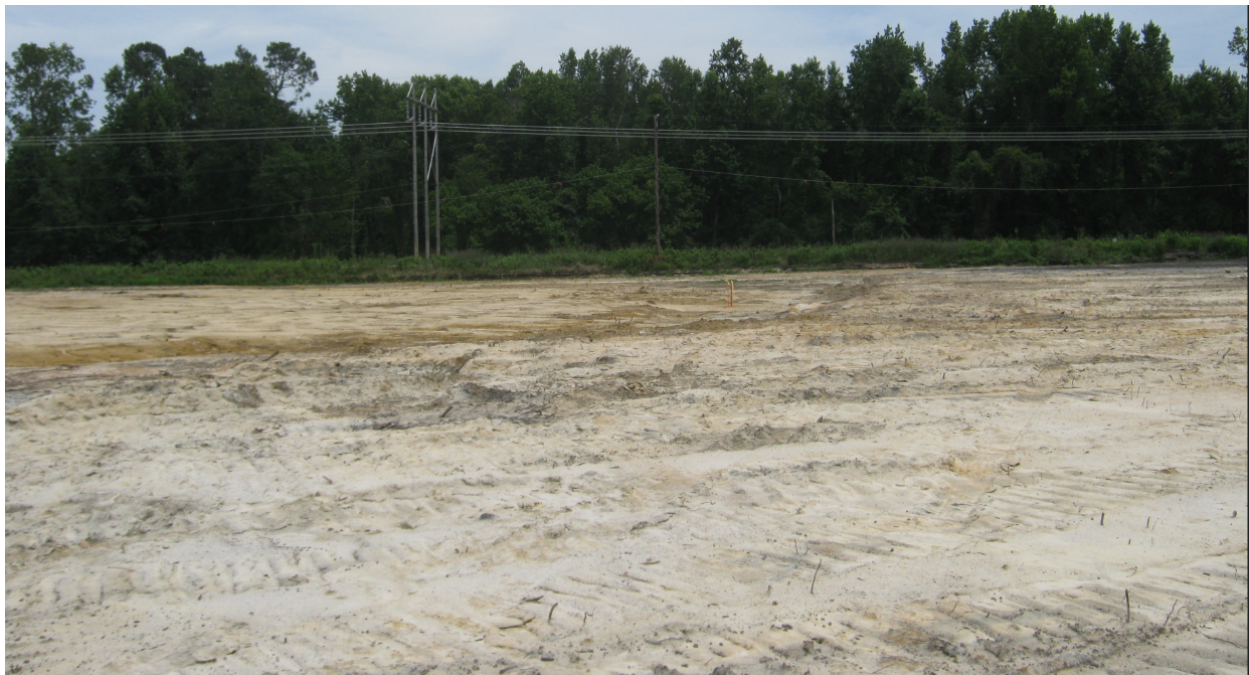
Figure 13. NARA Phase II Confirmation Sampling

Additional soil was excavated from a portion of sampling Grid N-05 where the original topography indicated a natural drainage channel, and the area was resampled in two more locations: one inside the additional excavated area (location N-05A) and another outside of this area but still within sampling Grid N-05(location N-05B). The Cs-137 result from location N-05A was 0.879 pCi/g, above the RG 0.68 pCi/g but below the SRS maximum background of 3.3 pCi/g. The Cs-137 result from location N-05B was 4.05 pCi/g which triggered additional excavation and resampling. Six additional samples were collected from the sampling Grid N-05 at locations N-05C through N-05H. Results from these locations were below the RGs. Sampling locations are shown on Figure 13, and analysis of the data is described in Appendix A.

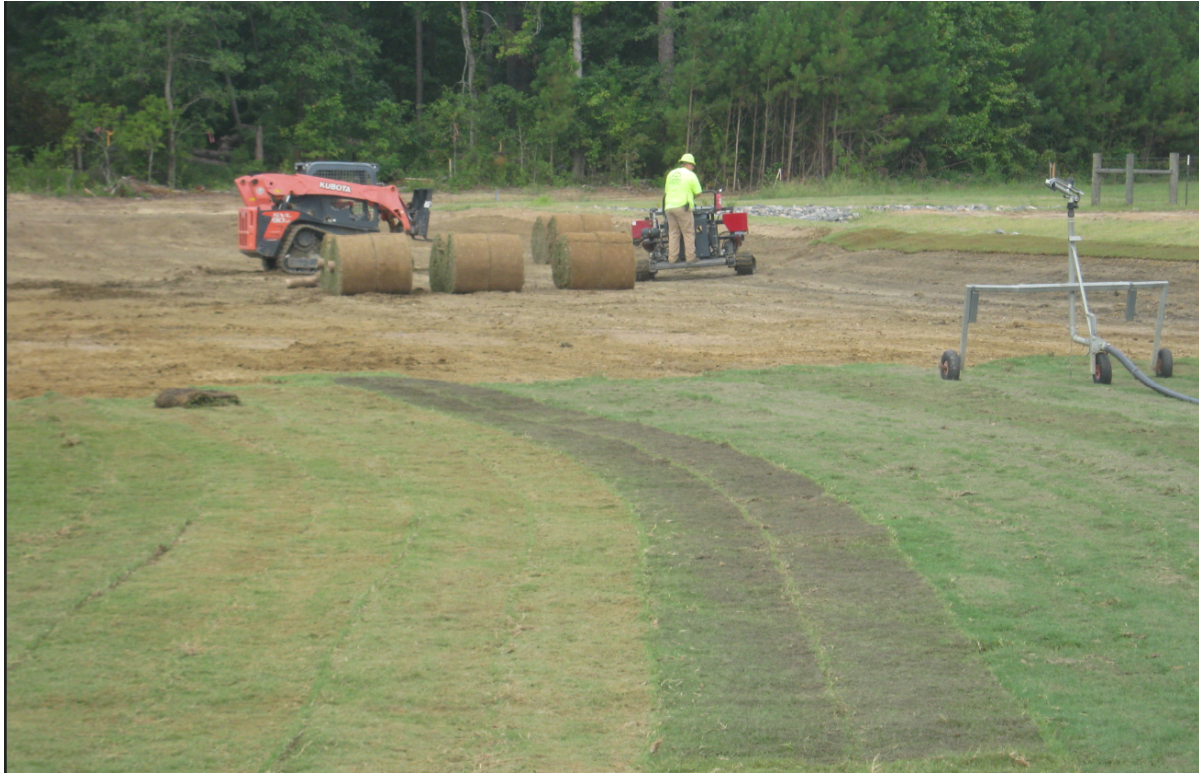
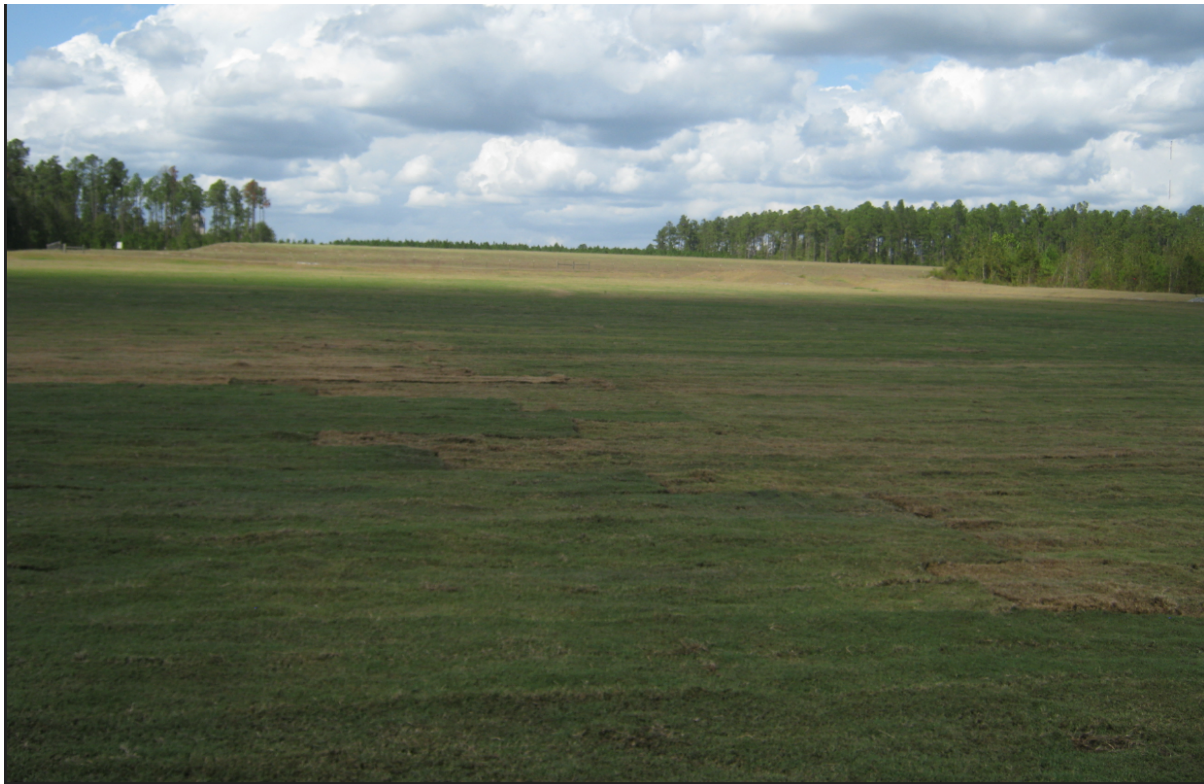
**Figure 14. NARA Phase II Stabilization Activities and Final Stabilization**

included grading to the design contours and the installation of sod on all disturbed areas within the NARA. Sampling Grid N-05 was the last grid to be stabilized. Figure 14 shows the NARA after stabilization.
