**M-AREA HAZARDOUS WASTE MANAGEMENT FACILITY (BLDG. 904-51G) FIELD INSPECTION  
CHECKLIST**

M-Area Hazardous Waste Management Facility (Bldg. 904-51G) Field Inspection Checklist

Manual: C3  
 Procedure: ER-IDS-019-022  
 Revision: 4  
 Page: 2 of 5

Map of M-Area Hazardous Waste Management Facility 904-51G

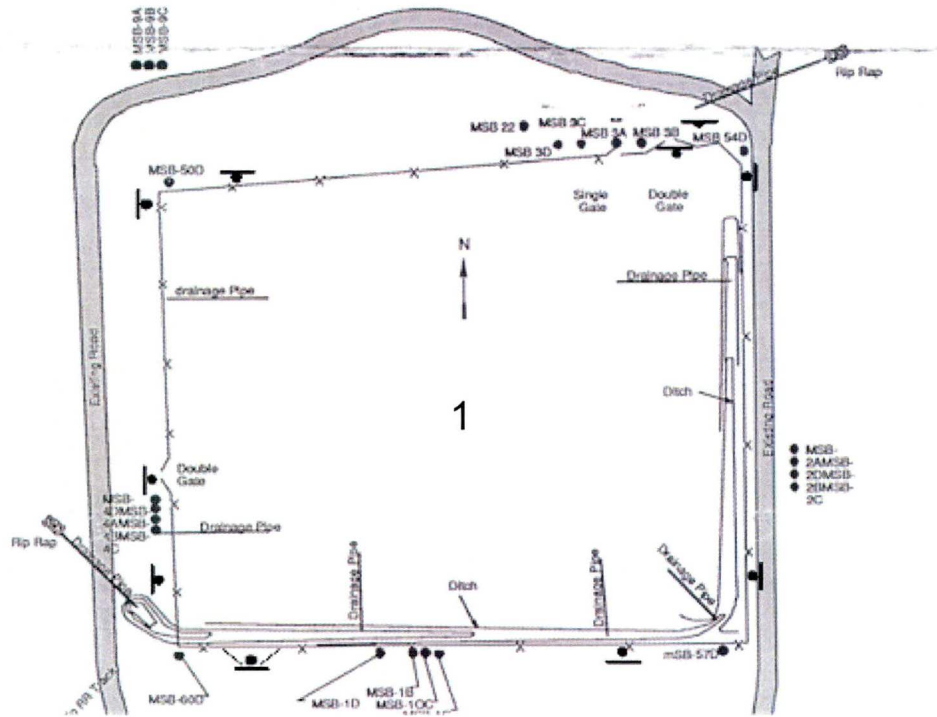
7. <b>CHECK</b> for excessive vegetation growing over fences which may obstruct warning signs or visibility of inspected area.	A	
8. <b>CHECK</b> M-Settling Basin cover for signs of burrowing animals.	X	Active ant mounds on soil cover. See map note 1. Reference maintenance register: PC-2023-00087

NOTES: 1=Active Ant Mounds on soil cover. Applied 3.0 lb. of Extinguish Ant Bait.

**Description Of Maintenance Item**  
Active ant mounds on soil cover

**Maintenance Item Corrected**  
Applied Extinguish ant bait.
