Decommissioning Project Final Report

D-Area Coal Handling Houses and Associated Facilities

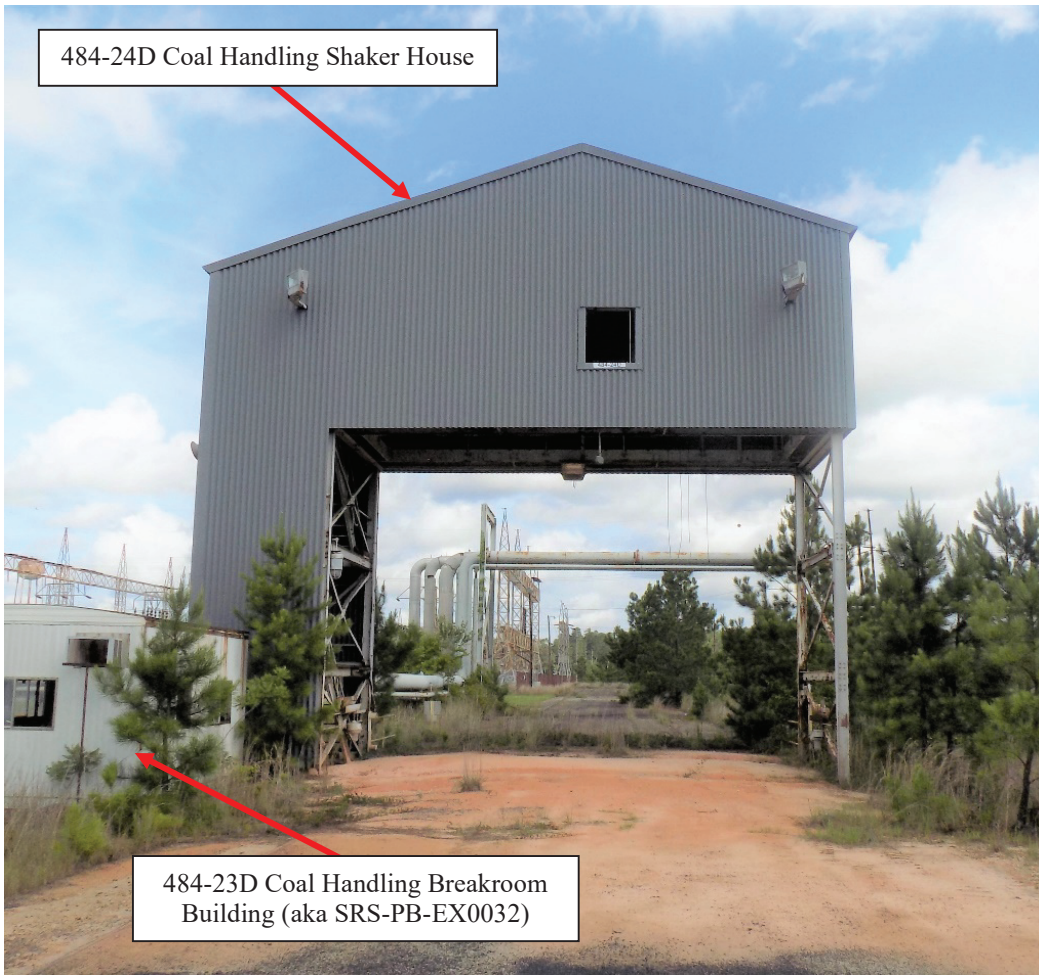
Figure A-1: Building 484-24D (Looking North) Before Decommissioning

484-24D: The starting point for coal handling was at 484-24D and the Track Hoppers beneath it. Coal was initially delivered to the Track Hoppers where an electrically operated rail car shaker in 484-24D assisted in emptying coal over the reciprocating plate feeders in the Track Hoppers. In 1988, coal delivery switched to delivery by truck instead of by rail. Because of this, the Track Hoppers on the north side of the building were abandoned the same year in favor of delivery by truck either to the south Track Hoppers or directly to the coal yard. 484-24D consisted of a concrete foundation and a steel I-beam framework with raised seam metal siding and roof panels. The lofted floor level was constructed of steel plate flooring which was accessed by a steel staircase. The building was deactivated in May 2013 along with removal of the shaker equipment. As part of that deactivation, oil was drained from all gearboxes and all shaker equipment was removed. The below-grade stairwell and Track Hoppers were filled with dirt and capped with clay under a D-Area work order in conjunction with a South Carolina Department of Health and Environmental Control (SCDHEC) structural fill permit (Reference 8.12). An asbestos survey of 484-24D was performed on February 10, 2021 and issued on April 14, 2021 (Reference 8.03).

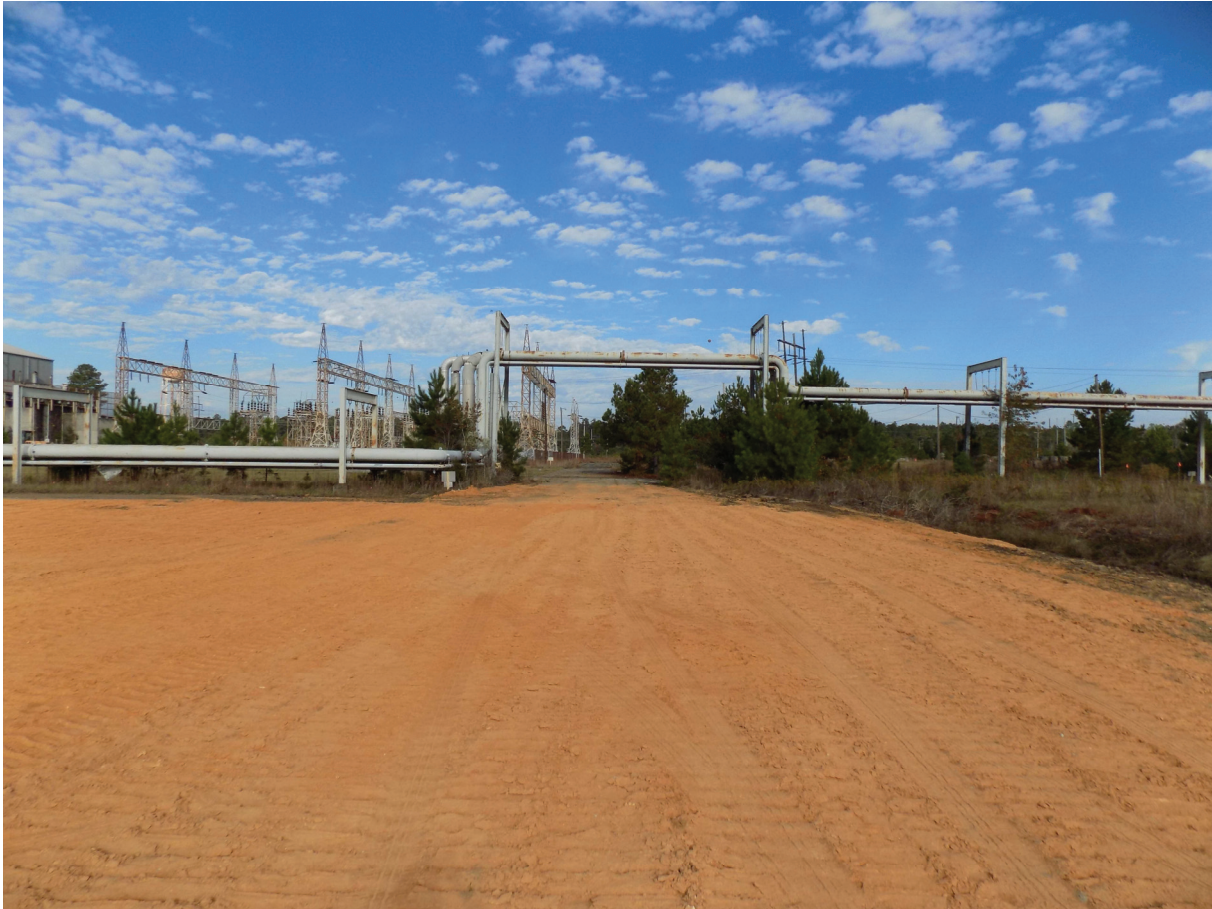
Figure A-2: Building 484-24D (Looking North) After Decommissioning

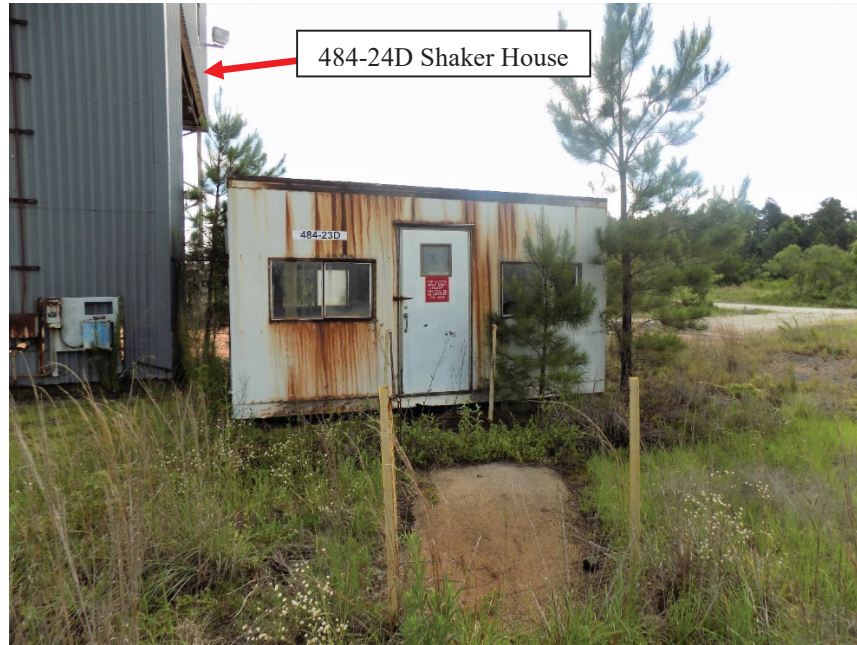
Figure A-3: 483-23D, aka SRS-PB-EX0032, (Looking East) Before Decommissioning

484-23D: Adjacent to 484-24D was 484-23D, a 12 foot (ft) by 16 ft portable building with a prefabricated wood framework, metal siding, and a metal roof, supported by non-grouted masonry blocks and wood blocks on a concrete slab. The building was electrically powered and supplied with an air conditioning (A/C) unit. During deactivation of D-Area, Freon was removed from the A/C unit and properly disposed of prior to removal of the A/C unit itself. Fluorescent lamps were also removed and all electricity to the building was disconnected (Reference 8.12). A baseline asbestos inspection of 484-23D was performed on February 23, 2021 and issued on April 14, 2021 (Reference 8.05).

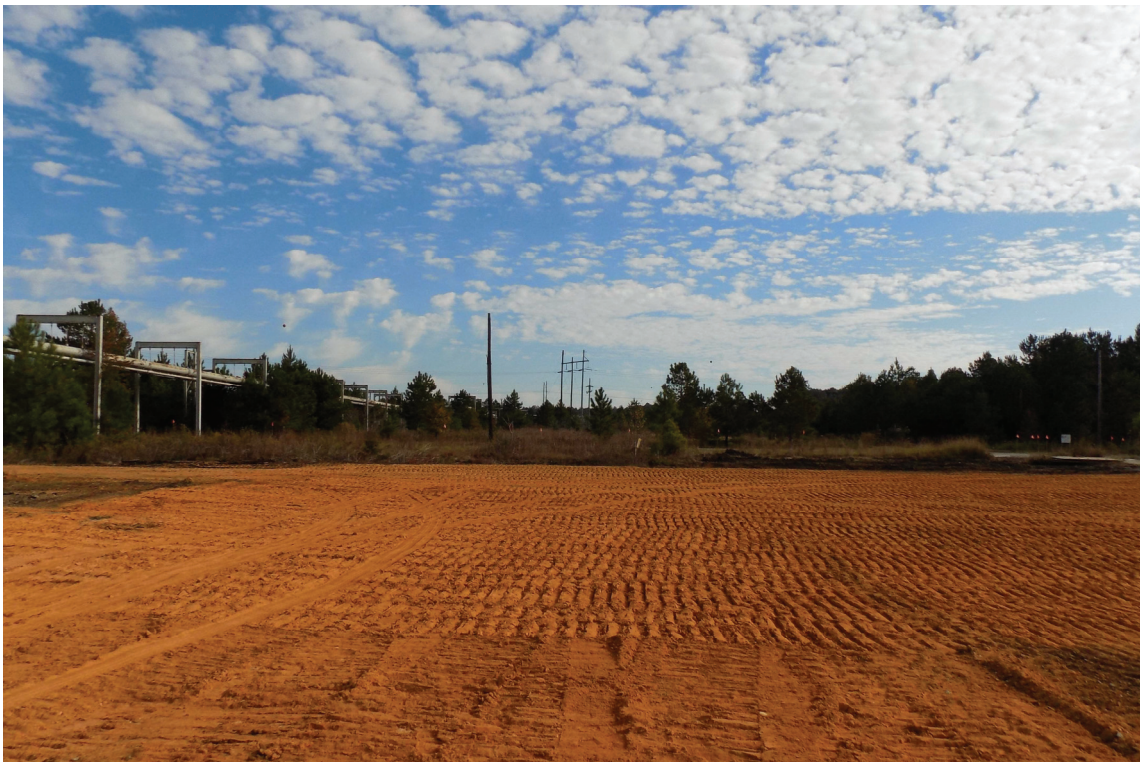
Figure A-4: 483-23D, aka SRS-PB-EX0032, (Looking East) After Decommissioning

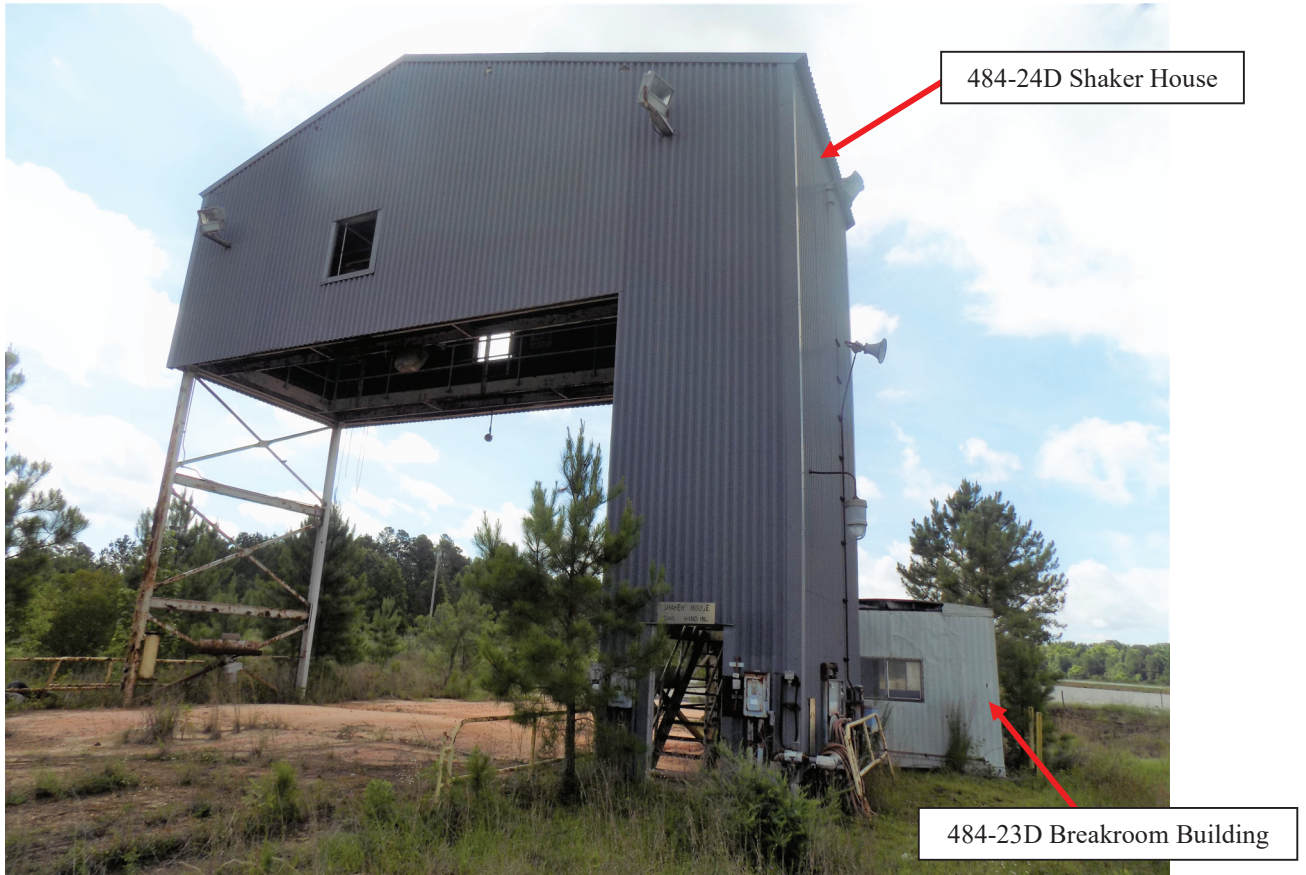
Figure A-5: 484-24D and 483-23D (Looking Southeast) Before Decommissioning

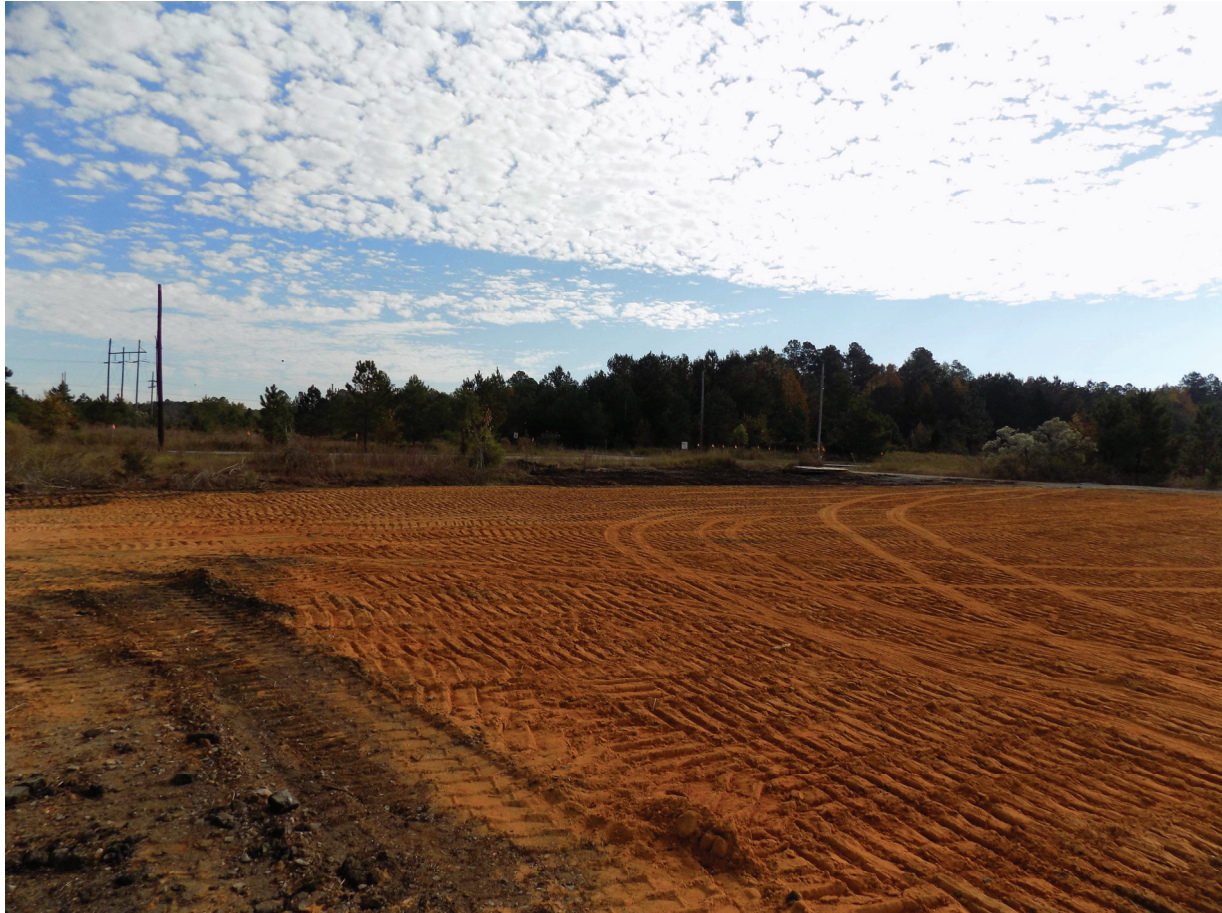
Figure A-6: 483-23D, aka SRS-PB-EX0032, (Looking East) After Decommissioning

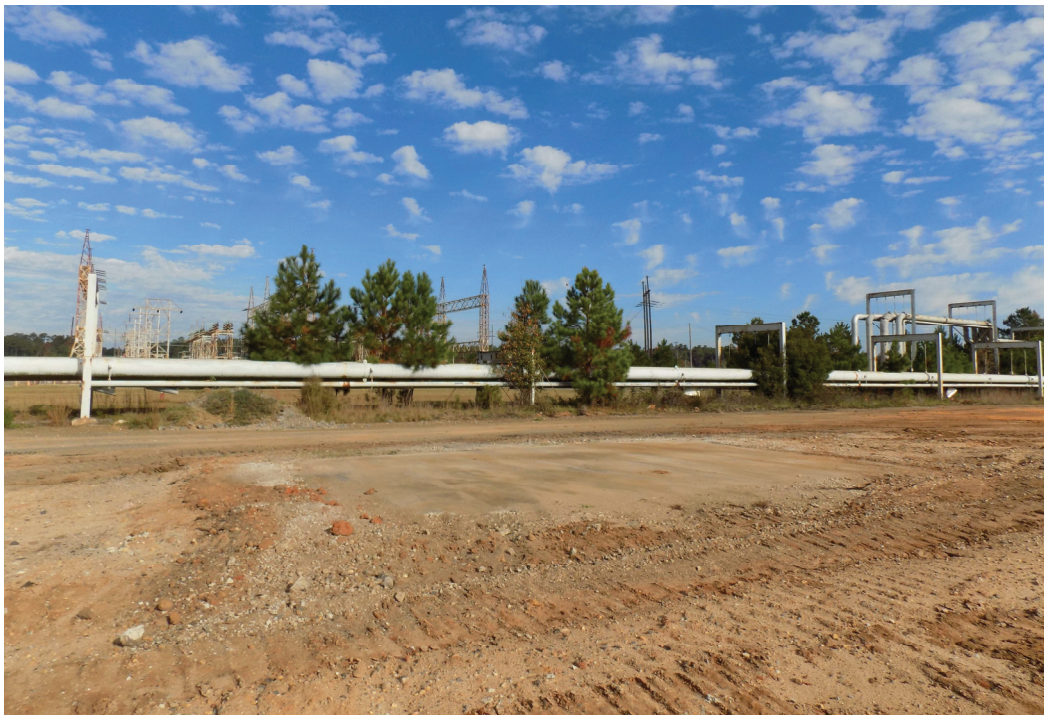
Figure A-8: Conveyor No. 1 Concrete Bunker (Looking Northeast) After Decommissioning

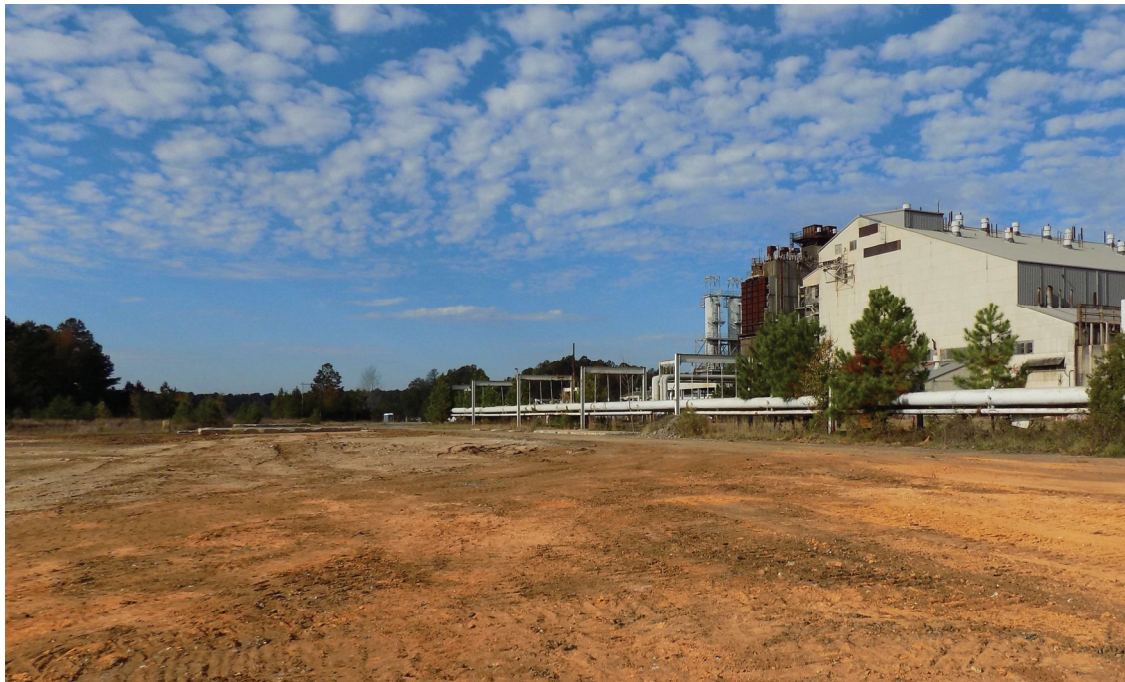
Figure A-10: Conveyor No. 1 and Bunker (Looking Northwest) After Decommissioning

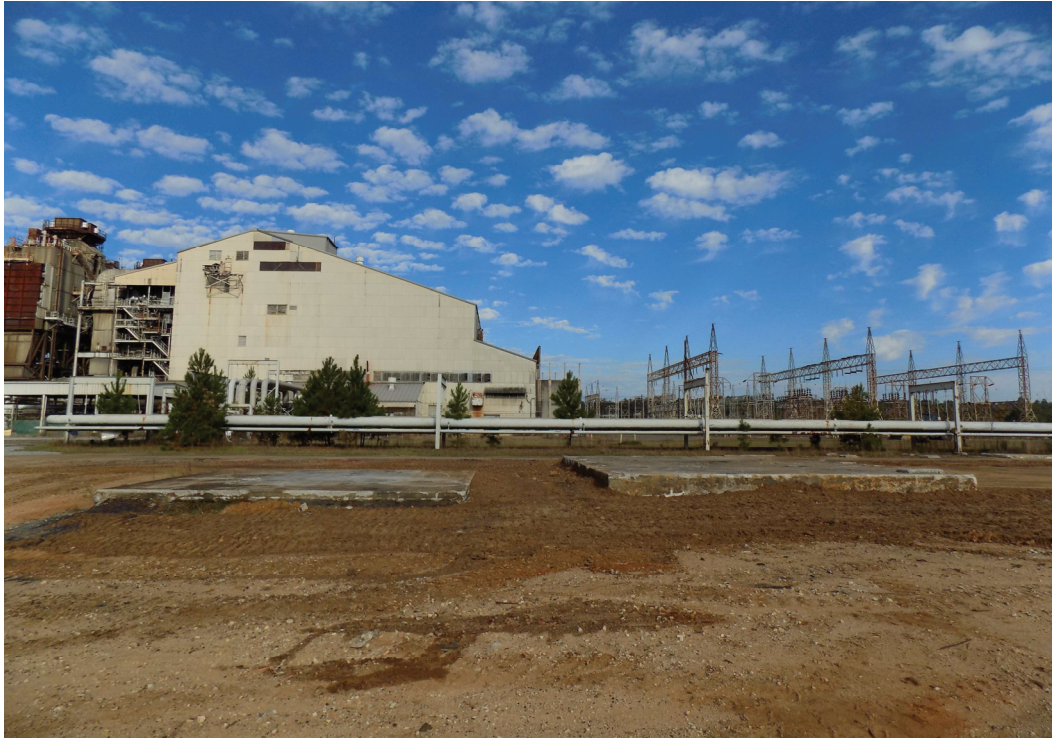
Figure A-12: 484-22D (Looking North) After Decommissioning

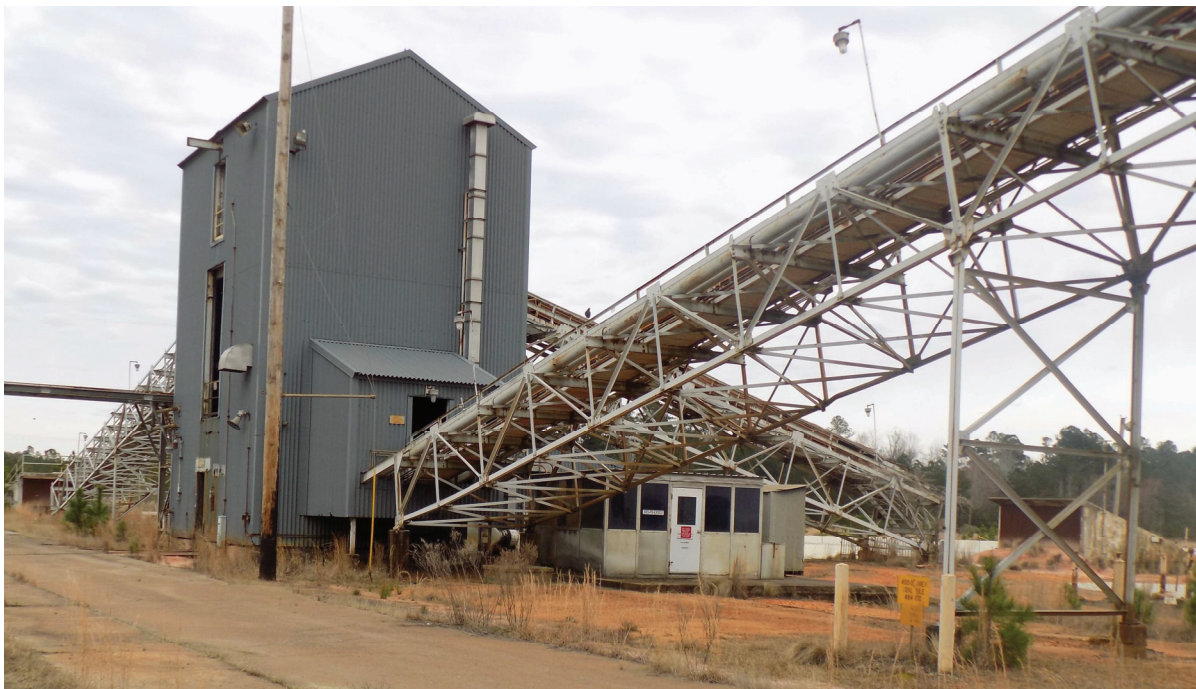
Figure A-13: 484-22D (Looking Southeast) Before Decommissioning

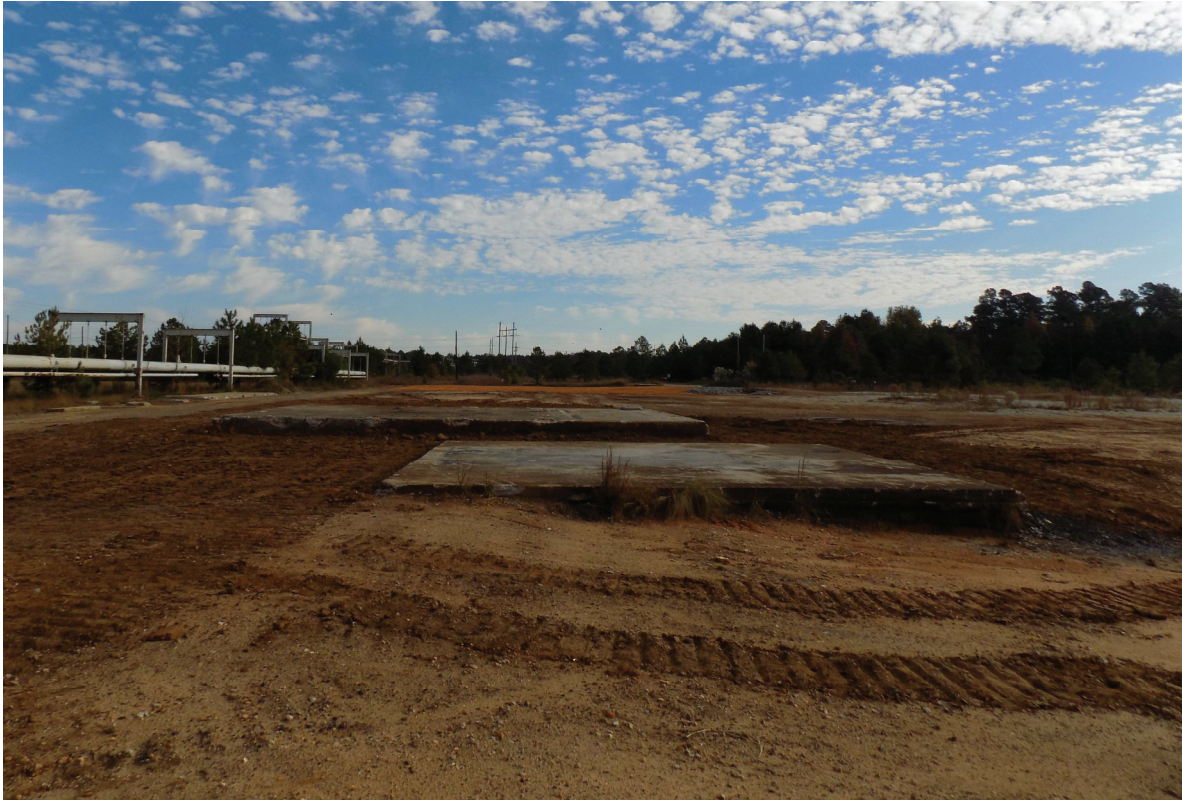
Figure A-14: 484-22D (Looking East) After Decommissioning

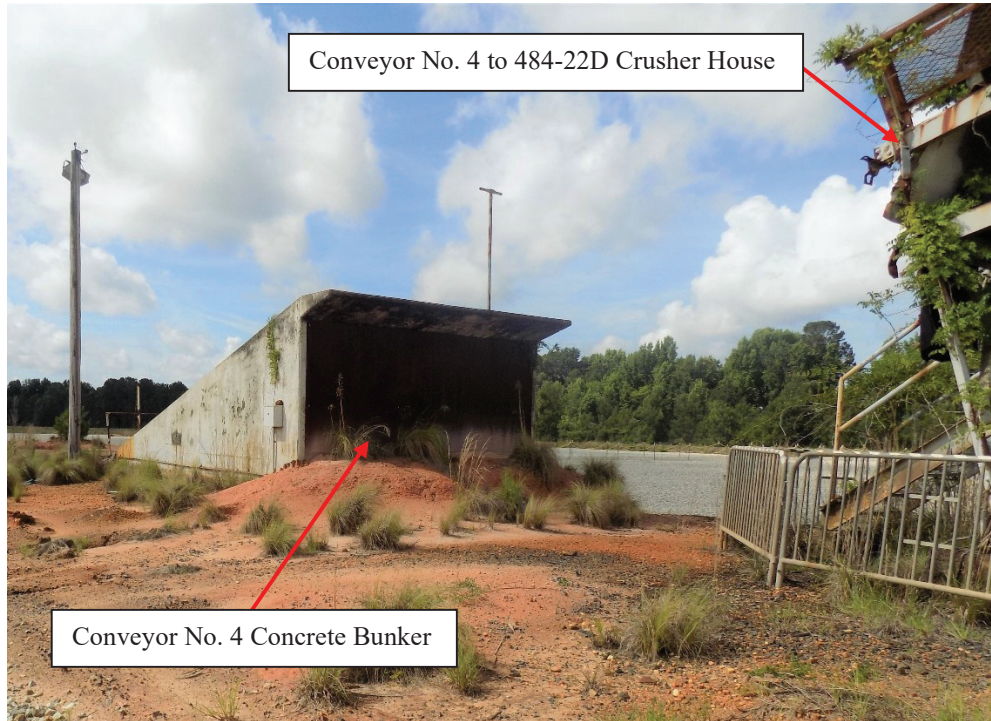
Figure A-15: Conveyor No. 4 Concrete Bunker (Looking Southwest) Before Decommissioning

Conveyor #4: A section of the aboveground portion of Conveyor #4 was removed in 2013 and its tunnel was closed with a steel plate to prevent water and animal intrusion after deactivation. The tunnel and the Reclaim Hopper were both deactivated in 2013 (Reference 8.12). Deactivation of the tunnel included electrical disconnects, removal of all light bulbs, draining oil from gearboxes, washdown of the tunnel floor, removal of the washdown water, and conveyor belts safely cut and left in place. The metal plate bolted to the front wall of the concrete bunker entrance to the underground portion of Conveyor #4 is also typical of the concrete structure leading to the tunnel for Conveyor #1. A baseline asbestos inspection for Conveyors #1, #2, and #4 was performed on February 10 and 25, 2021 and issued on April 14, 2021 (Reference 8.04).

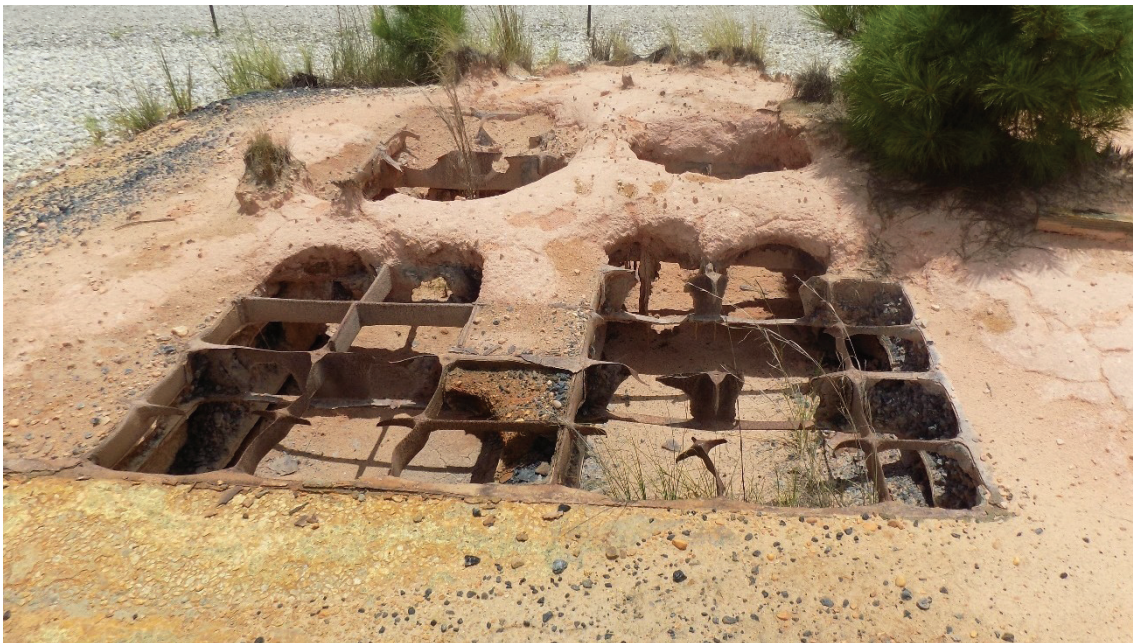
Figure A-16: Reclaim Hopper (Looking South) Before Decommissioning

Reclaim Hopper: The Reclaim Hopper was located at the south end of Conveyor #4. The Reclaim Hopper's gearbox was deenergized and drained of oil, which was properly disposed. Light bulbs were removed and properly disposed. The below grade structure of

the Reclaim Hopper was filled with dirt and capped with clay under a D-Area work order in conjunction with a SCDHEC structural fill permit (Reference 8.12).

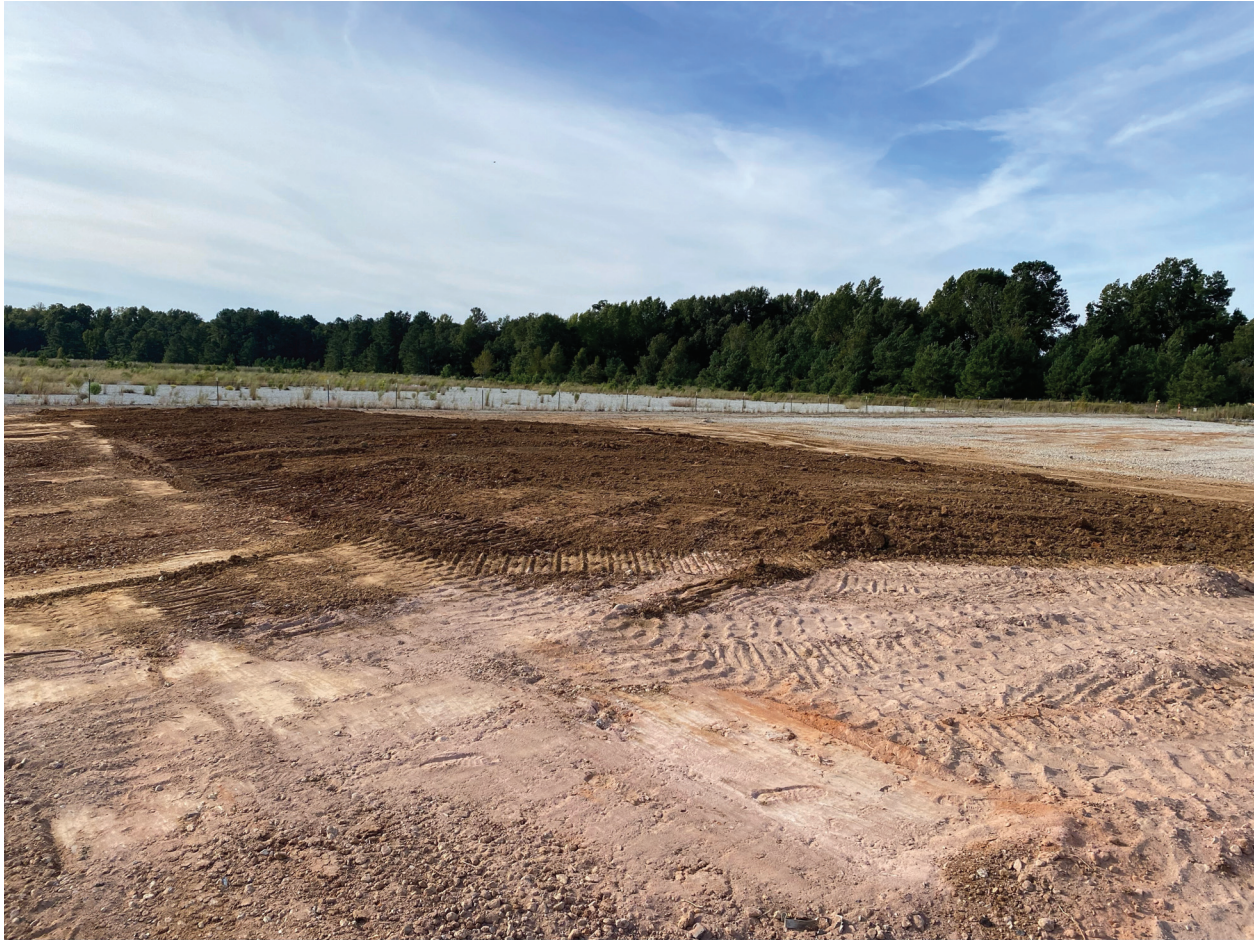
**Figure A-17: Conveyor No. 4 Concrete Bunker and Reclaim Hopper (Looking Southwest)
After Decommissioning**

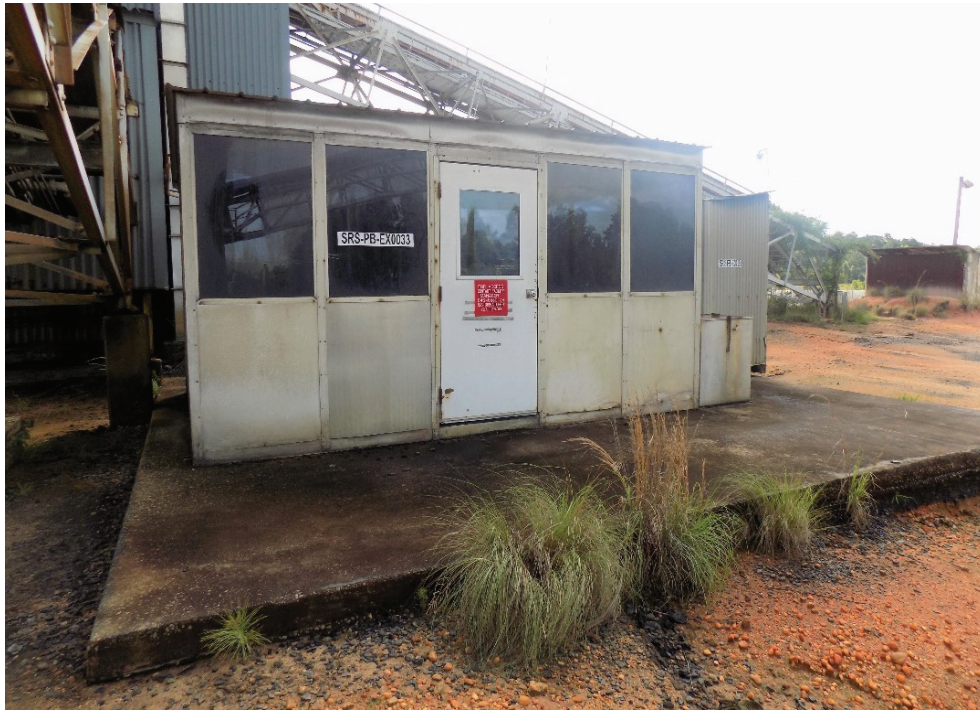
Figure A-18: SRS-PB-EX0033 (Looking Southeast) Before Decommissioning

SRS-PB-EX0033: Adjacent to 484-22D was SRS-PB-EX0033, a 12 ft by 16 ft portable building with a prefabricated wood framework, metal siding, and a metal roof, supported by non-grouted masonry blocks and wood blocks on a concrete slab. The building was electrically powered, but had no A/C. During the deactivation of D-Area, all electricity to the building was disconnected. A baseline asbestos inspection for SRS-PB-EX0033 was performed on February 22, 2021 and issued on February 25, 2021 (Reference 8.06).

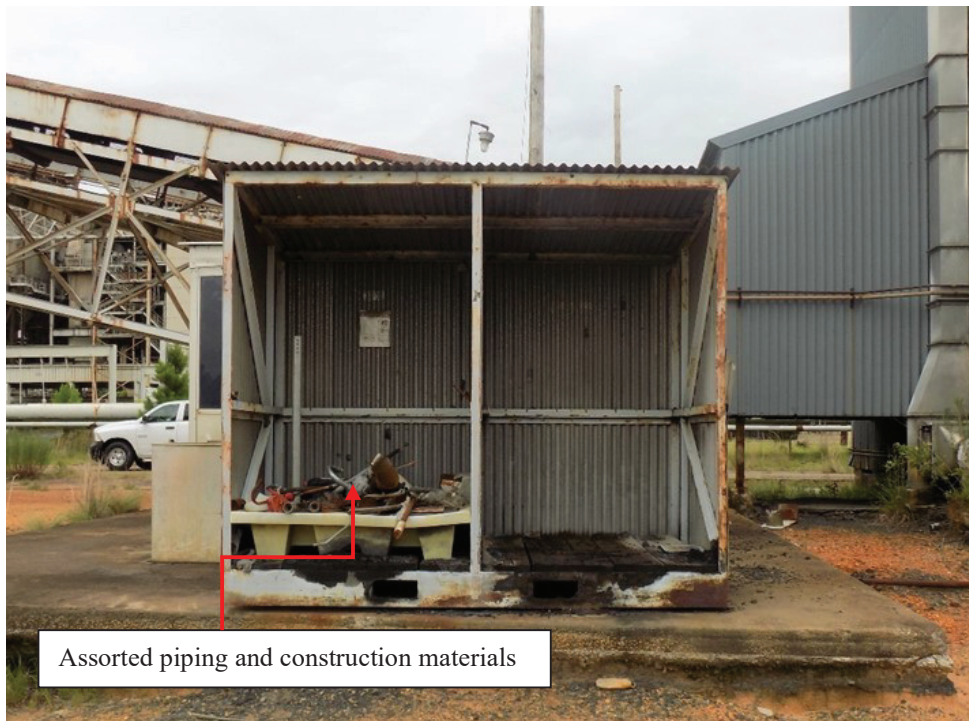
Assorted piping and construction materials

Figure A-19: SRS-PB-EX0035 (Looking North) Before Decommissioning

SRS-PB-EX0035: Also adjacent to 484-22D was SRS-PB-EX0035, a 10 ft by 5 ft open-faced storage shed comprised of a metal framework, corrugated metal on three sides, and a roof. The structure was mounted on an affixed metal pallet and had no electricity or plumbing. A baseline asbestos inspection was performed on March 4, 2021 and issued on March 9, 2021 (Reference 8.07).

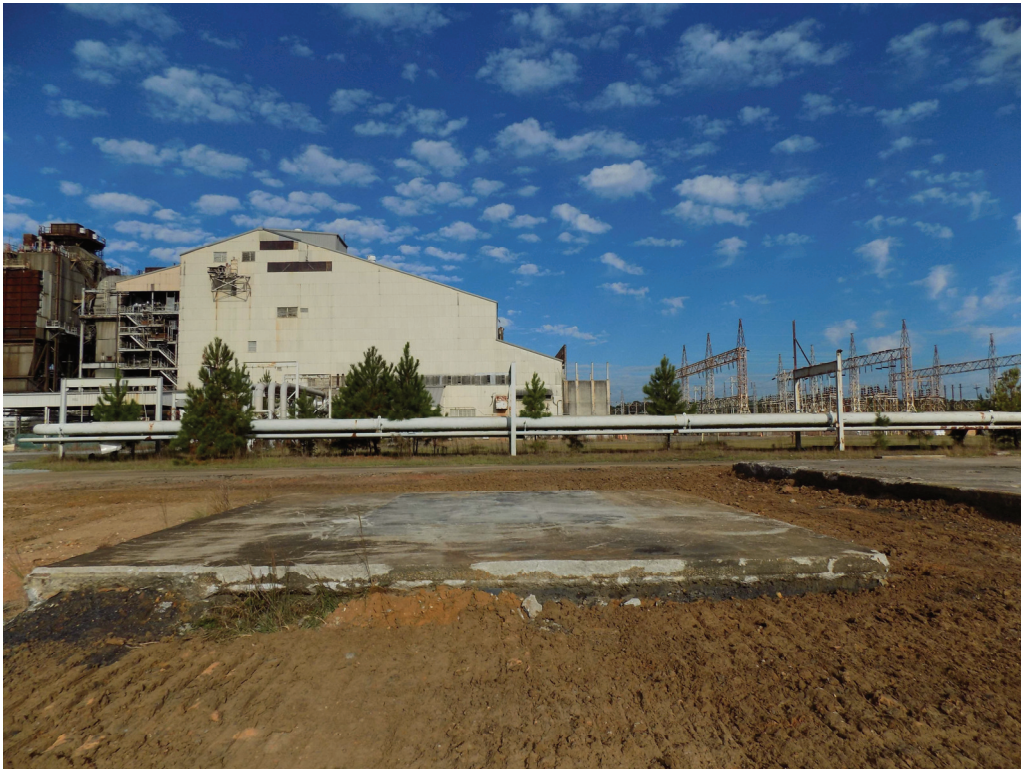
Figure A-20: SRS-PB-EX0033 and SRS-PB-EX0035 (Looking North) After Decommissioning

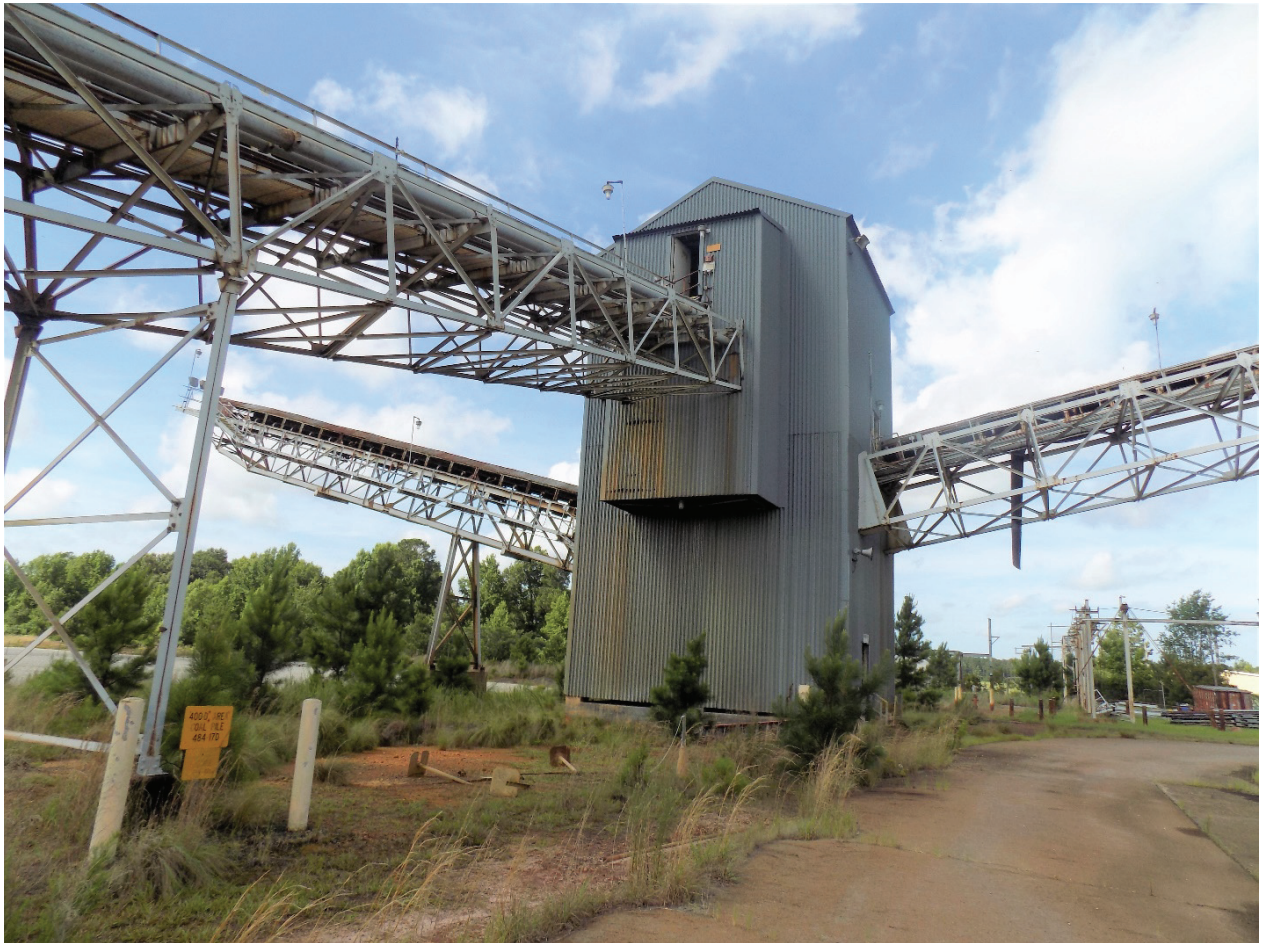
Figure A-21: 484-21D (Looking Southwest) Before Decommissioning

484-21D: 484-21D was constructed in 1953 and consisted of a concrete foundation and a steel I-beam framework with raised seam metal siding and roof panels. The multi-level interior was constructed with steel plate flooring that was interconnected and accessed by a steel staircase. Coal was received via Conveyor #2 in 484-21D from 484-22D. In 484-21D, Conveyor #2 discharged coal to either Conveyor #3 (to the 484-D Powerhouse) or Conveyor #5 (returned to the coal storage yard). Coal was reclaimed from the storage yard and dumped/pushed into the Reclaim Hopper which was carried back to 484-22D via Conveyor #4 to repeat the process of feeding the crusher and sending it to 484-21D. A baseline asbestos inspection of 484-21D and Conveyors #3 and #5 was performed on February 25, 2021 and issued on April 14, 2021 (Reference 8.02).

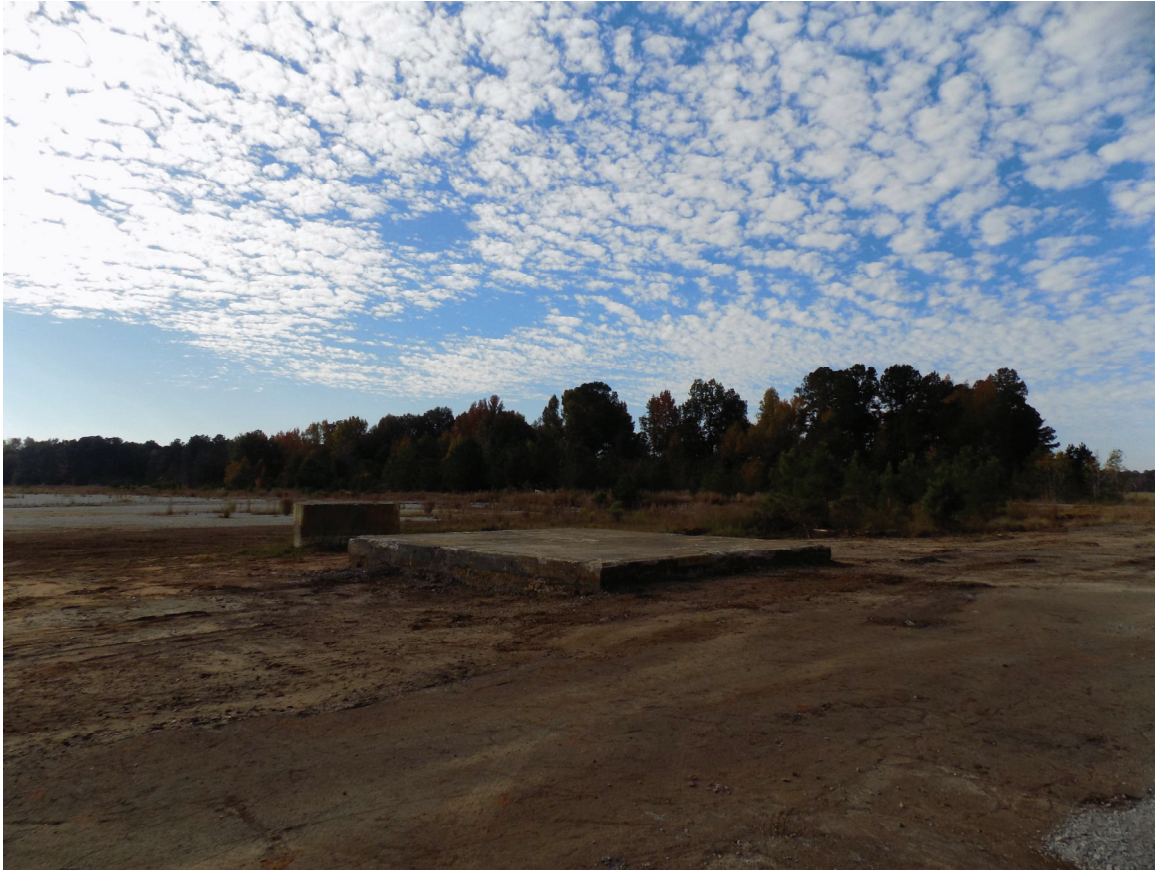
Figure A-22: 484-21D (Looking Southwest) After Decommissioning

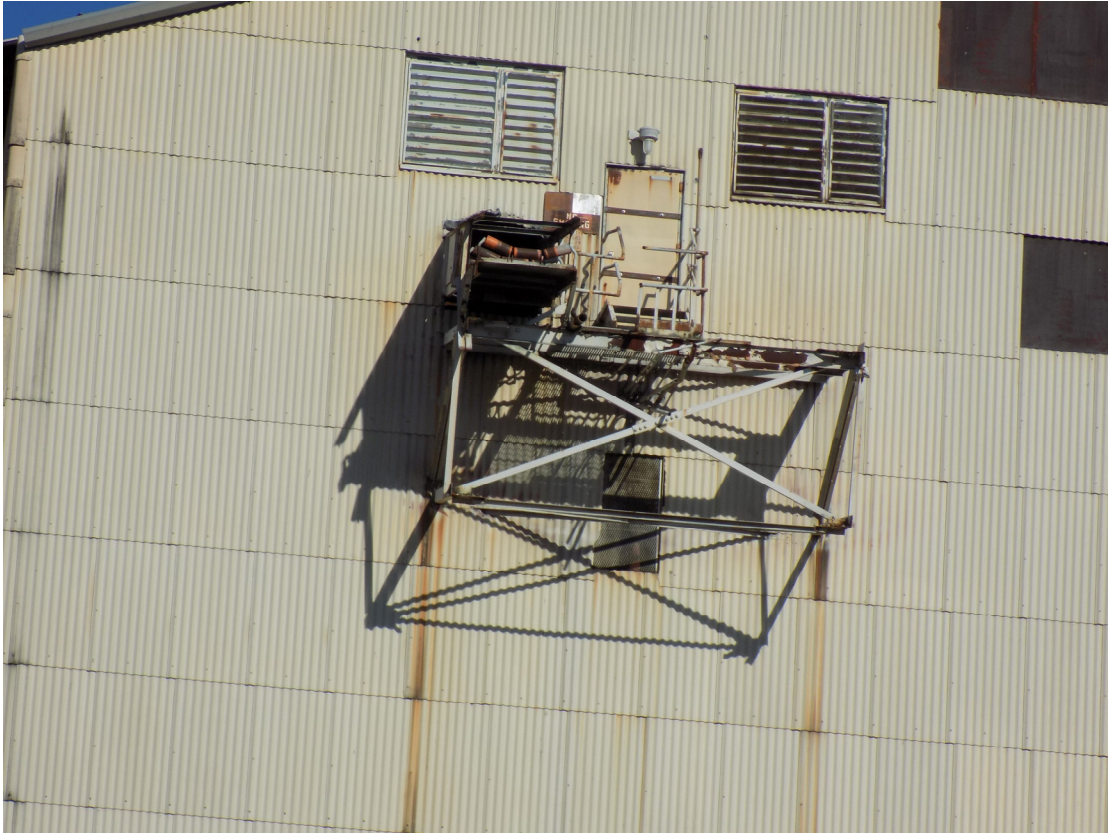
Figure A-23: Conveyor #3 and Door Exterior After Decommissioning

#3 was decommissioned from 484-21D to the 484-D Powerhouse. A small section of Conveyor #3 remains attached to the 484-D Powerhouse wall (Figure A-23). The door leading from Conveyor #3 to the 484-D Powerhouse was barricaded on both the exterior and interior by steel bars bolted to the door frame as a maintenance activity to prevent unsafe access (Figure A-23). Electrical junction boxes were demolished and removed. Any remaining holes were filled to the top of elevation with gravel/stone. All interfacing utilities were isolated, disconnected, and plugged. All coarse debris was removed from the remaining slabs. All concrete slab penetrations greater than 2 in. in diameter were cut off level with the slab, plugged, and grouted in accordance with Reference 8.13. Slab protrusions were cut off flush with the slabs. Any stains identified on the concrete slabs during decommissioning were pressure washed and/or cleaned with an effective surfactant.

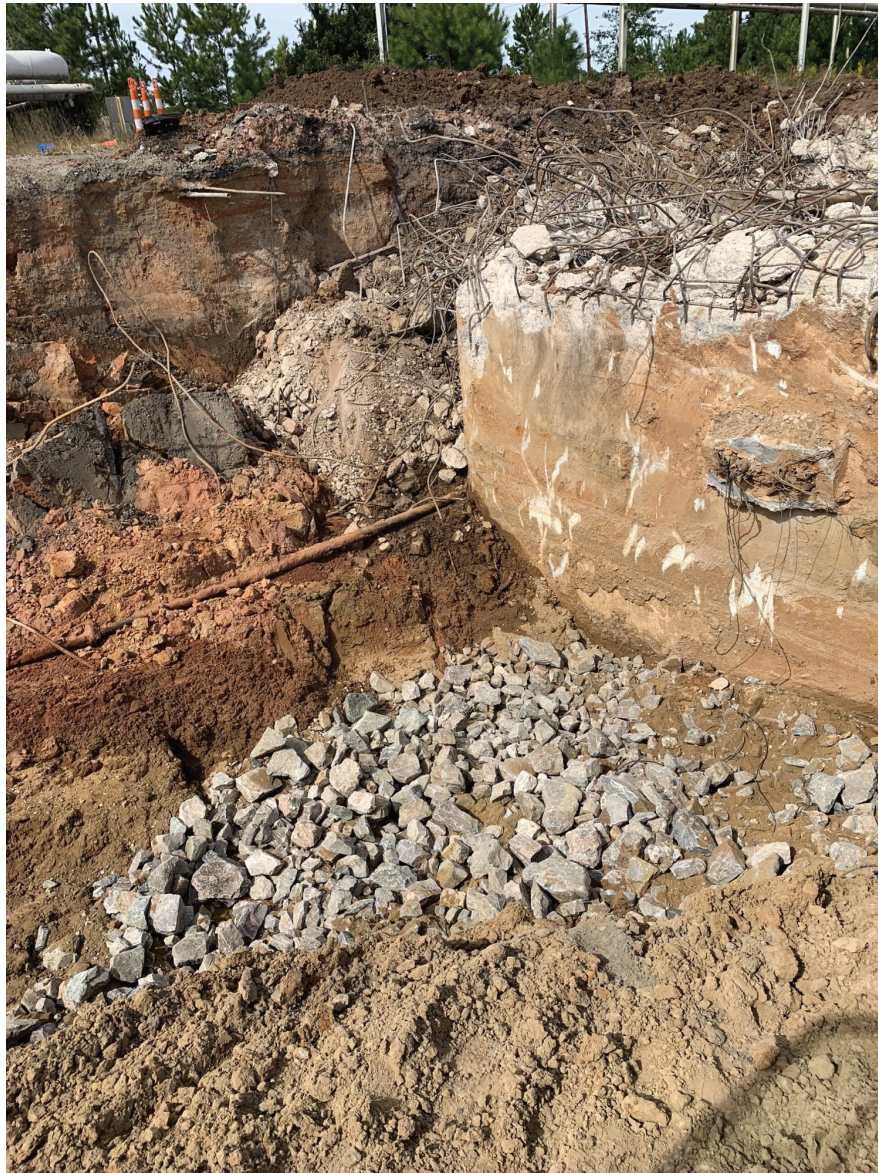
Figure B-1: Conveyor #1 Tunnel during Excavation/Fill

Hoppers, and the Reclaim Hopper all remain in place after decommissioning, though not readily visible. The floors of both Conveyor #1 and #4's tunnels were penetrated at their low points to allow drainage, refilled with both riprap and excavated dirt, and augmented with additional fill material to bring them to grade. See Appendix B for in-process photos of excavation and filling of Conveyor #1 and tunnels. The same refilling and grading process was used for Conveyor #4 tunnels.

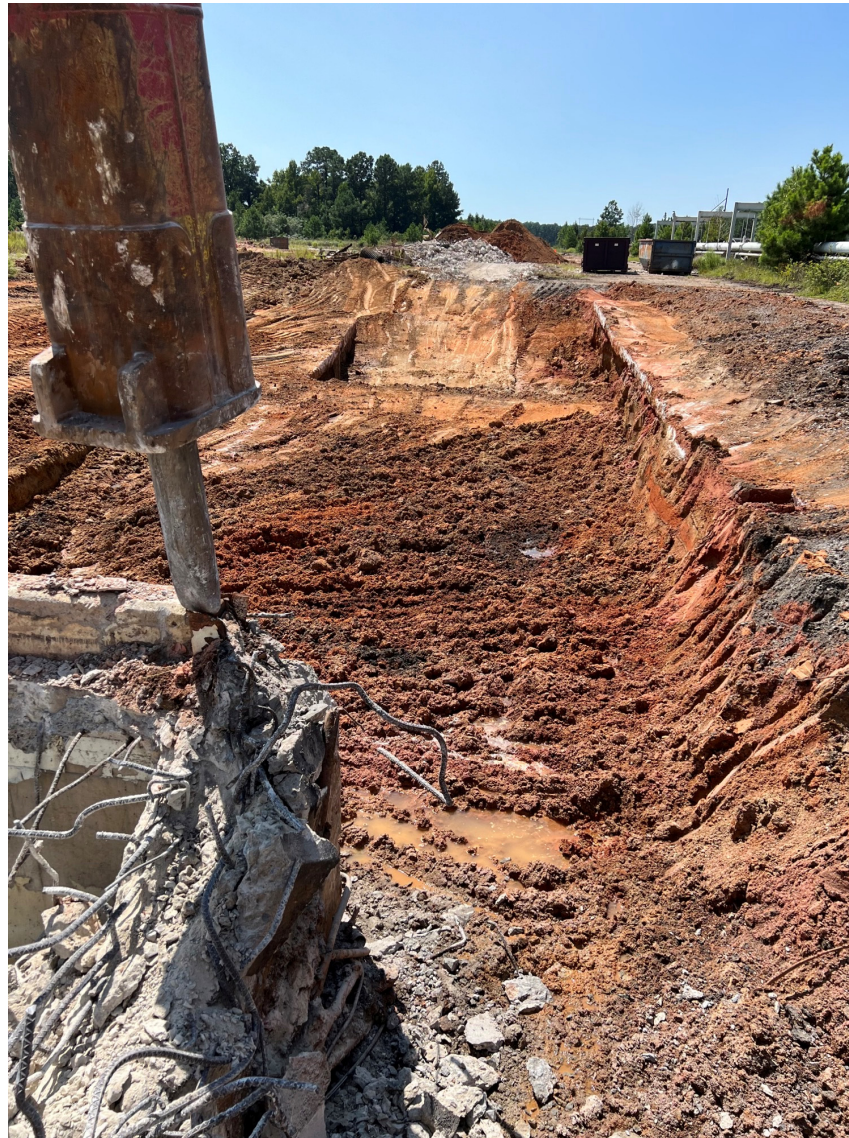
Figure B-2: Conveyor #1 Tunnel during Excavation/Fill
