## Facility Decommissioning Evaluation Building 710-16D, Storage Building

This is a Simple Model Decommissioning per Facility Disposition Manual 1C

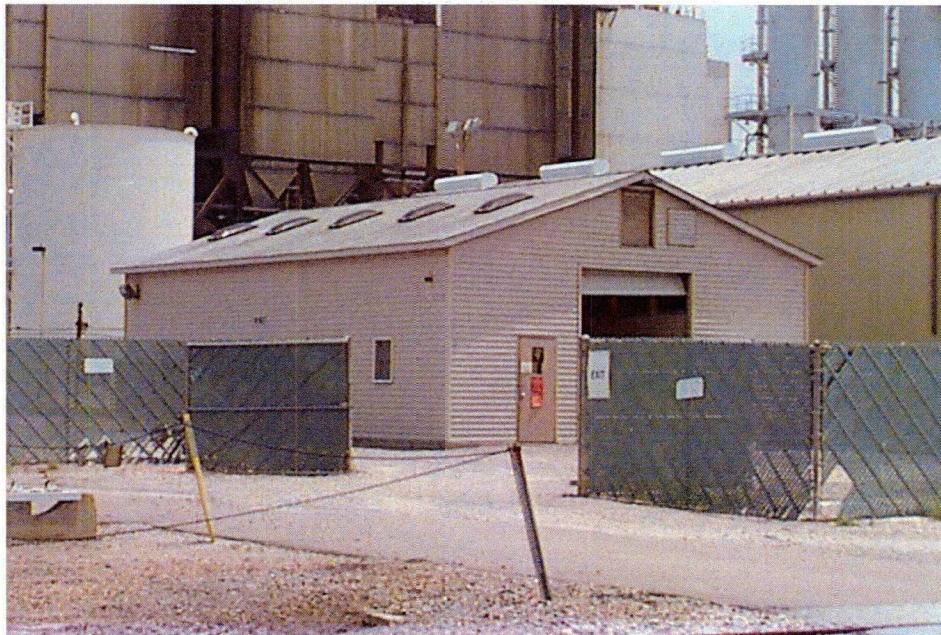
**Figure 1. Building 710-16D, Storage Building**

The 710-16D (Figure 1) storage building was built in 1993. The 1580 square foot (49.75' x 31.76') building is wood frame construction on a concrete foundation. The foundation is not a slab; however, it does consist of some interior concrete floor as it extends inward beyond the walls in many locations. The remaining floor space is natural dirt (Figure 2). The building has an asphalt shingle roof and vinyl siding. The building has eight (8) storage areas. Additional "attic" storage, with ladder access in Storage 1, is available above the ceilings installed over Storage 2 and 3 and over Storage 4, 5, 6, 7 and 8. Building position with respect to surrounding buildings is shown in Figure 4.

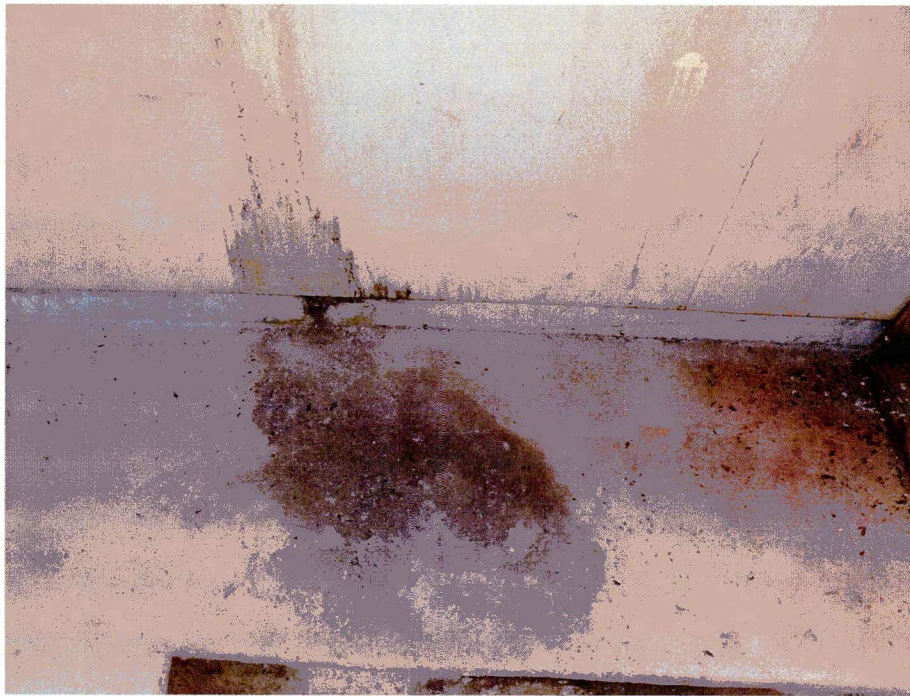
**Figure 3. Stain in Storage 8**

Though no chemical or radioactive processes were associated with this storage building, what appears to be a small (~1 ft<sup>2</sup>) oil stain is evident on the concrete within Storage 8 (Figure 2 and Figure 3). There is no evidence of the spill having reached onto the adjacent dirt floor area. Stained concrete will be cleaned with BioSolve® or equivalent surfactant during decommissioning.

| <b>Clean Facilities</b> | | | | |
|---|---|---|---|--|
| 2. | If there was stored packaged material, has there ever been a spill?<br><i>If No or N/A, this is a Simple Model. Stop.</i> | X | | A stained area of concrete exists in Storage 8 (See Figures 2 & 3). It appears to be an oil stain, but source is unknown. It is not radiological (Reference 4). |
| 3. | Was spill confined inside structure and cleaned to free release standard per Radiological Control Manual 5Q (for radiological) or continued occupancy per Industrial Hygiene Manual 4Q (for hazardous)?<br><i>If Yes, this is a Simple Model. Stop.</i> | X | | Stain from spill in Storage 8 appears to be petroleum oil based. The apparent spill was contained within the facility. Concrete has been cleaned. Stained concrete will be further cleaned with BioSolve® or equivalent surfactant. This will be a SIMPLE MODEL DECOMMISSIONING. |
