Facility Decommissioning Evaluation Building 690-N, Process Heat Exchanger Repair Facility

G-FDE-N-00013

Revision 2

May 13, 2019

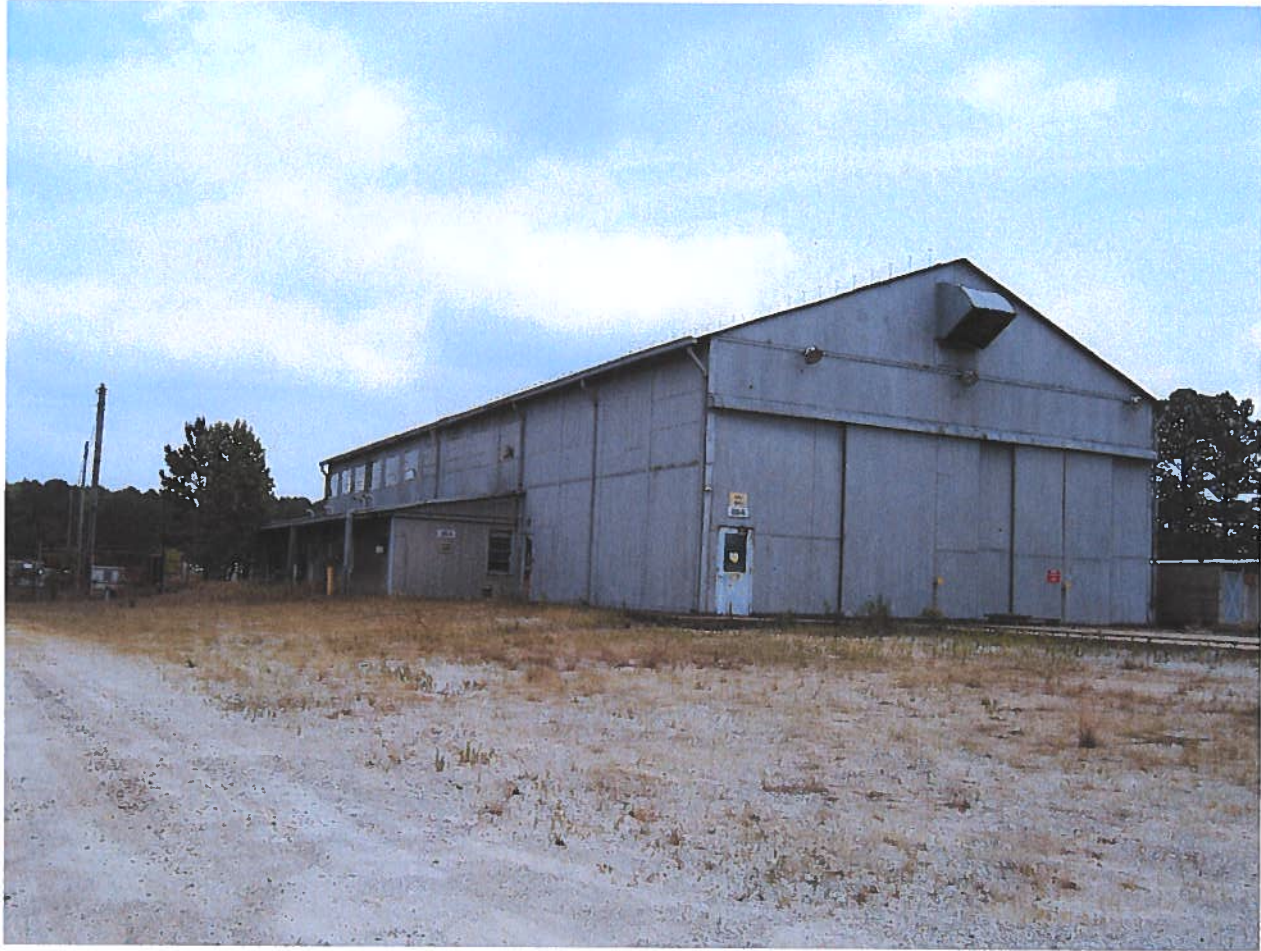
Figure 1 – Building 690-N, Process Heat Exchanger Repair Facility (Looking Southeast)

Building 690-N, Process Heat Exchanger Repair Facility, built in the 1950s, is a one-story metal frame structure on a concrete slab covering approximately 9,700 square feet. It is located in the extreme southeastern tip of the Central Shops (N-Area) near the center of SRS. The primary area consists of a machine shop with offices, storage rooms, restrooms and service area, which can only be accessed from the outside of the building on the north side. In the mid-1960s, a sealed shell was installed inside the original building frame with a ventilation and High Efficiency Particulate Air (HEPA) filter system to maintain a slight negative pressure and allow the facility to serve as a repair shop for leaking SRS reactor contaminated process water heat exchangers. The HEPA equipment was removed in 2012 as part of an American Recovery and Reinvestment Act (ARRA) deactivation project.” The ground in the area was covered with plastic and huts erected to contain any contamination. HEPA Housings, filters, and ductwork were loaded into Sealand containers and disposed of in the SRS Solid Waste Burial Ground (E-Area). Following removal of the HEPA Housings, the curbed concrete containment pads (i.e., sumps) beneath them were sampled and found to be slightly contaminated. “The curbed containment pads and sumps were filled with concrete and each capped with a reinforced concrete slab. Radiological monitoring and sampling throughout the removal iteration showed non-detect readings except on the concrete of the curbed sumps which are now filled in and covered with concrete.

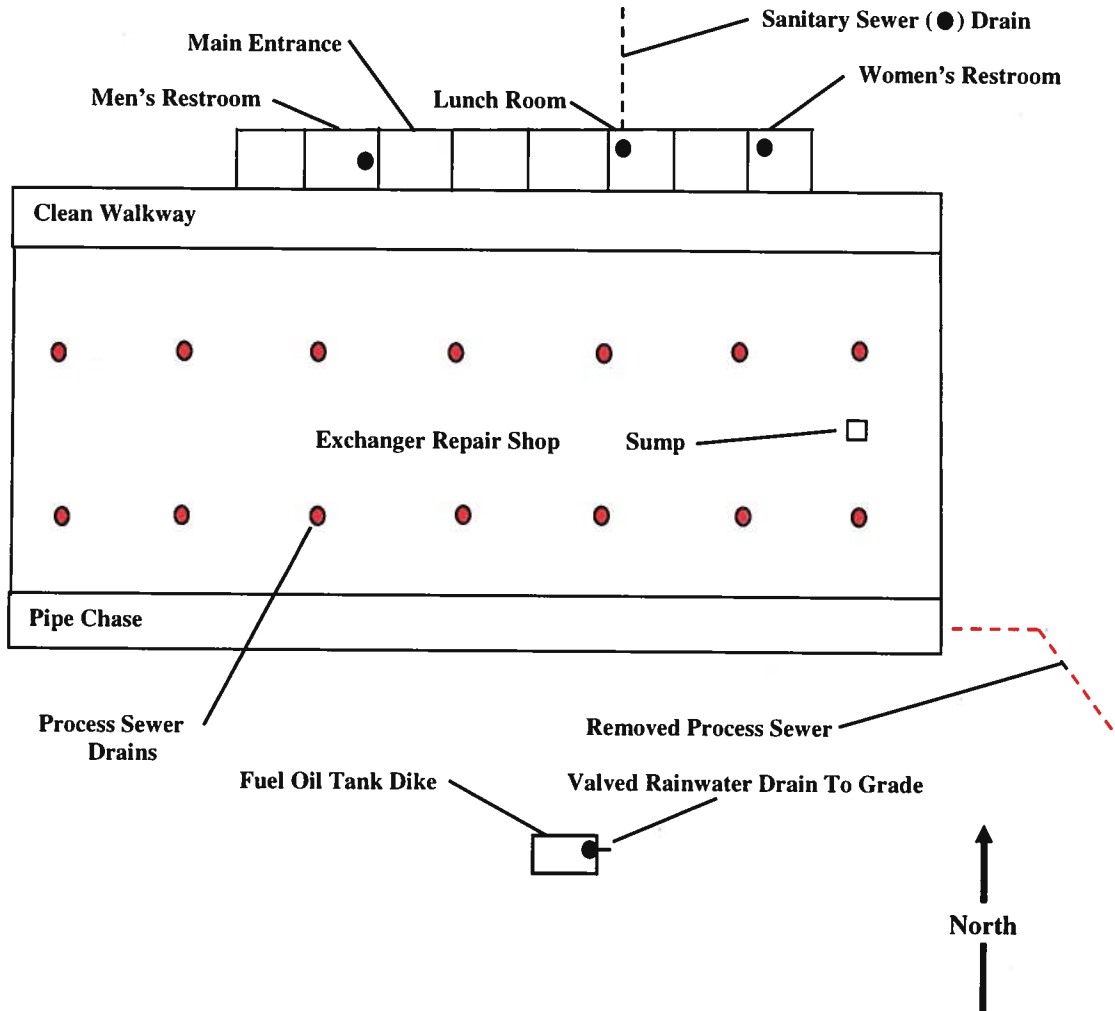
(See Reference 7 for previous cleanup effort involving the removed process sewer.)

Figure 3 – Building 690-N, Process Heat Exchanger Repair Facility (Floor Plan)

The shop area also contains a single 1’-6” X 1’-6” X 1’-0” sump located near the east end of the shop area, between the two sets of railroad tracks, at the radial drill.

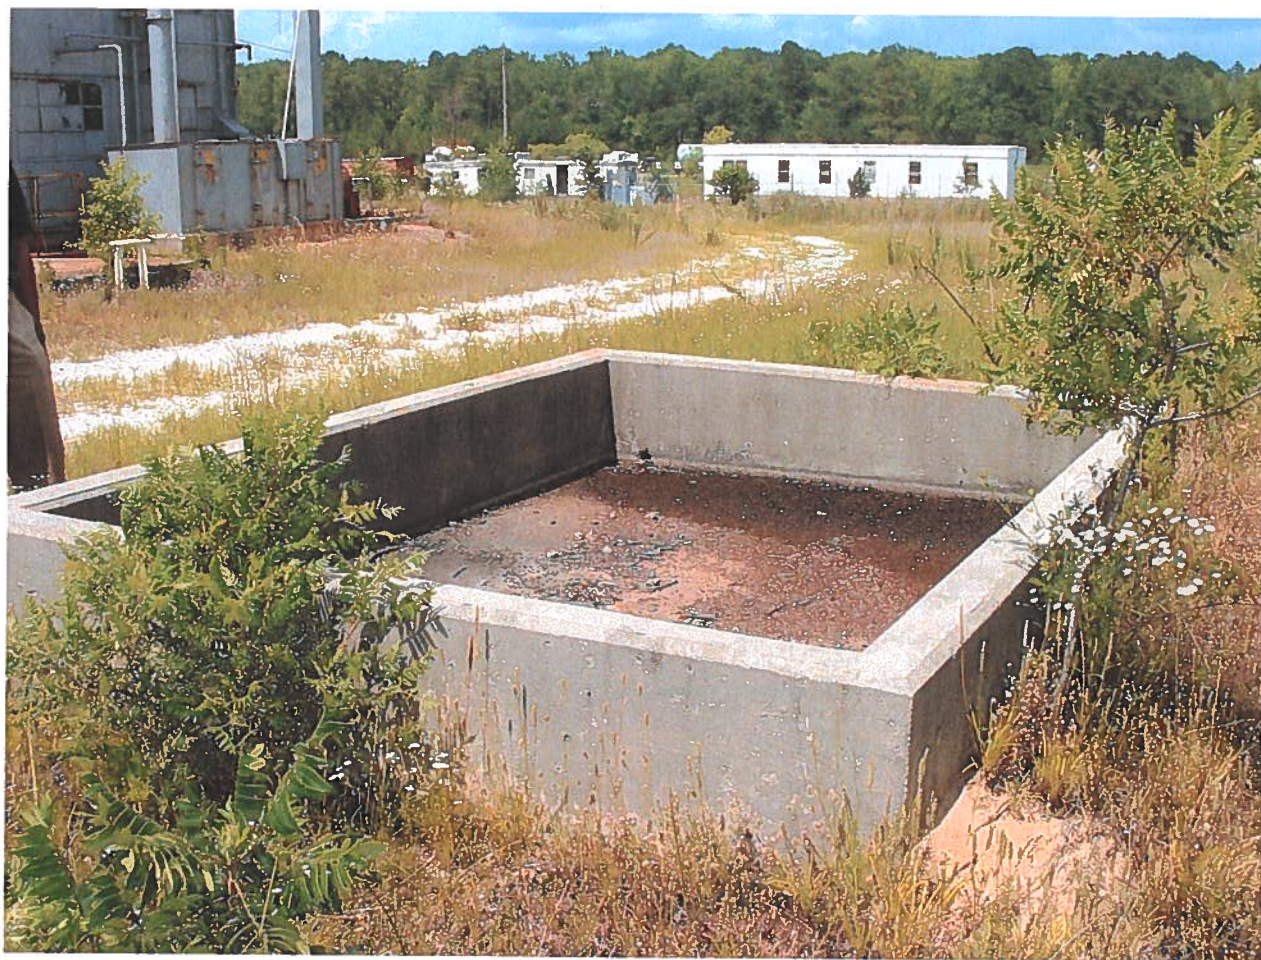
Figure 4 -Fuel Oil Tank Concrete Containment Dike (Looking East)

1. The concrete containment dike, located to the south of Building 690-N, contained a fuel oil tank that has been removed. The fuel oil tank was used to supply the 690-N Building heating systems.

A visual inspection of the tank containment dike was performed and there were no visible cracks that appear to penetrate the slab. There is no evidence of spills (e.g., oil stains); however, dirt and water stains are present. There were no visible stains around the tank containment perimeter.
