**Q-SDD-F-00007****S&M Inspection Report 221-1F, A-Line Pipe Cap/Wrap and Taps  
February 8, 2022**

The purpose of this report is to document the inspection performed 1/27/2022 on the pipe caps/wraps and pipe taps on the A-Line, Building 221-1F pipe bridge and associated piping, and address any repairs/actions that may be required. The guidelines and requirements for this inspection were based on the following documents:

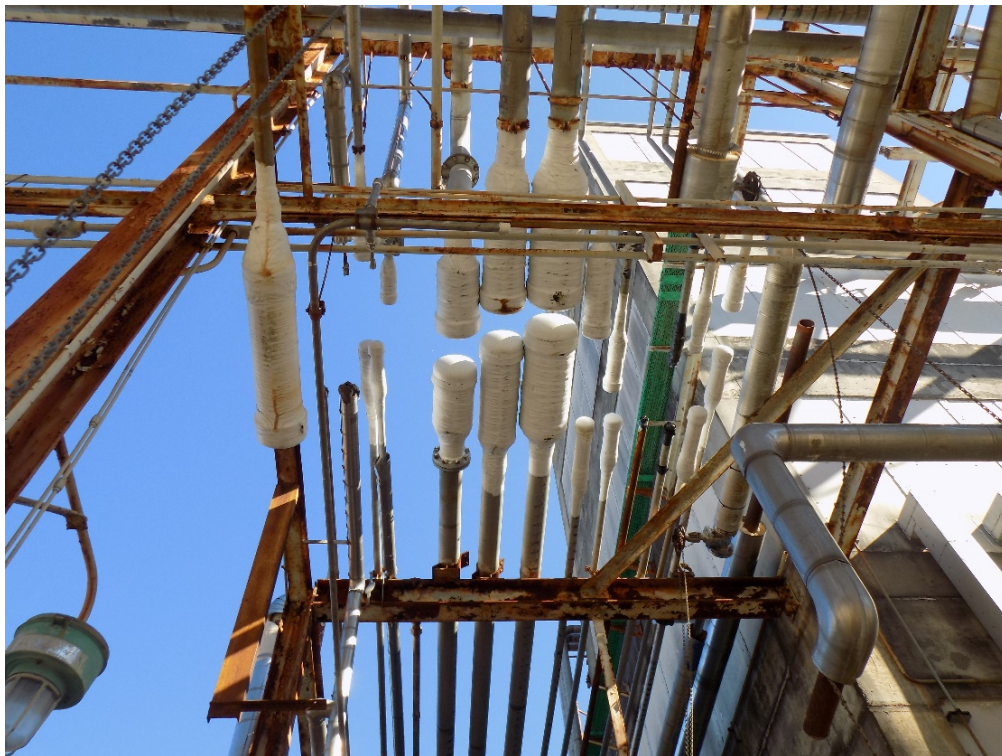
**Photo 1 - Pipe Caps/Wraps Only**

1. There is no evidence of leaking of any of the pipe taps and no further action is required until the next annual walkdown is performed or if circumstances/conditions warrant its occurrence (Photos 1-9).
2. Although the pipe wraps exhibit minor staining there is no instance noted that would require the wraps to receive additional layers or to have to be recoated with Imron™ or equivalent acrylic enamel paint for UV protection (Figures 1-9). Unless conditions change or there is evidence of leakage of any of the caps/wraps, the next walkdown should occur in one year in conjunction with the pipe tap inspection.
