STATUS AND OPERATION OF THE 242-25H EVAPORATOR SYSTEM

SRR-CWDA-2018-00022

Technical Justification for Operation of 242-25H Evaporator Pot with Known Leak Sites

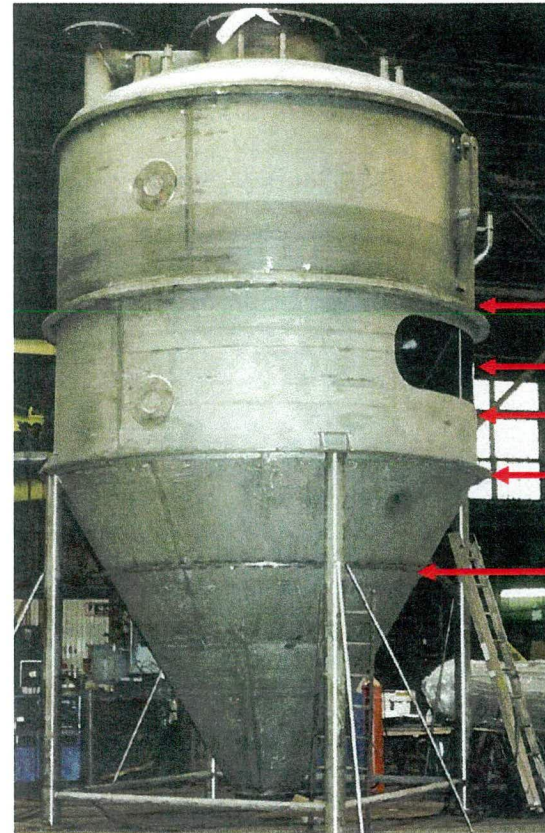
Normal Operating Level - 95"

Center of Steam Chest - 76"

Bottom of Opening - 62"

Stiffener Band - 37"

Stiffener Band - 0"

Levels are approx indicated level

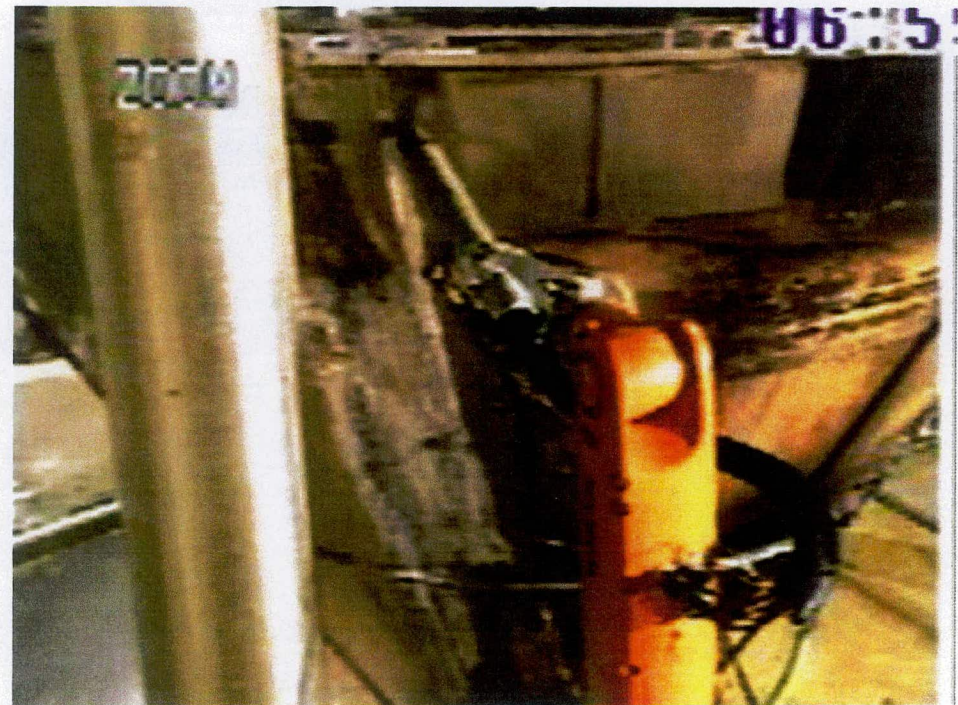
- On February 17, 2016, the 3H was shutdown after salt waste was discovered in the stainless steel-lined concrete cell
 - Leaked ~3000 gallons into secondary containment
 - Leak rate 150 gallons/day
- Extensive testing was performed to pinpoint the source of the leak
 - Including the remote removal of the encased insulation on the cone of the pot using robotics
- Leak site location was confirmed on February 28, 2017 after insulation removal

Picture taken during removal of the stainless steel-wrapped insulation on the cone of the evaporator pot

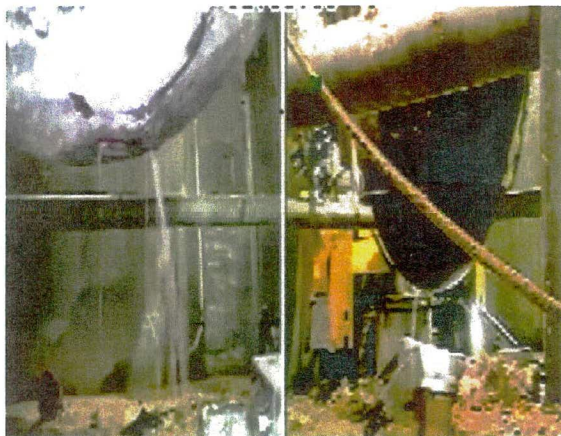
Original Leak Sites

- Cause determined to be erosion initiated by steam lance
- Installed repair cap using robotically deployed powder-injection laser welding
- Post maintenance test with heated water and subsequent In-Service Leak test with waste at normal operating conditions showed no leakage
- **RESTART**
- Completed normal evaporator start-up December 13 and operated ~55 hours
- **Identified two new leak sites 3-5 feet above the repair cap at weld seams**
 - No leaks in repair cap area
- Inspections showed no free-liquid or accumulation on cell floor beneath new leak sites

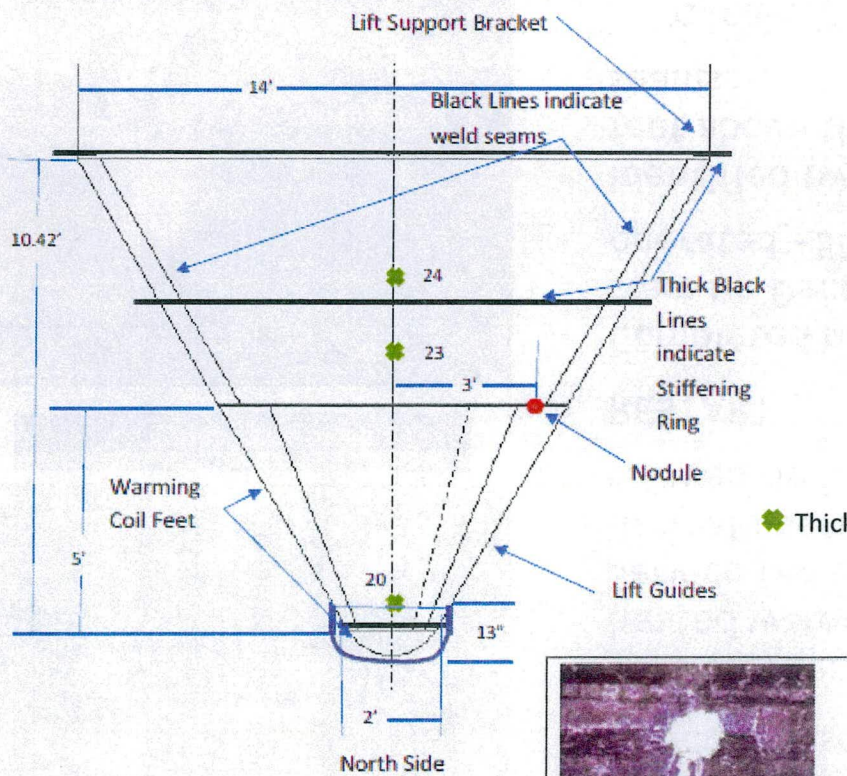
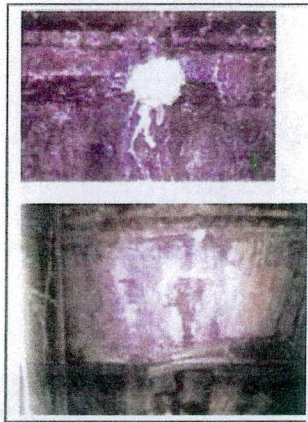
North Leak-site (the nodule)

- Leaks are at welds
- Leaks are approximately the diameter of a human hair (~3 mils); calculated leak rate of $<1/10^{\text{th}}$ gallon per day per leak site
- Inspections showed dry material and salt nodule formation, minimizing the amount of salt waste outside of the pot
- Most likely cause is undetected weld discontinuities or defects during original manufacture
- Leaks sites will not grow during continued operation; if they are cracks, there is insufficient energy to drive crack growth
- The vessel is still structurally sound

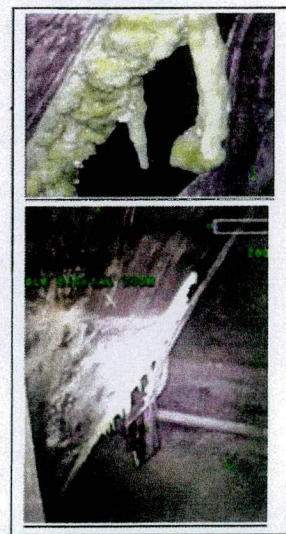
South Leak-site (the salt streak)

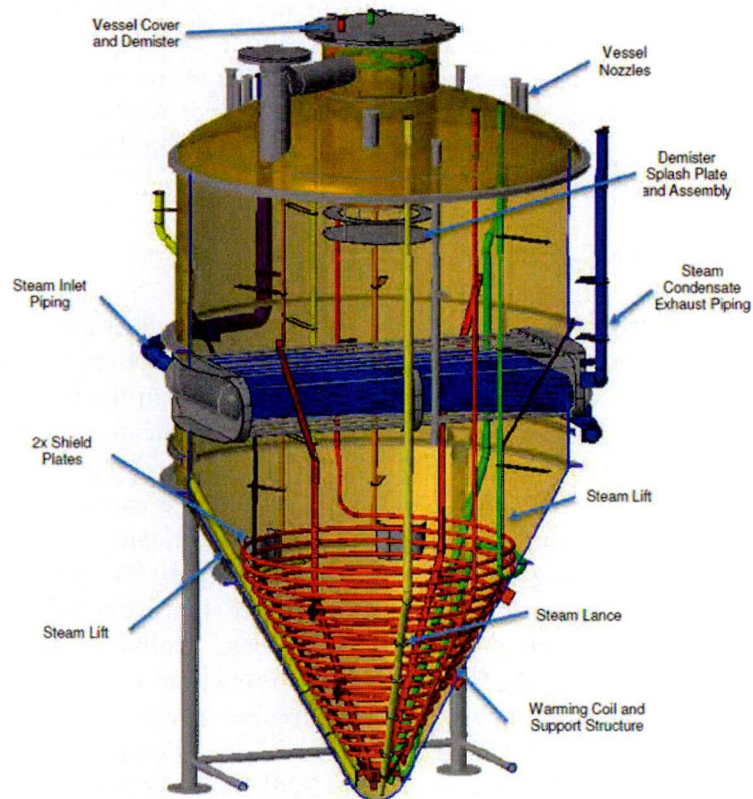
Figure 1: Major Components of the 242-25H Evaporator Pot

The 3H evaporator pot, shown in Figure 1, is a single-staged “pot” evaporator. It is about 26.7 feet high by 14 feet in diameter, and the wall thickness of the conical section is ~0.41 inches. The vessel shell consists of:

- A pressure vessel head at the top with multiple nozzle penetrations;
- An upper cylindrical section with a horizontal steam tube bundle;
- A lower conical section supported by four legs and a support ring; and
- A small spherical head at the bottom.

The tube-bundle has hundreds of slightly curved tubes running between two thick vertical tube-sheets on opposite sides of the vessel. A steam lance injects steam into the vessel bottom to keep the waste suspended. Two sets of steam and lift lines also run to the bottom of the vessel cone to remove concentrated waste. The pot was surrounded by two inches of calcium silicate insulation that was sealed with 16-gauge (1/16-inch thick) stainless steel sheathing.

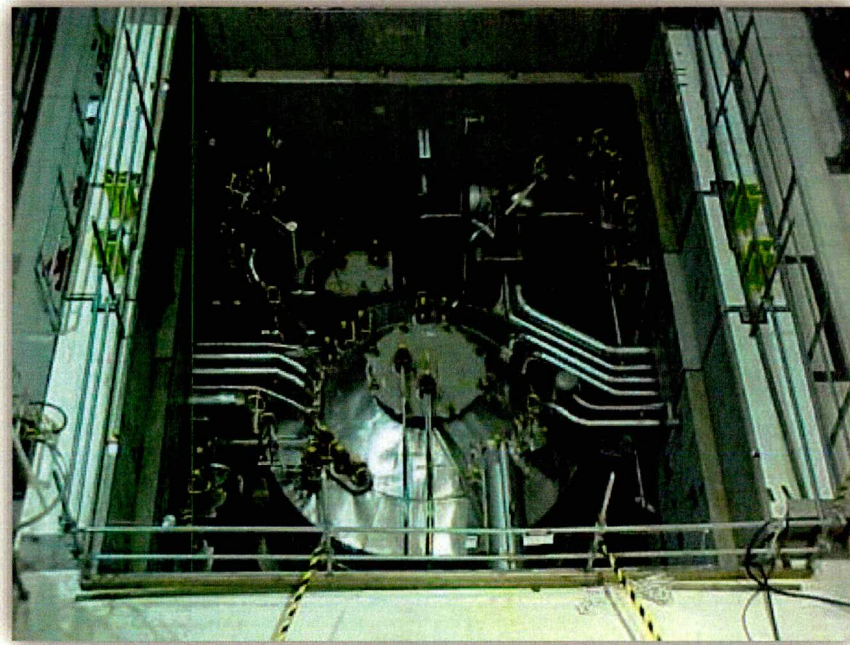
Figure 2: 3H Evaporator Pot and Associated Evaporator Secondary Containment Cell (Cell Covers Removed)

Pinpointing the exact location and cause of the leak site was challenging due to presence of the insulation and sheathing on the outside of the pot and the high radiation levels prohibiting personnel from entering the evaporator cell. Ultimately, the sheathing and insulation had to be removed from the conical portion of the pot to reveal the leak site. The removal of this insulation and sheathing itself was very challenging due to the high radiation rates and relatively tight space restrictions within the cell (Figure 2). A subcontractor, AREVA, was hired to perform the removal of the insulation from the pot. A BROKK 100™ remote excavator with a KUKA robot arm was used to perform this difficult task.

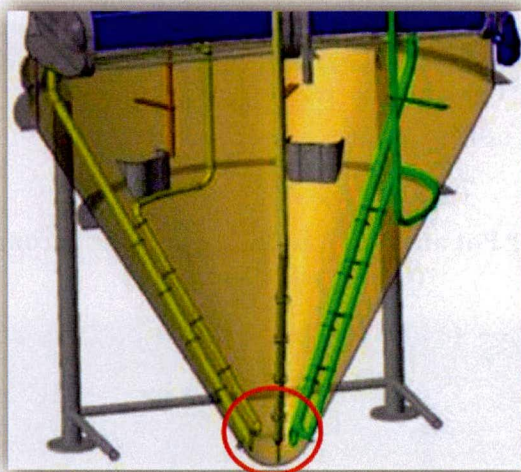
Figure 3: Site of Erosion

In February 2017, approximately one year after being shut down, multiple leak sites were clearly identified through visual observation once the insulation below the support ring was removed and the evaporator's steam lance was activated. Leakage was not observed without the activation of the steam lance; this has been attributed to the plugging of the leak sites by debris. Ultrasonic measurements of the pot wall thickness confirmed general thinning in the area where the steam from the lance impinges on the vessel wall. Following an extensive assessment, it was concluded that the loss of material, and ultimately the development of leak sites, was due to erosion from abrasive impingement of steam and salt solids on the vessel wall through the operation of the lance during the 16 years of operation at a steam flow rate of approximately 1,200 lb_m/hour (Figure 3).

Because the thinning of the vessel was restricted to the bottom portion of the evaporator cone, it was determined that a cap could be remotely welded to the bottom of the vessel sealing the leak sites. A ½-inch thick Alloy G-30 cap was designed and fabricated for this function. In November 2017, following extensive full-scale mock-up testing, this cap was successfully welded to the bottom of the vessel and on December 11, 2017, the Savannah River Remediation LLC (SRR) Professional Engineer certified that the cap was successfully installed per the design. This activity utilized all remote/robotic equipment and powder injection laser welding, a first-of-a-kind achievement in the industry. This welding technique was implemented by feeding Hastelloy® beads/fines from a hopper on the cell cover down approximately 35 feet into the evaporator cell to a laser head operated by the robot, with weld paths pre-programmed into the robot and operations controlled by an operator in a remote control room.

Prior to restarting the 3H Evaporator System, the 3H lance supply orifice was resized to reduce the mass flow rate for the steam lance by more than one-half — down to 500 lb_m/hour from the original 1,200 lb_m/hour. It was determined that evaporator operations would not be impacted by this reduction. By physically resizing the 3H lance steam gang valve orifice to reduce the mass flow rate to 500 lb_m/hour, the nominal erosion rate seen by the vessel wall is reduced by a factor

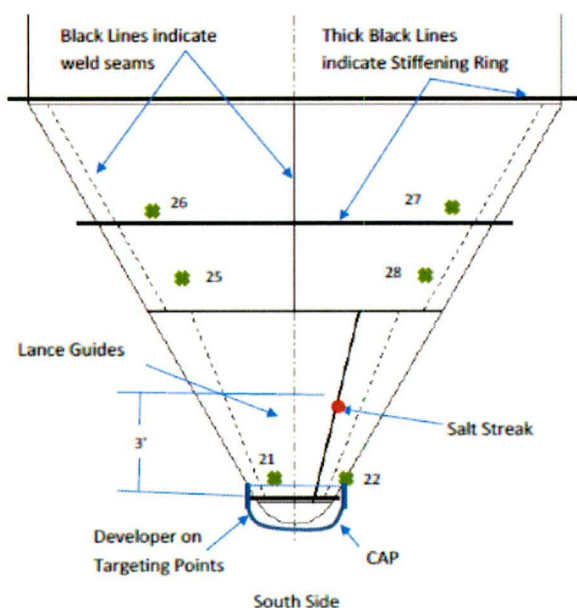
Figure 4: Location of South Leak Site

The first leak site (“South Leak Site”) is located on the south side, about one-third the way up the conical section of the evaporator pot. Figures 4 and 5 show the location of the leak site and the salt present.

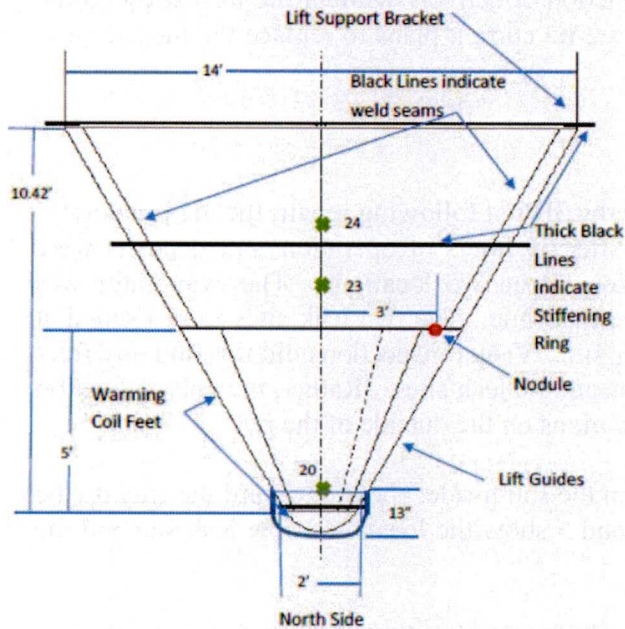
Figure 6: Location of North Leak Site

The second leak site (“North Leak Site”) is located on the northwest side, about half way up the conical section of the pot. Figures 6 and 7 show the location of the leak site and the salt nodule present.

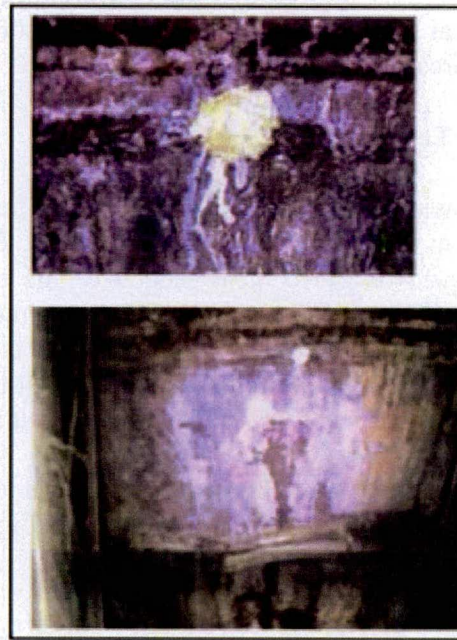
Figure 7: Salt Nodule from North Leak Site

The newly discovered leak sites were not apparent during visual inspections in 2017 prior to the installation of the repair cap, nor following the repair during post-maintenance testing; they only became apparent after operating the evaporator at higher temperatures and specific gravity, 135°C and 1.5 g/cm³ respectively. Since their discovery, it has been determined that these two sites are located on or near welds and have an equivalent hydraulic diameter of about 3 mils (0.003 inches) – roughly the size of a human hair. The calculated leak rate from these two leak sites during normal operations of the evaporator is calculated to be less than 1/10 gallon per day per leak site. This calculated leak rate assumes that no dry salt is present at the leak site, which would likely further reduce the leak rate. This very slow, drop-like rate is more than four orders of magnitude lower than the rate that was seen from the erosion-induced leaks at the bottom of the evaporator pot after the insulation and sheathing were removed. The presence of the insulation and sheathing around the vessel hid the presence of these defects during its 16 years of initial operation.

The most likely cause of these recently discovered leak sites has been determined to be undetected weld discontinuities or defects during the original vessel manufacturing process. Due to the nature of these defects, the leak sites will not grow through the continued operation of the evaporator system. Further, it has been shown even if these sites were actually cracks, there is insufficient energy present at these sites to induce further crack growth. Despite the presence of these weld defects, the 3H evaporator pot is structurally sound in its present state.
