## Facility Decommissioning Evaluation Building 484-7D, D-Area Storage Building

This is a Simple Model Decommissioning per Facility Disposition Manual 1C

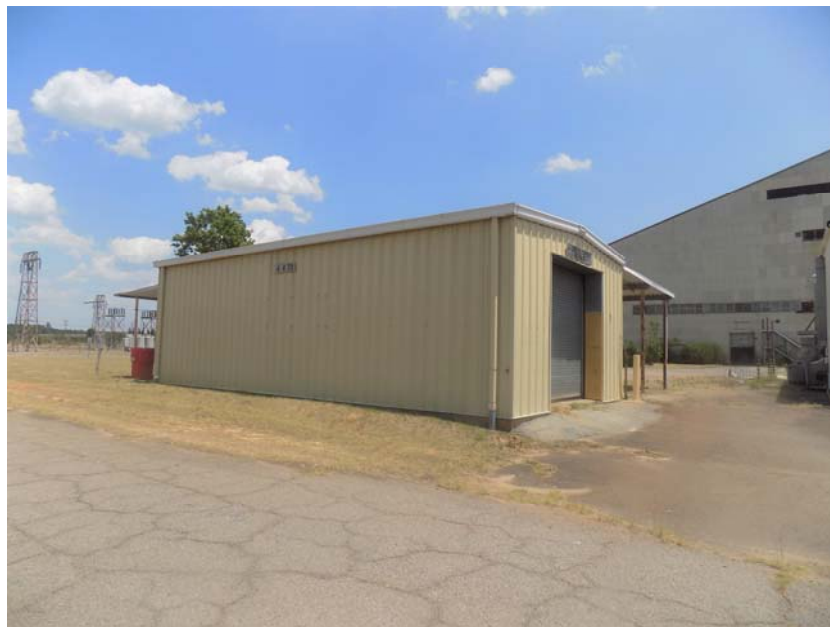
**Figure 1. Building 484-7D, D-Area Storage Building**

Building 484-7D (see Figure 1 for photograph, Figure 2 for layout of the structure, and Figure 3 for layout of the area in the vicinity of the structure) is an approximately (~) 24-year old metal frame structure with metal skin. The interior walls are aluminum. The structure is attached to a concrete slab. The structure itself is ~20 feet (ft)' by 42 ft, with a non-partitioned interior. The structure does not appear to have any asbestos or lead in the materials. The building was used primarily for receiving of D-Area Materials. Electrical power, which was disconnected during deactivation, was the only utility supplied to the structure (refer to "Deactivation Project Final Report Building 484-D Powerhouse and Ancillary Buildings", V-PCOR-D-00042, Reference 6). There are no sumps and/or drains associated with the facility. Concrete associated with the facility is in good condition.

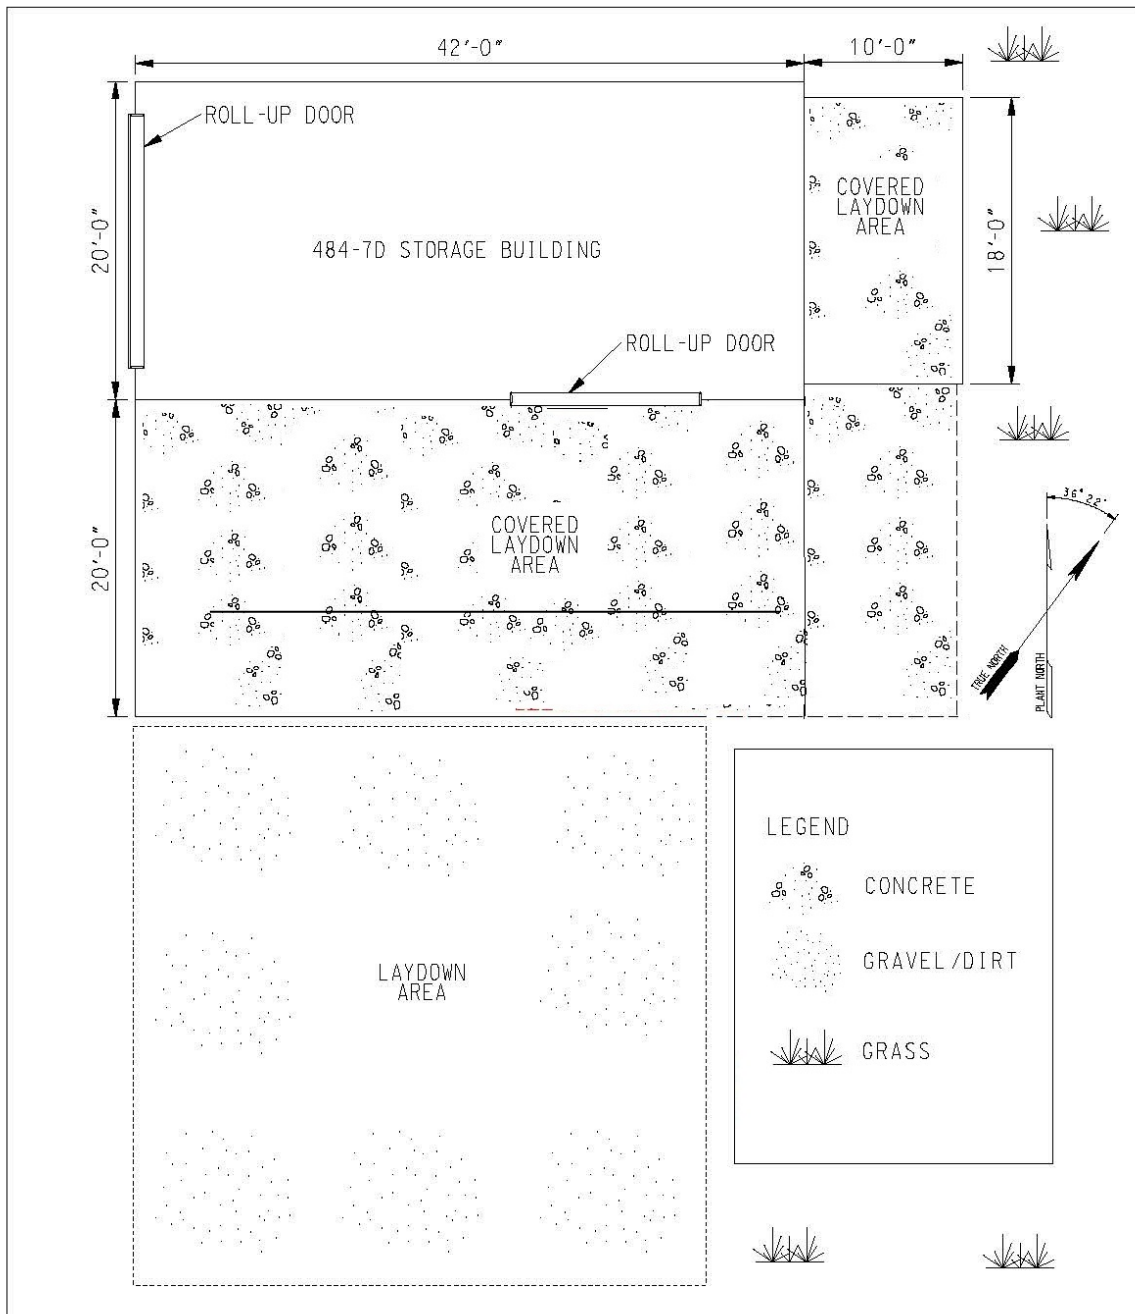
Figure 2. Building 484-7D, Storage Building (Layout)

To the east and south sides of the building (Figures 2 and 3) are covered laydown areas. Each area has a concrete slab and a metal roof extended over it that abuts the building structure and is supported by posts distal to the structure.

Abutting the covered lay-down are a gravel/dirt and a smaller uncovered concrete lay-down area (Figures 2 and 3). These areas were used for temporary storage of powerhouse parts and equipment suitable for outside storage. The covered laydown area on the south side of the building is currently being used for temporary storage of tools, equipment, cabinets, etc. that belong to the Community Reuse Organization (CRO). All items in temporary storage will be removed prior to decommissioning. The bollard on the southwest corner of the structure will also be removed during decommissioning.

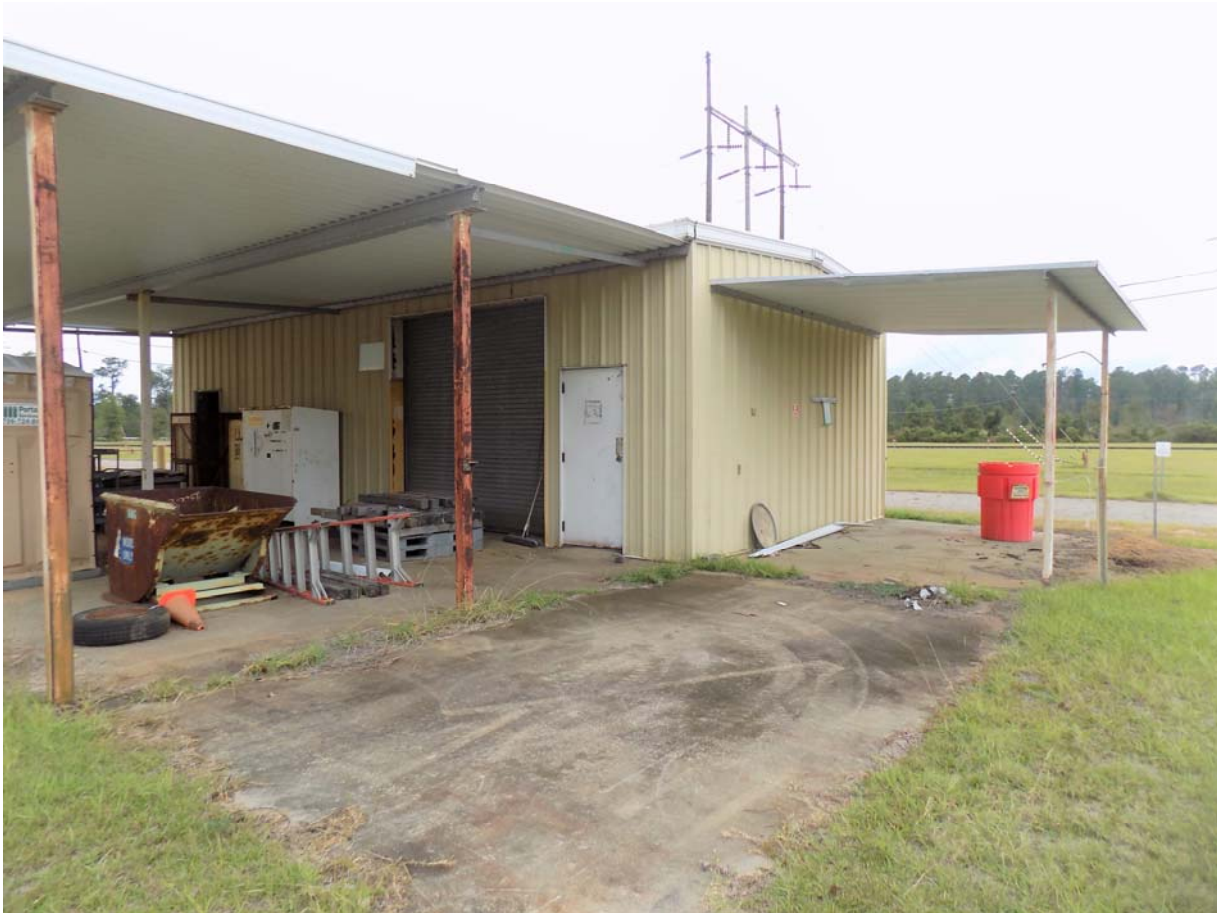
**Figure 4. Building 484-7D, Storage Building Covered Lay-down Areas**

The covered lay-down pad on the east side of the structure currently has an overpack container that also belongs to CRO (Figure 4). The overpack container will be removed and properly dispositioned prior to building decommissioning. The uncovered concrete pad south of this pad appears to have discoloration due to vehicle traffic. Any stains on the concrete will be spray washed and cleaned with BioSolve® or equivalent surfactant during decommissioning of the structure.
