Engineering Survey & Interference Report for Building 480-3D, Maintenance Field Office and Shop

1.0 Introduction

The purpose of this survey / report is to provide guidance for the safe demolition of Building 480-3D, a 24' x 24' prefabricated structure built in the early 1950s, as well as meeting the requirements of OSHA Standard 1926.850(a).

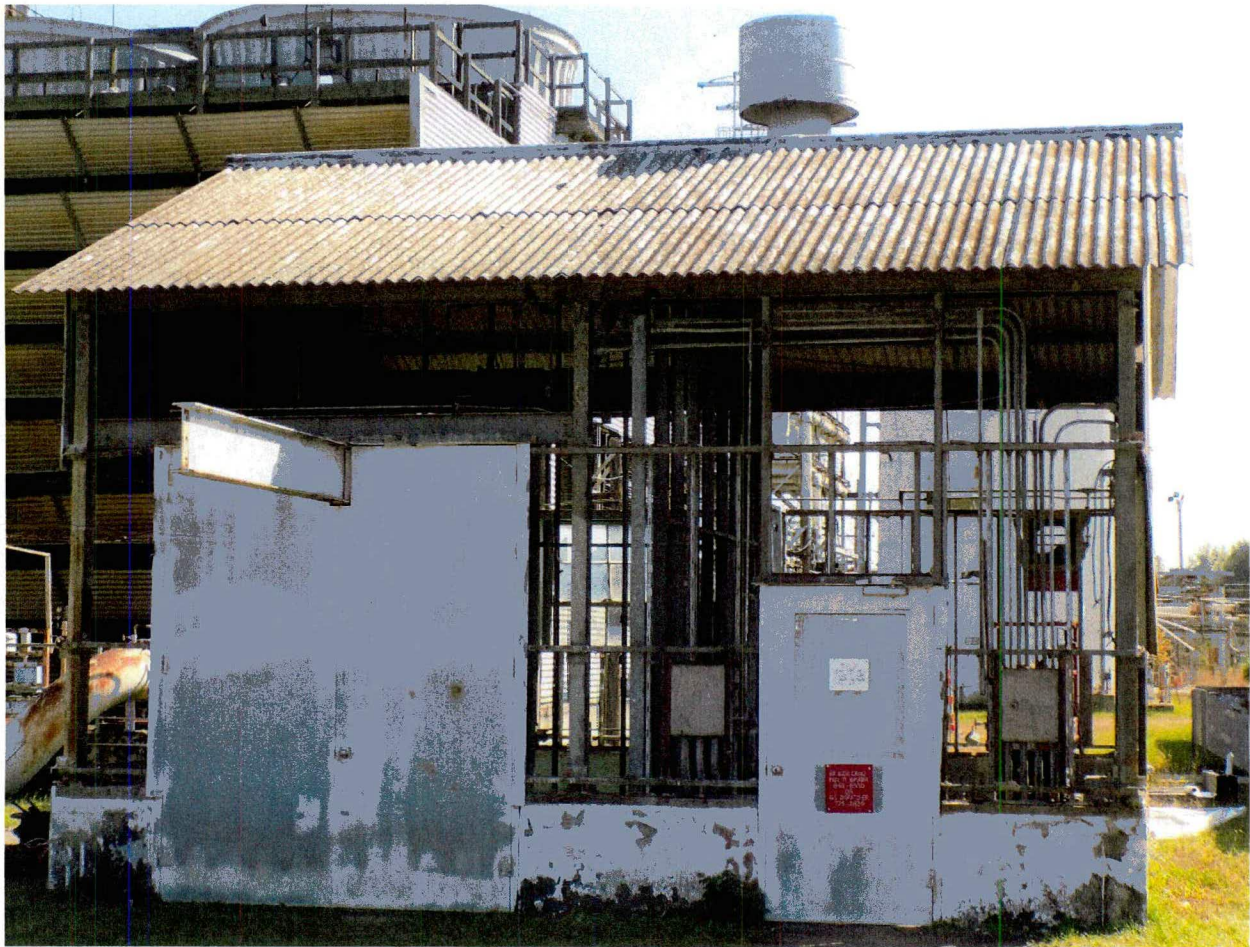
Based on visual inspection on October 25, 2020, the structure as defined in Reference 5.1 is in good condition, and there is no potential for an unplanned collapse of the structure either due to forces of nature and/or vibrations created by movement of heavy equipment in proximity to the building.

Figure 3: Photo Building 480-3D Looking South (North Side of Building)
