Post-Construction Report for the Lower Three Runs Integrator Operable Unit Upper Subunit (U)

SRNS-RP-2023-00109

January 2025

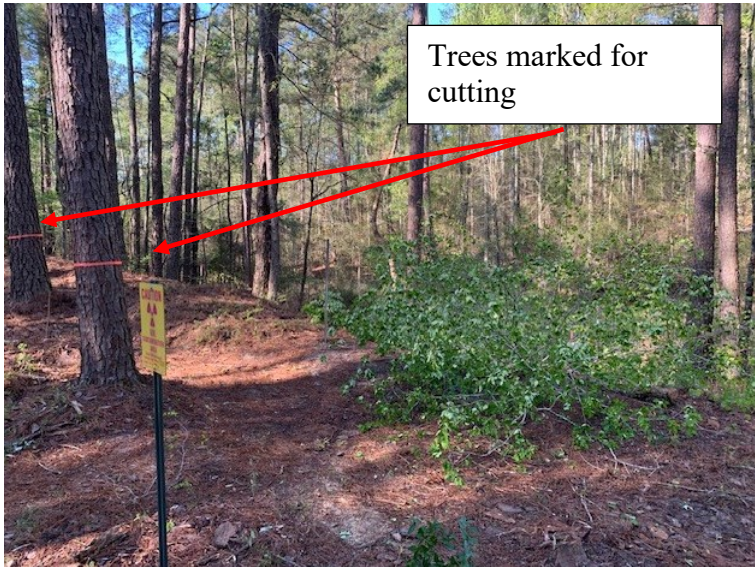
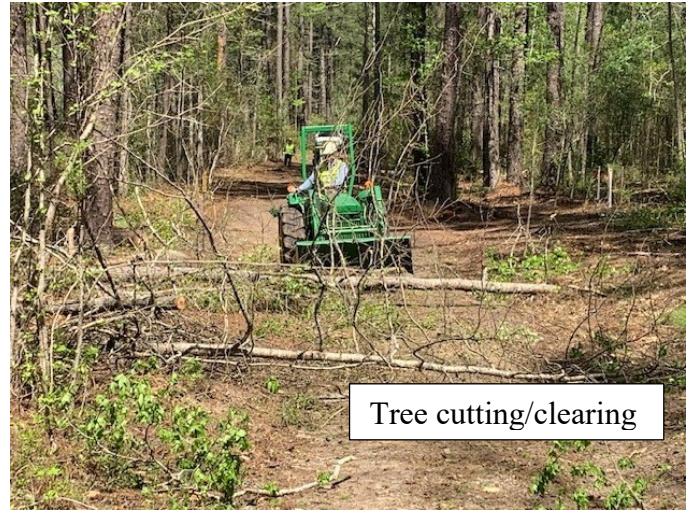
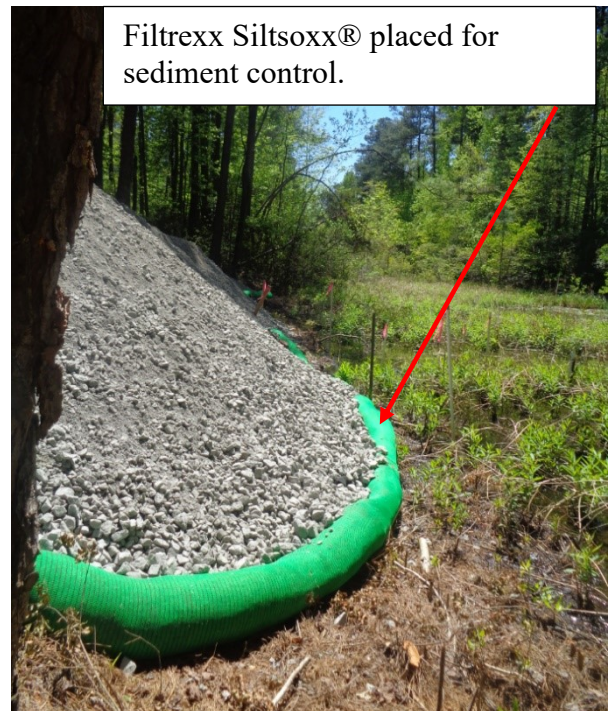
Figure 11. Tree Clearing and Placement of Stone for Working Platform

Initial land clearing was performed to allow access to the R-Area Discharge Canal and to establish a working platform for the excavator. Trees were cut above grade and pushed to the side. No grubbing was performed so there was minimal disturbance to the soil. Filtrexx Siltsoxx® was used as the edge of the canal to mitigate migration of soil to the canal (Figure 11).

The subcontractor prepared an access path and working platform along the bank of the canal consisting of a non-woven geotextile fabric covered by approximately 12 loads of stone (rip rap and #57 stone). The platform has approximate dimensions of 9.1 m by 12.2 m (30 ft by 40 ft) to permit parallel tracking along the excavation footprint.

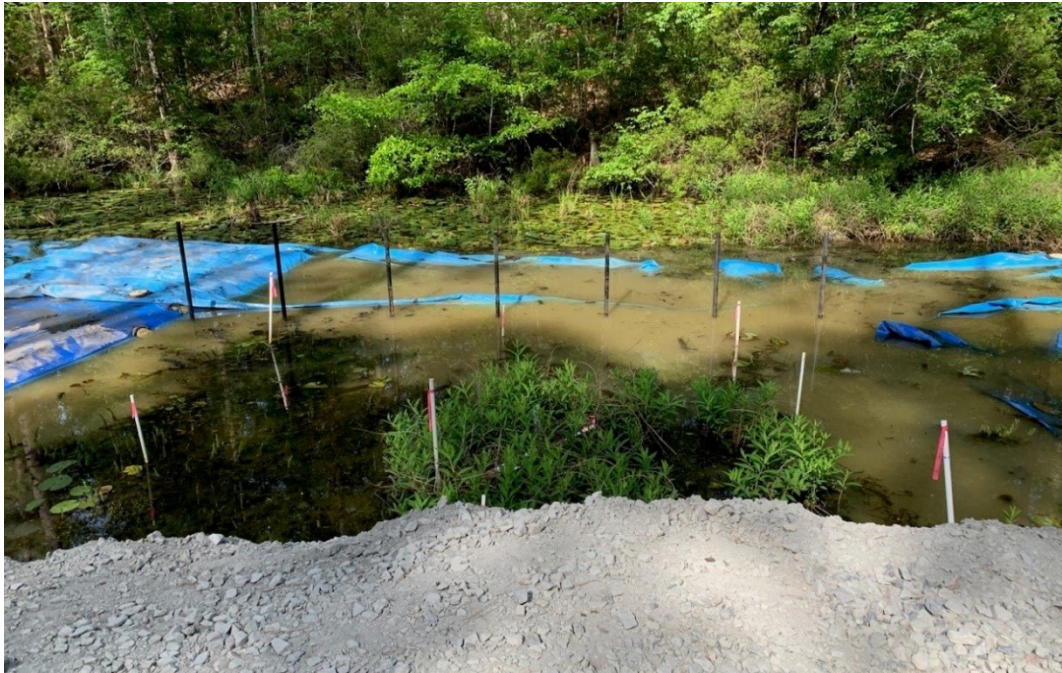
Figure 13. Cofferdam Construction Using Aqua Barriers

Aqua Barrier Layout Prior to Inflation

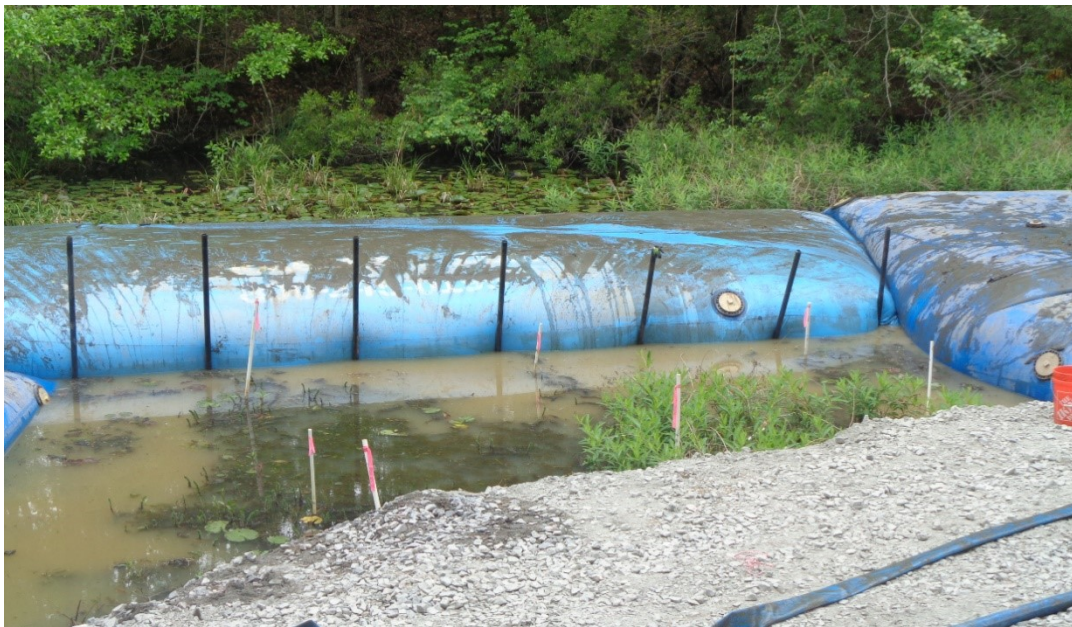
Aqua Barriers Inflated with Canal Water

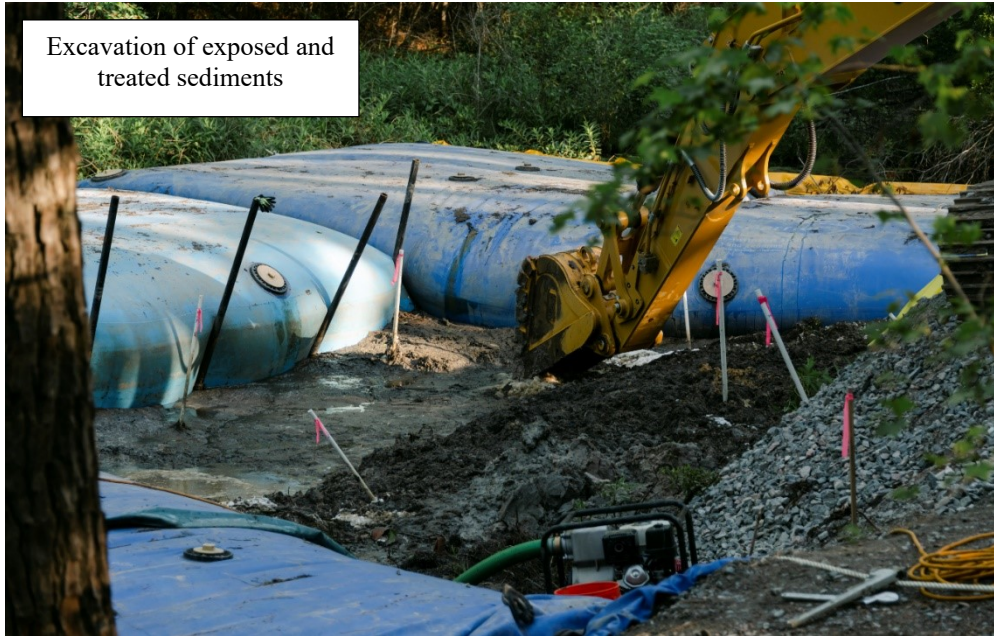
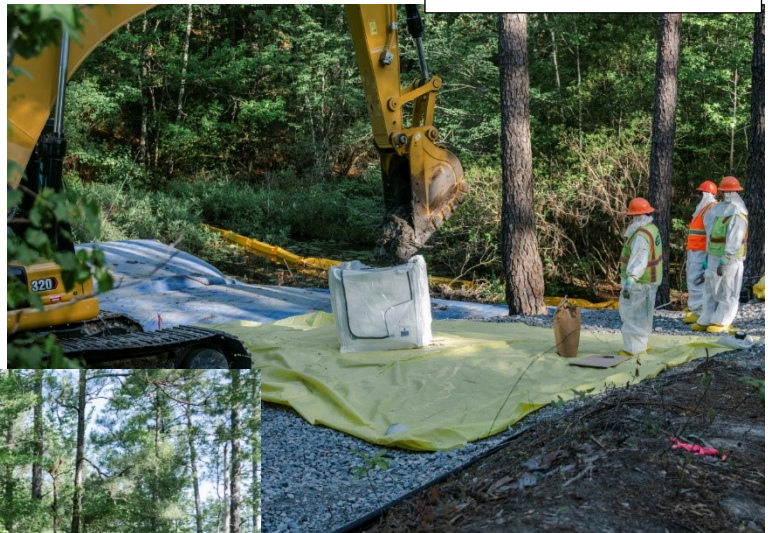
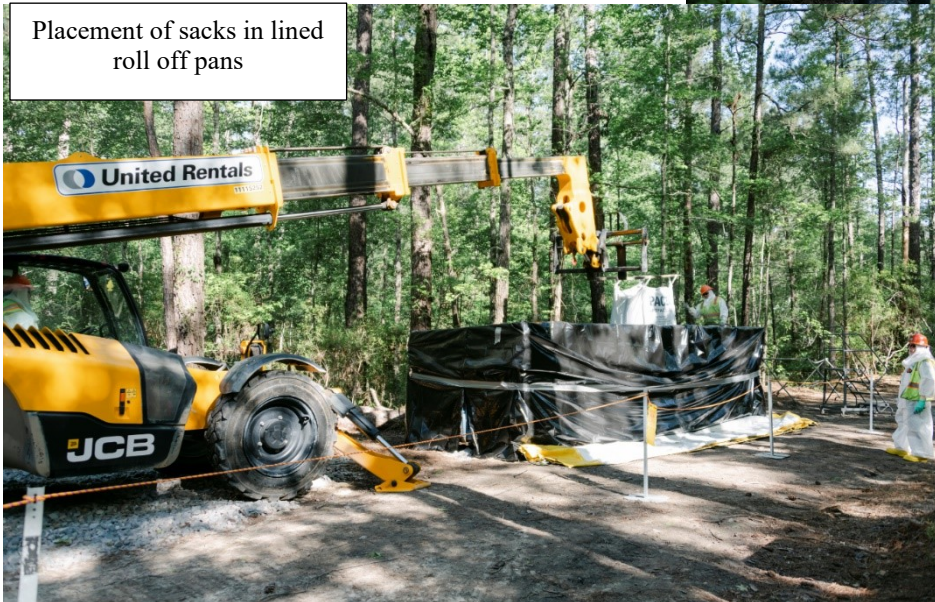
Figure 15. Excavation of R-Area Discharge Canal Sediments

Excavation of exposed and treated sediments

Placement of sediments in 1 cy double line sacks

Placement of sacks in lined roll off pans

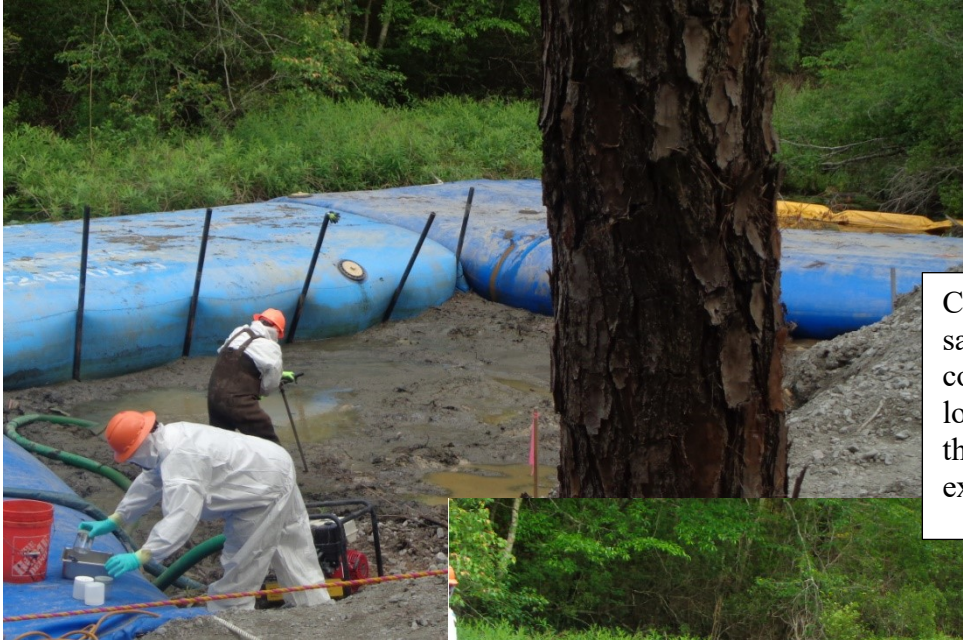
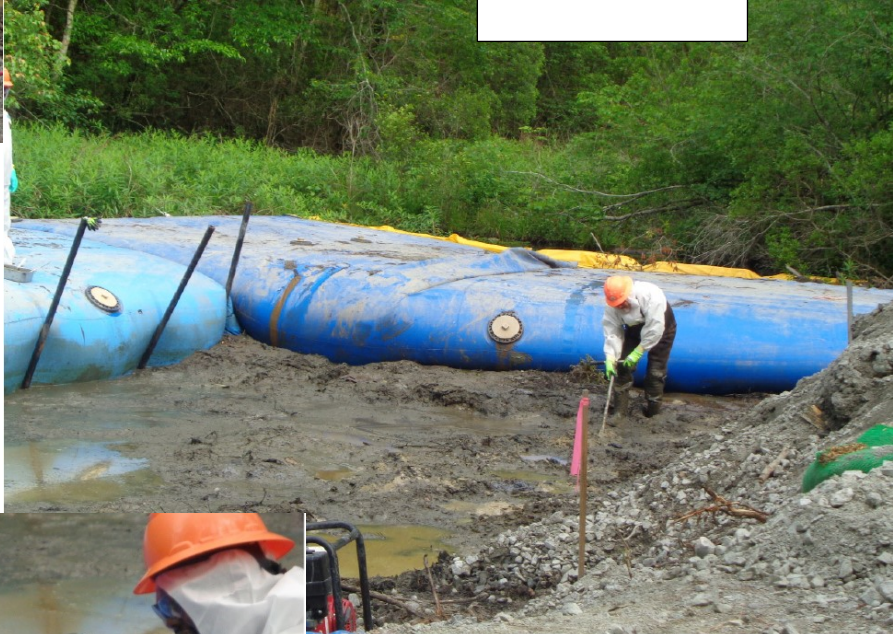
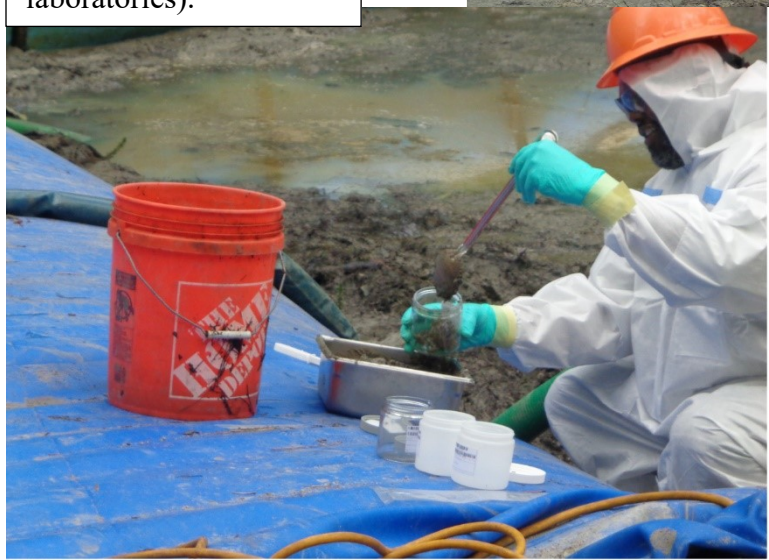
Figure 16. Confirmation Sampling

Confirmation samples were collected from 5 locations within the 500 ft² excavation area.

The sediment samples were then composited and packaged for shipping to GEL and TAL (offsite laboratories).

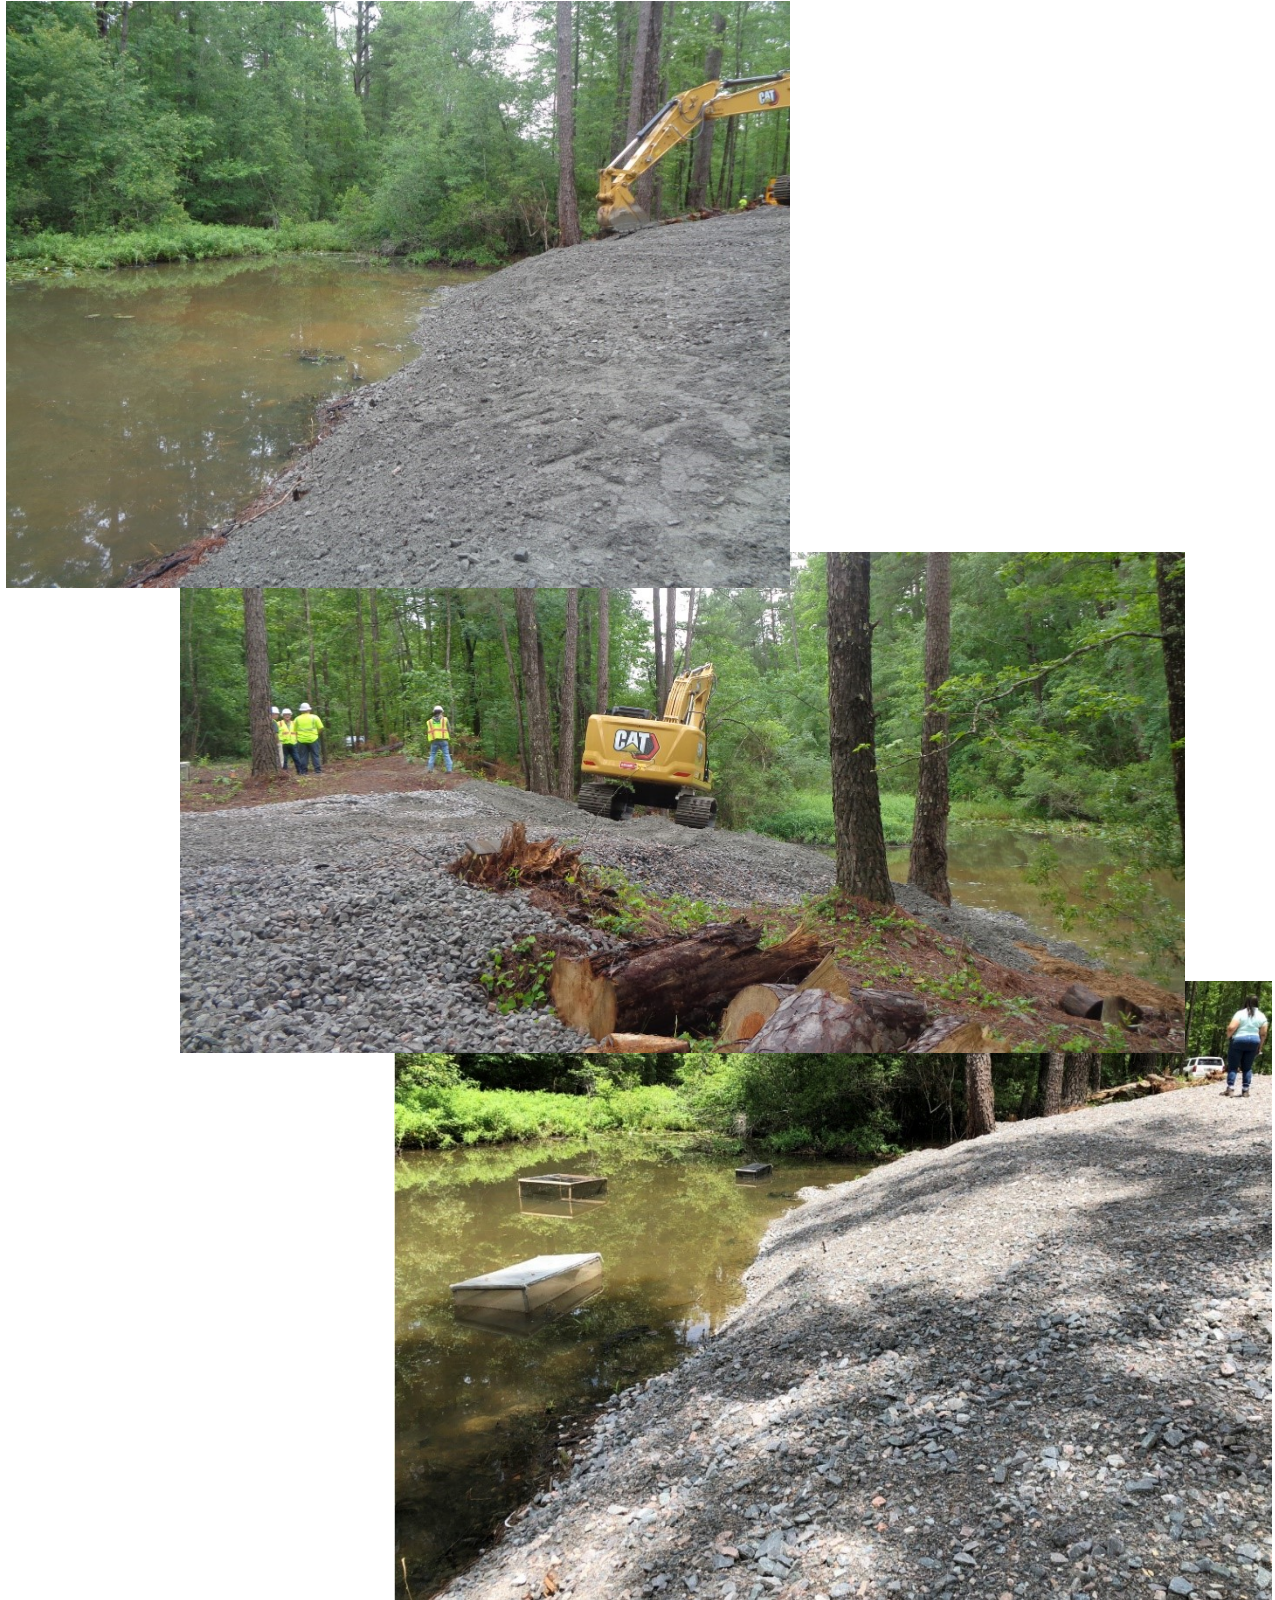
Figure 18. Final Grading and Final Acceptance Inspection

the design requirements. A final acceptance inspection for the R-Area Discharge Canal excavation and access gate installation was held on May 25, 2023, and SRNS approved the site conditions. A final acceptance inspection for the LUC access warning sign installation was held on July 17, 2023, and SRNS approved the site conditions.

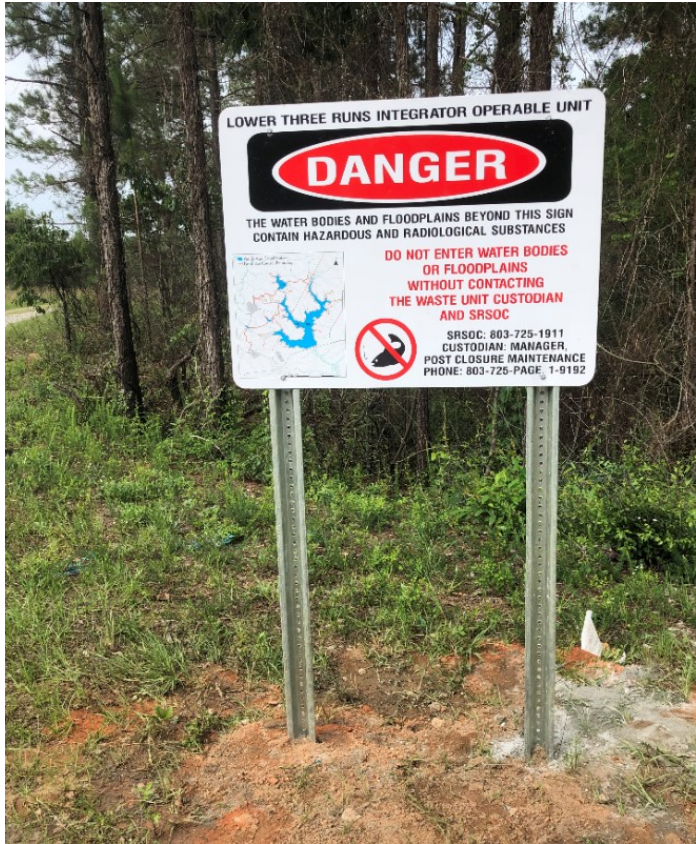
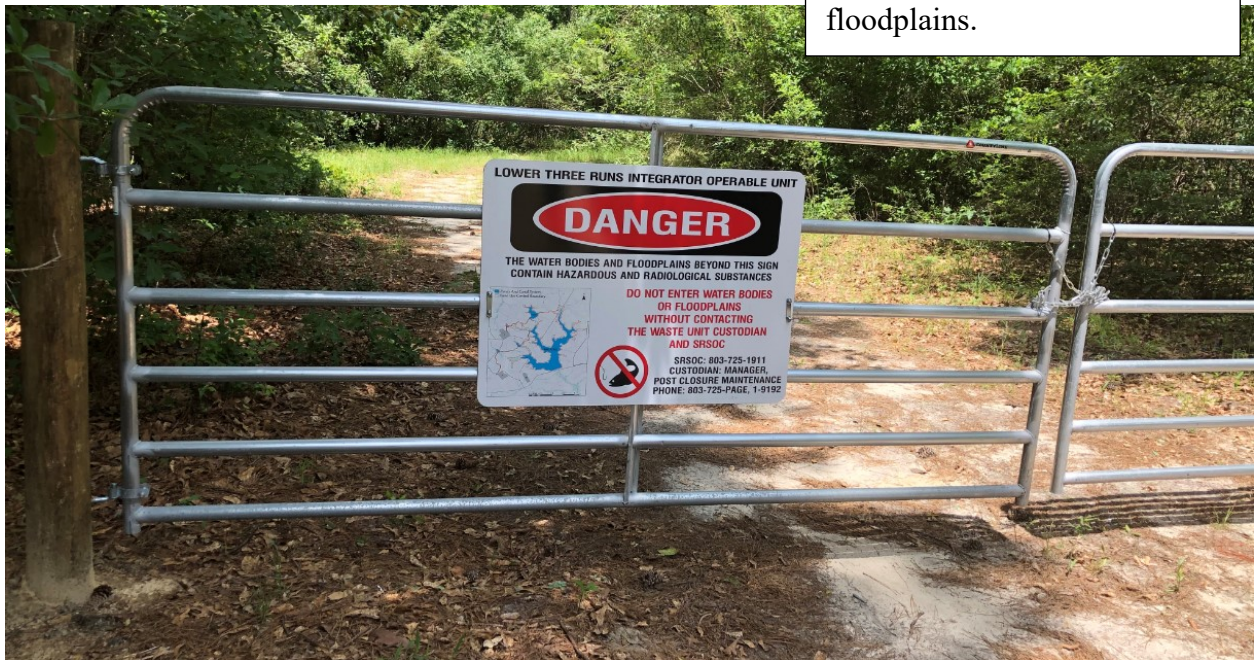
Figure 20. Access Control Warning Signs (typical)

51 Signs were installed on posts at access points to the LTR IOU waterbodies and floodplains.

4 Signs were installed on gates: 2 at access points to the LTR IOU waterbodies and floodplains.

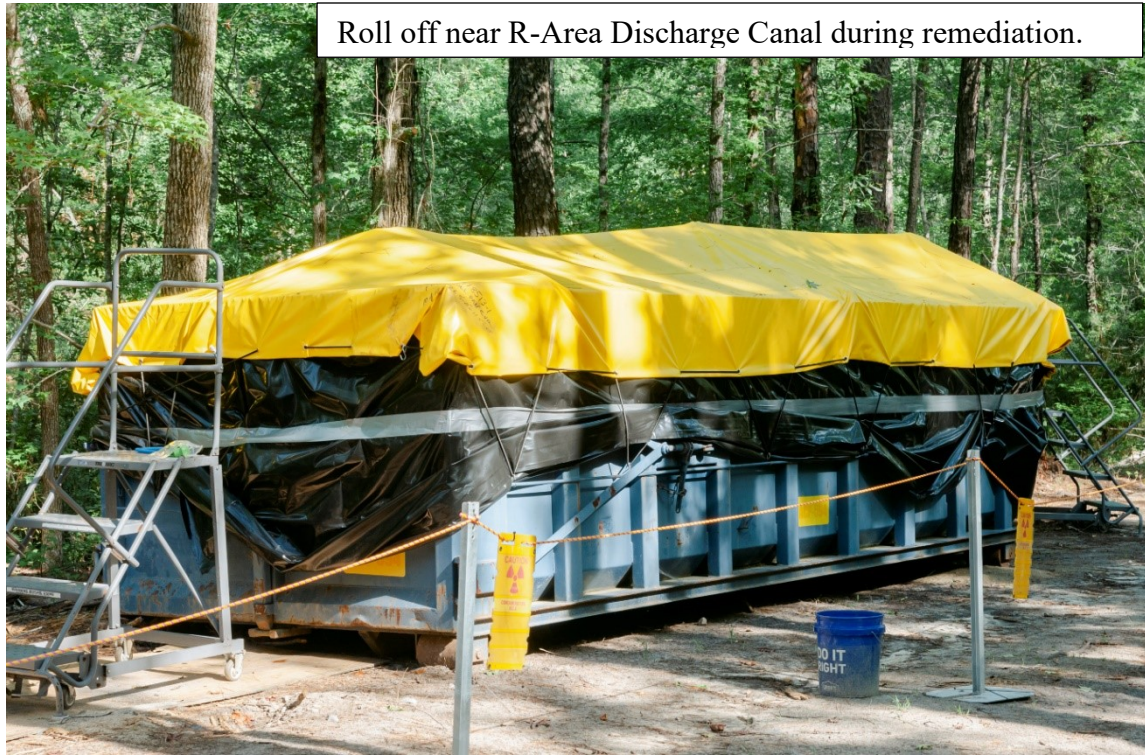
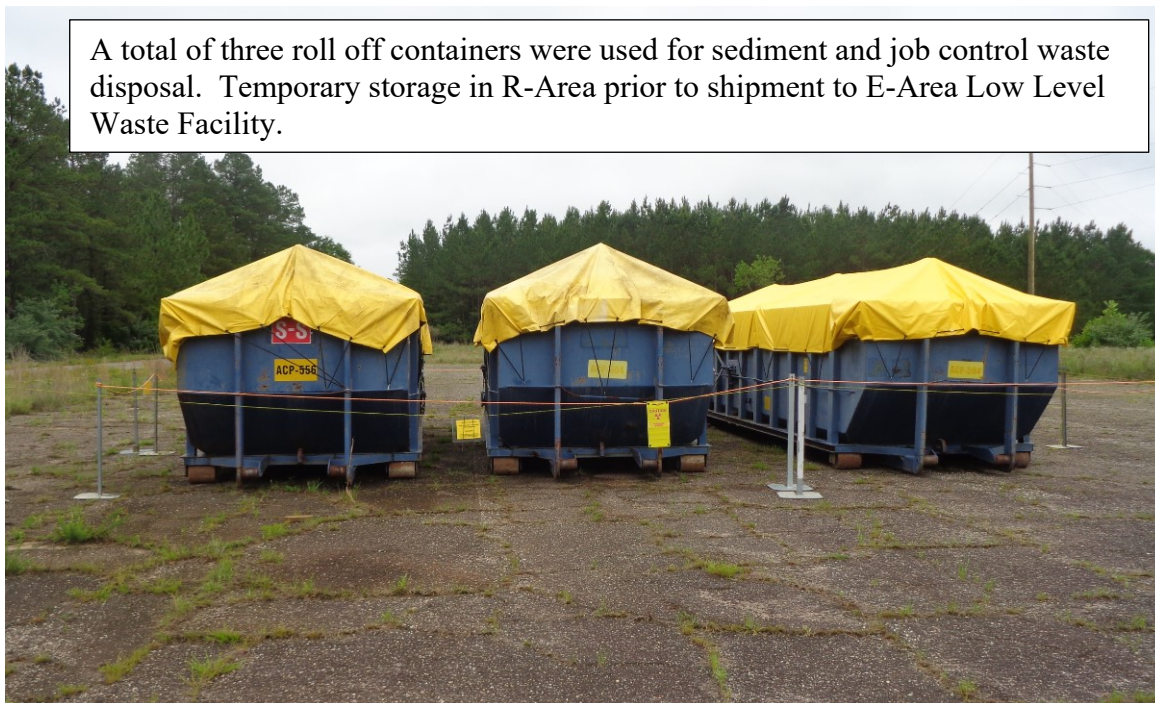
Figure 22. Disposal Containers

The roll off containers were covered to prevent rainwater infiltration and then staged in a paved parking area near the former entrance to the R-Area reactor perimeter fence. After the project was completed, the roll off pans were shipped to the SRS LLWF in E-Area for disposal.
