Seventh Five-Year Remedy Review Report for Savannah River Site Operable Units with Engineered Cover Systems (U)

SRNS-RP-2025-01064

Revision 1

August 2026

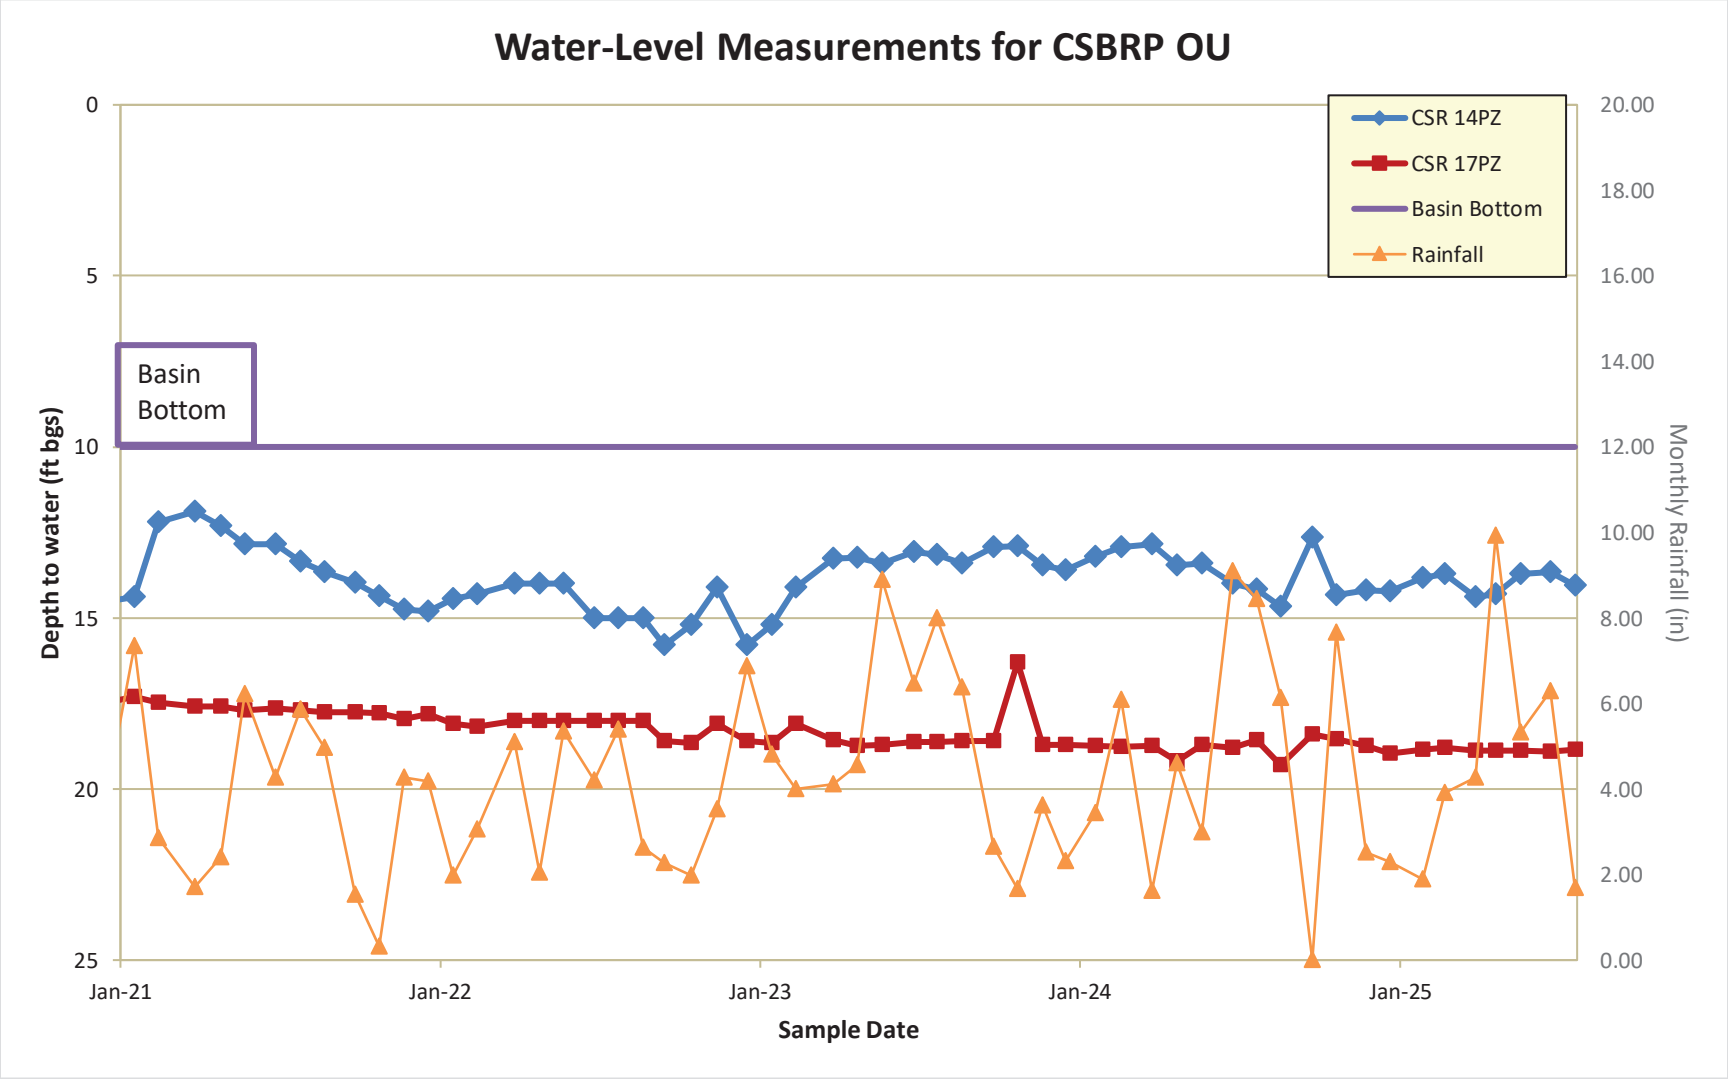
Figure C-7. Water Level Measurements from CSR 14PZ and CSR 17PZ (2021-2025)

- Due to water-level measurements at Central Shops Burning/Rubble Pits (631-1G/631-3G) OU continuously being below the bottom of the basin for more than five years, SRS proposes to discontinue taking water-level measurements since these results meet the requirement of three consecutive years of decreasing water-level in Pit 3G (WSRC 2005).
