Minor
OPERATION AND MAINTENANCE
Activity Plan

Repair Fire Water Line between 292-H/292-2H and 294-H - Site Indices 346, 549, and 591

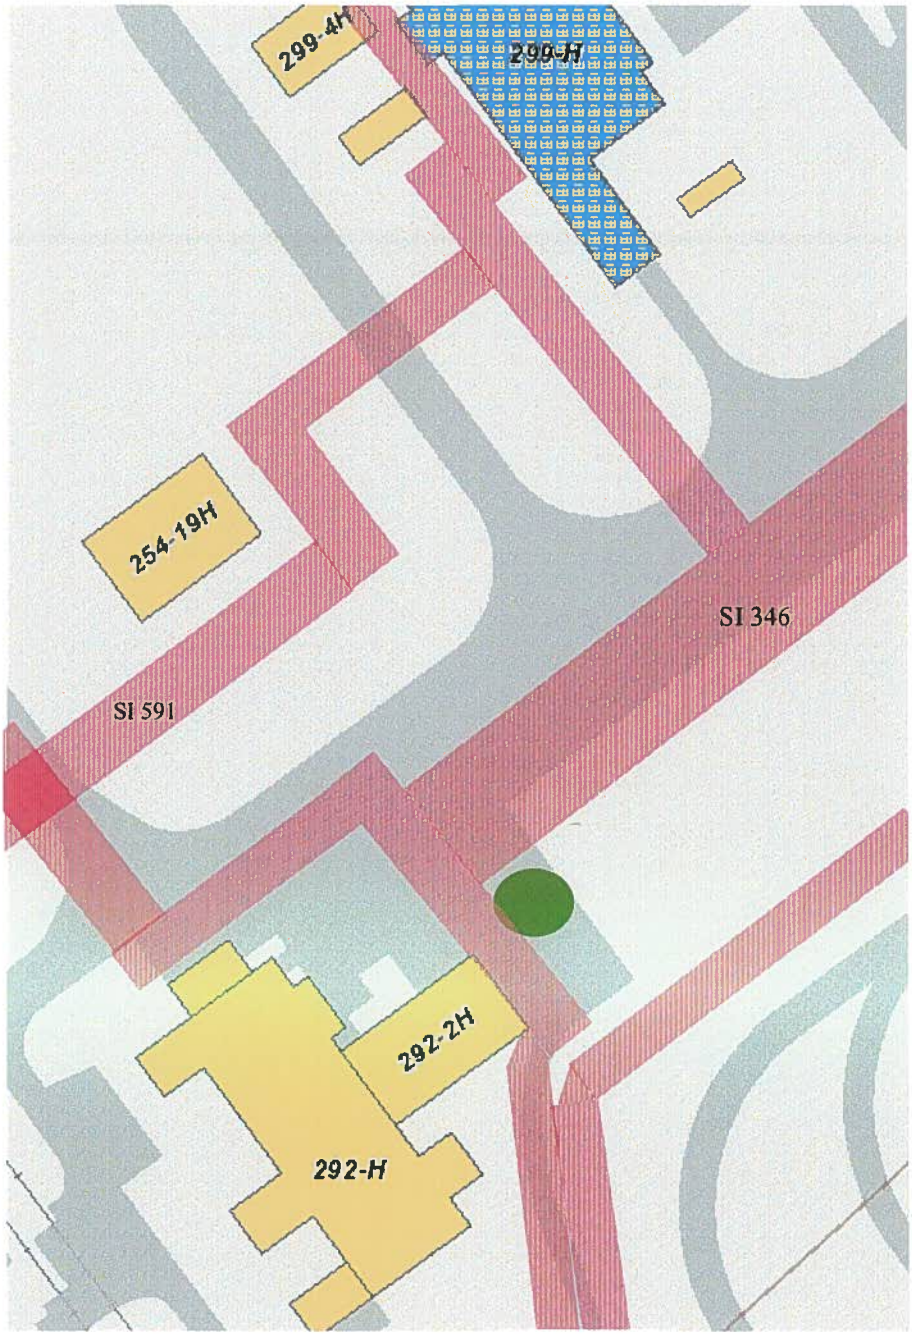
Attachment 2. Drawing Showing Approximate Location of Fire Water Line Leak (Green Dot) and Specific Site Indices (Red Areas)

Note: The entire drawing is within SI 549.
