Seventh Five-Year Remedy Review Report for Savannah River Site Operable Units with Engineered Cover Systems (U)

Aiken, South Carolina

SRNS-RP-2025-01064

January 2026

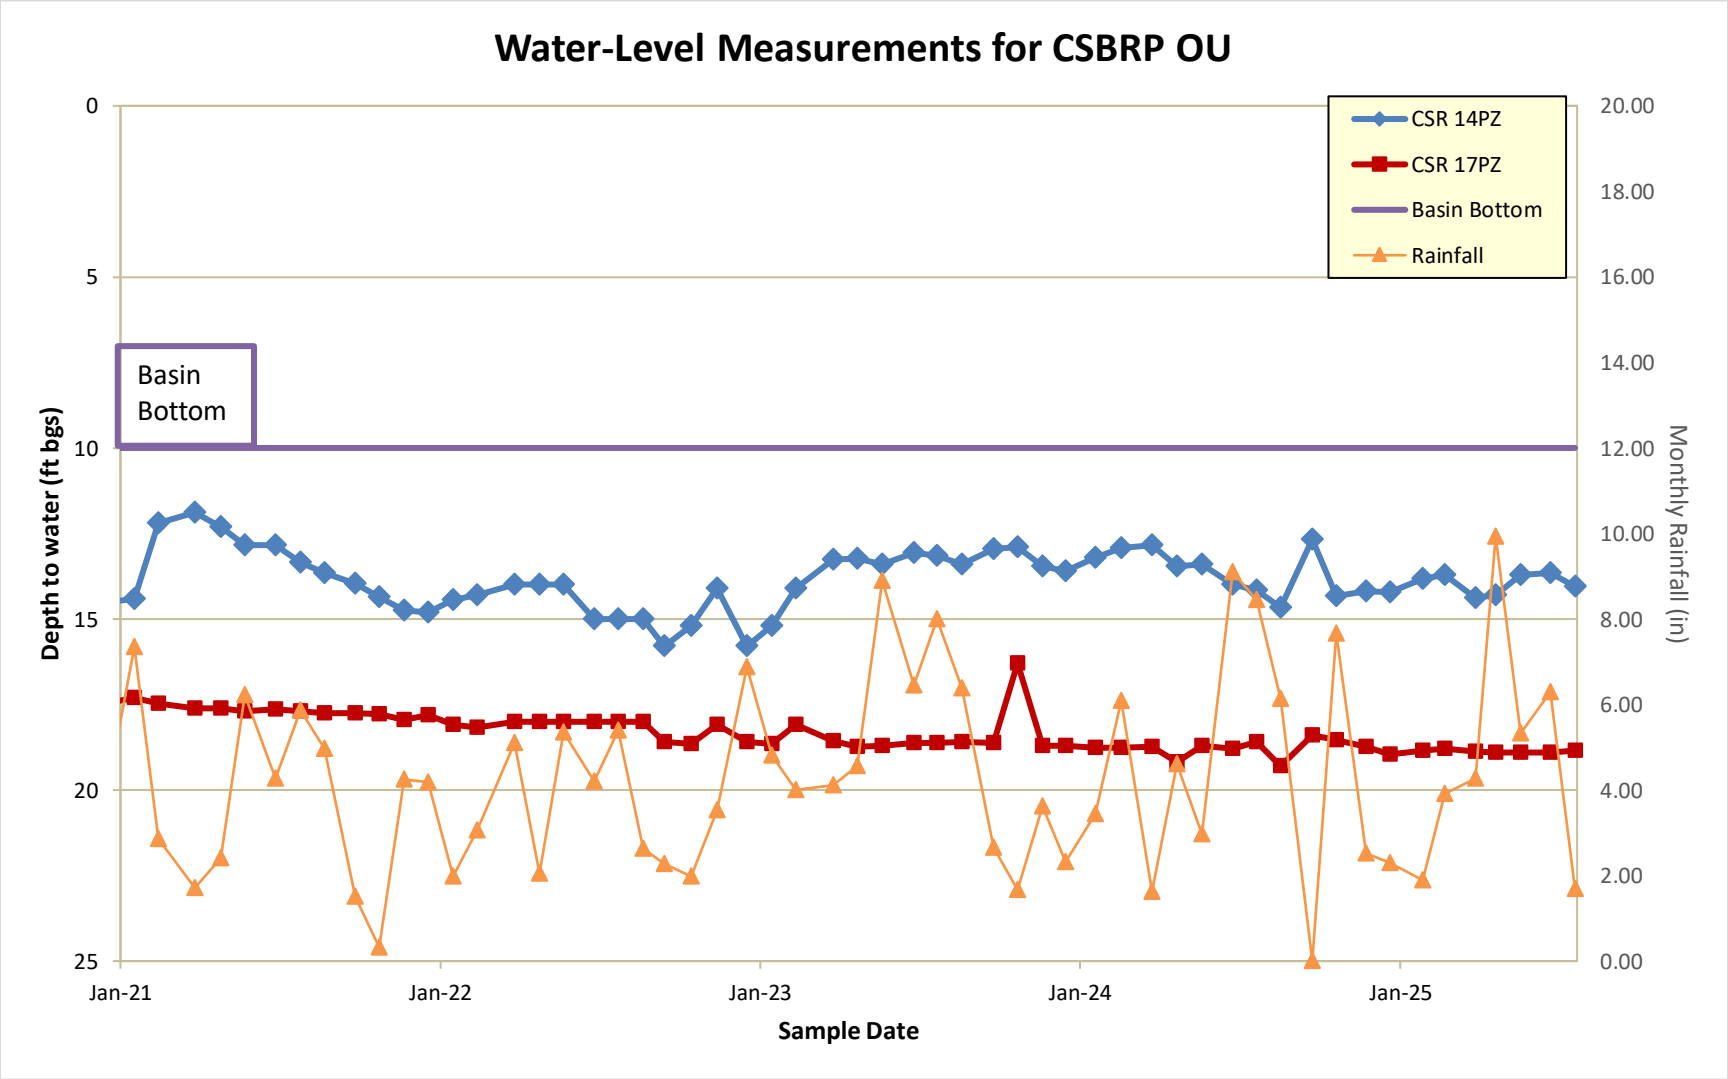
Figure C-7. Water Level Measurements from CSR 14PZ and CSR 17PZ (2021-2025)

- Due to water-level measurements at Central Shops Burning/Rubble Pits (631-1G/631-3G) OU continuously being below the bottom of the basin for more than five years, SRS proposes to discontinue taking water-level measurements since these results meet the requirement of three consecutive years of decreasing water-level in Pit 3G.
