Fifth Five-Year Remedy Review Report for Savannah River Site Operable Units with Operating Equipment (U)

Aiken, South Carolina

SRNS-RP-2017-00567

December 2017

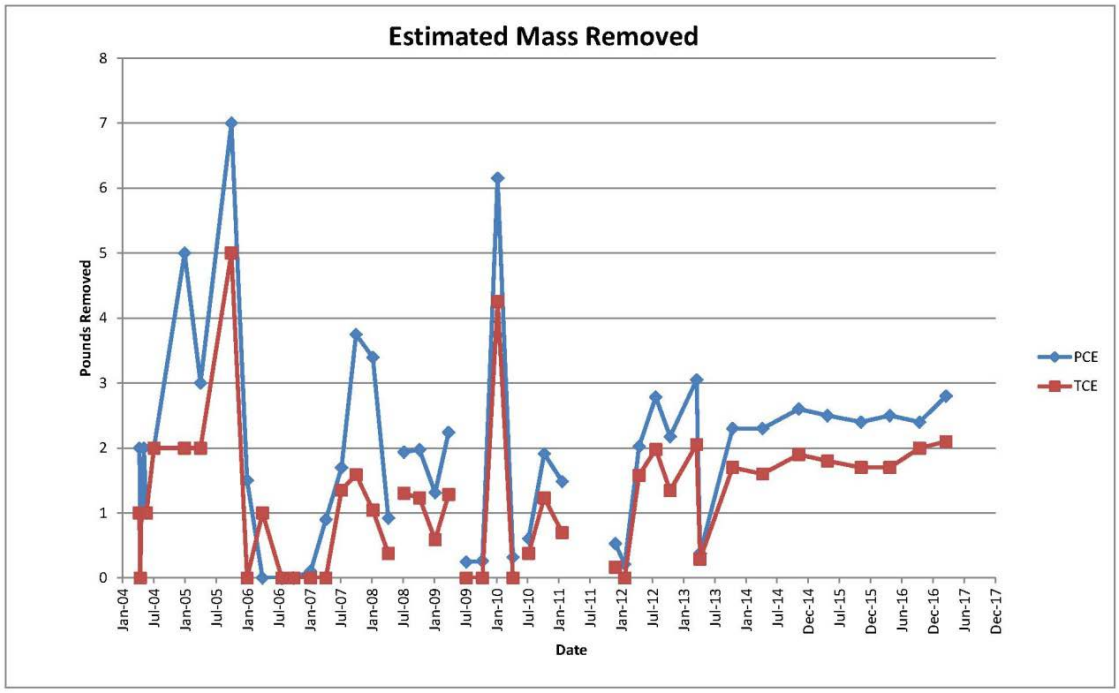
Figure E-6. AMRP OU Performance Monitoring – Estimated Cumulative Mass Removal

SRS recommends shutdown of the AMRP passive SVE system if RGs for trichloroethylene and tetrachloroethylene have been achieved. Additional characterization of the ash layer and vadose zone soils will be conducted to verify that the remedial goals have been met.

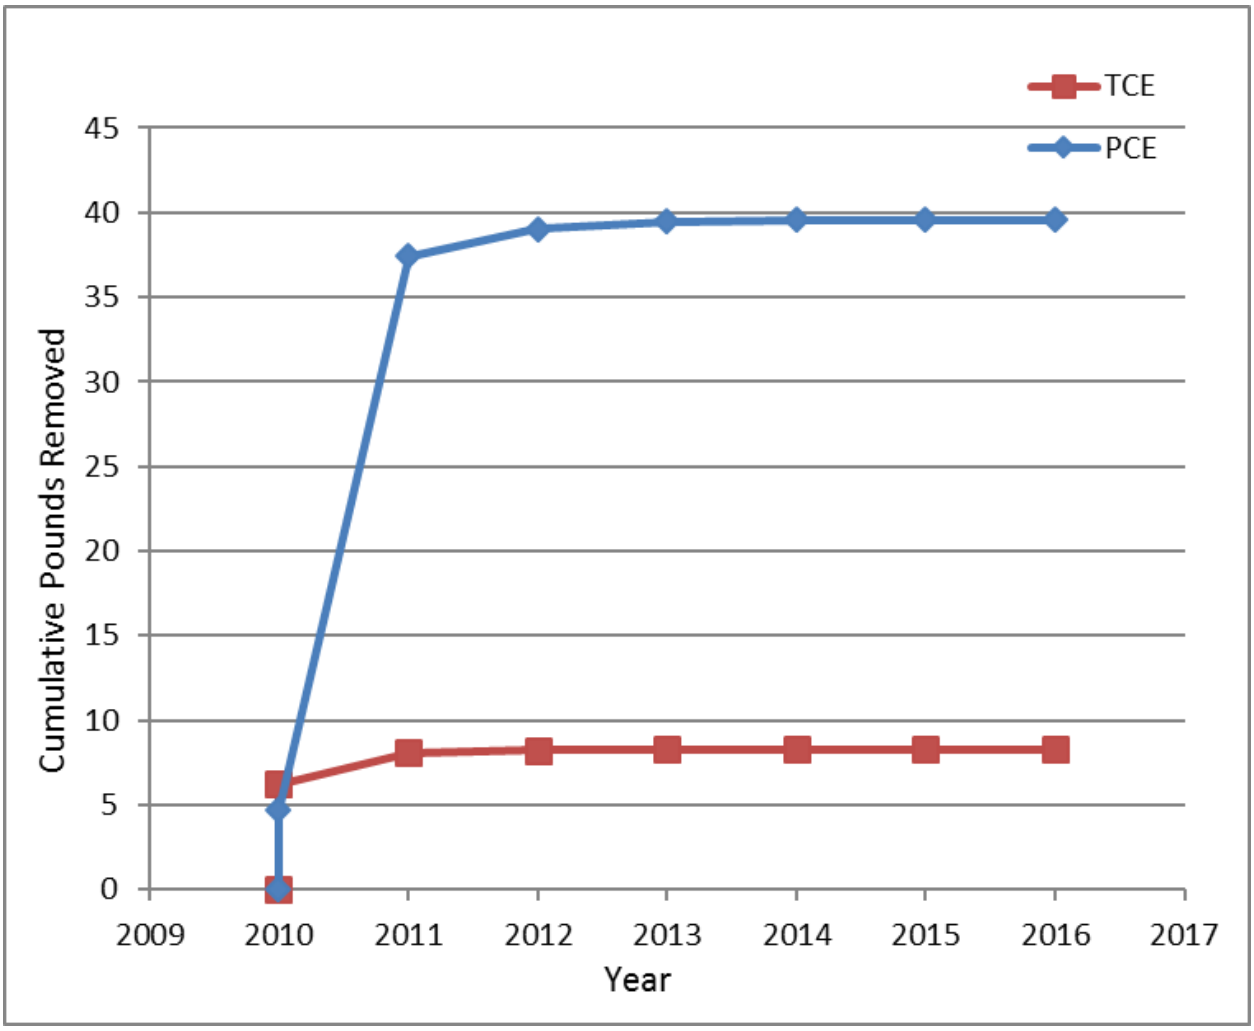
Figure G-2-2. Cumulative PCE and TCE Mass Removed by Year

SRS recommends shutdown of the DAOU Bubble Tower MicroBlower™ SVE system due to the minimal removal of contaminants for the last four years. Confirmation soil samples will be collected to determine whether the PCE soil RGs have been met.

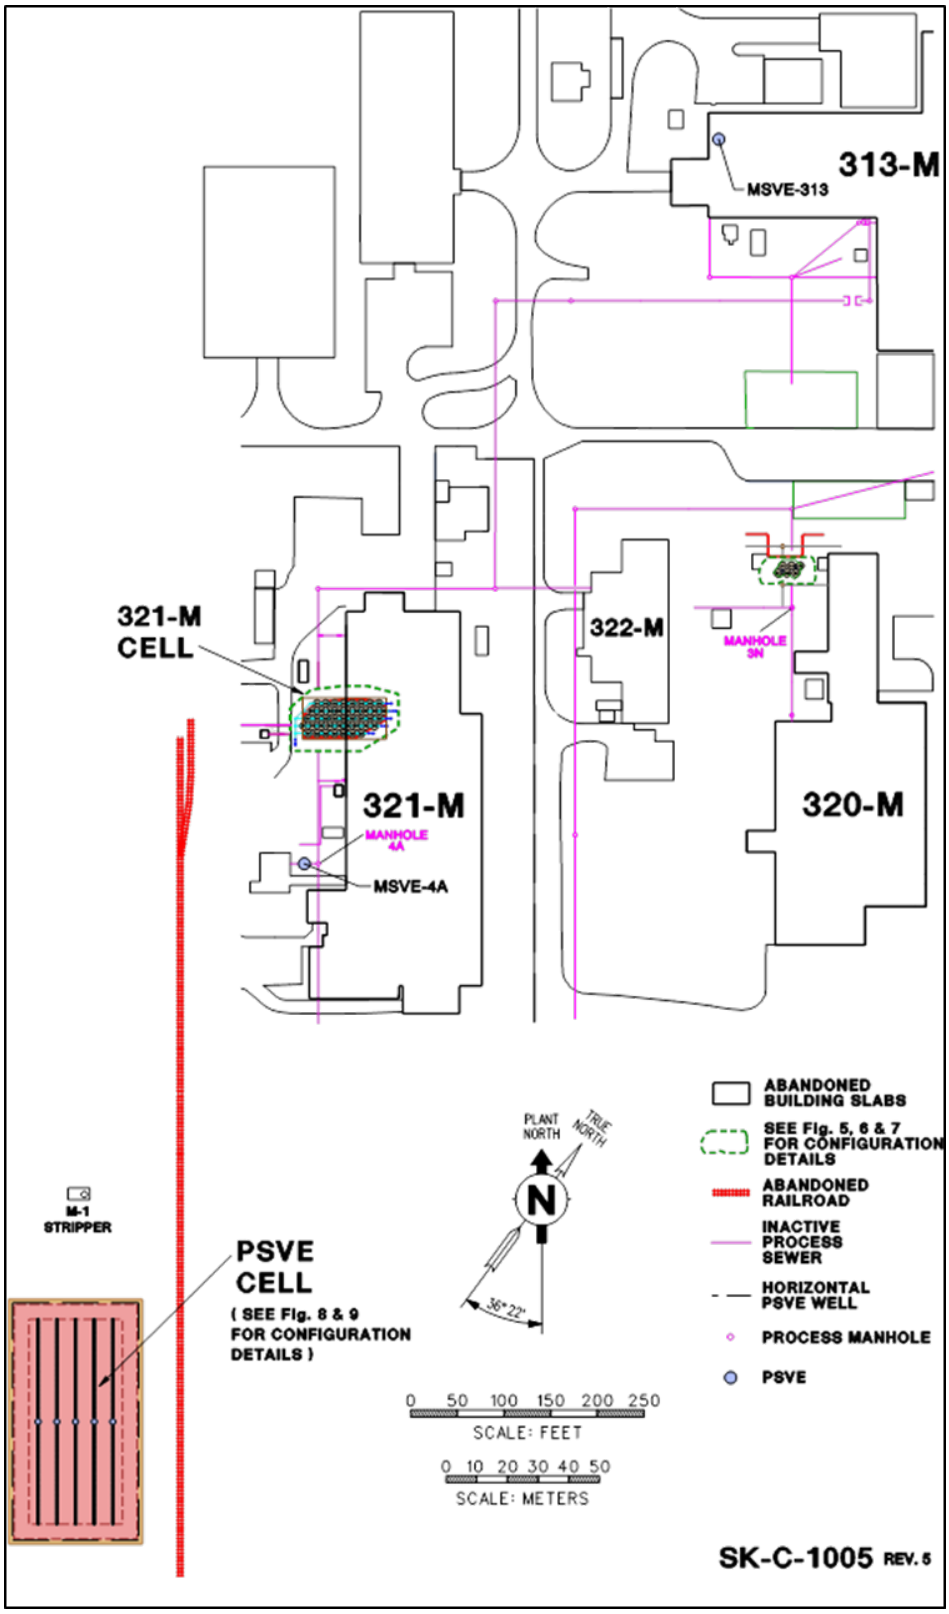
Figure J-2-1. Location of the Passive Soil Vapor Extraction Systems in MAOU

All passive soil vapor extraction systems in MAOU appear to be operating as designed. The systems continue to extract cVOC but at a much lower rate. The cVOC concentrations have been lower in the 313-M, 320-M, Manhole 4A, and the Passive SVE Cell, over the past years because the sources are smaller and less concentrated. As of 2016, concentrations in all wells seem to be relatively low. In fact, PCE and TCE concentrations were all below MCLs in 2016 except at the 321-M Passive SVE Cell. Concentrations are not yet believed to be low enough to achieve remedial goals; therefore, continued passive operation and yearly monitoring of the passive SVE systems is expected until vapor levels drop and level off to diminishing returns. No confirmatory soil samples are proposed to be collected at this time.
