Post-Construction Report/Corrective Measures Implementation Report/Remedial Action Completion Report for the Early Construction and Operational Disposal Site N-1 (NBN), Central Shops Scrap Lumber Pile (631-2G), and Building 690-N, Process Heat Exchanger Repair Facility (aka Ford Building) Operable Unit (U)

SRNS-RP-2025-00808

February 2026

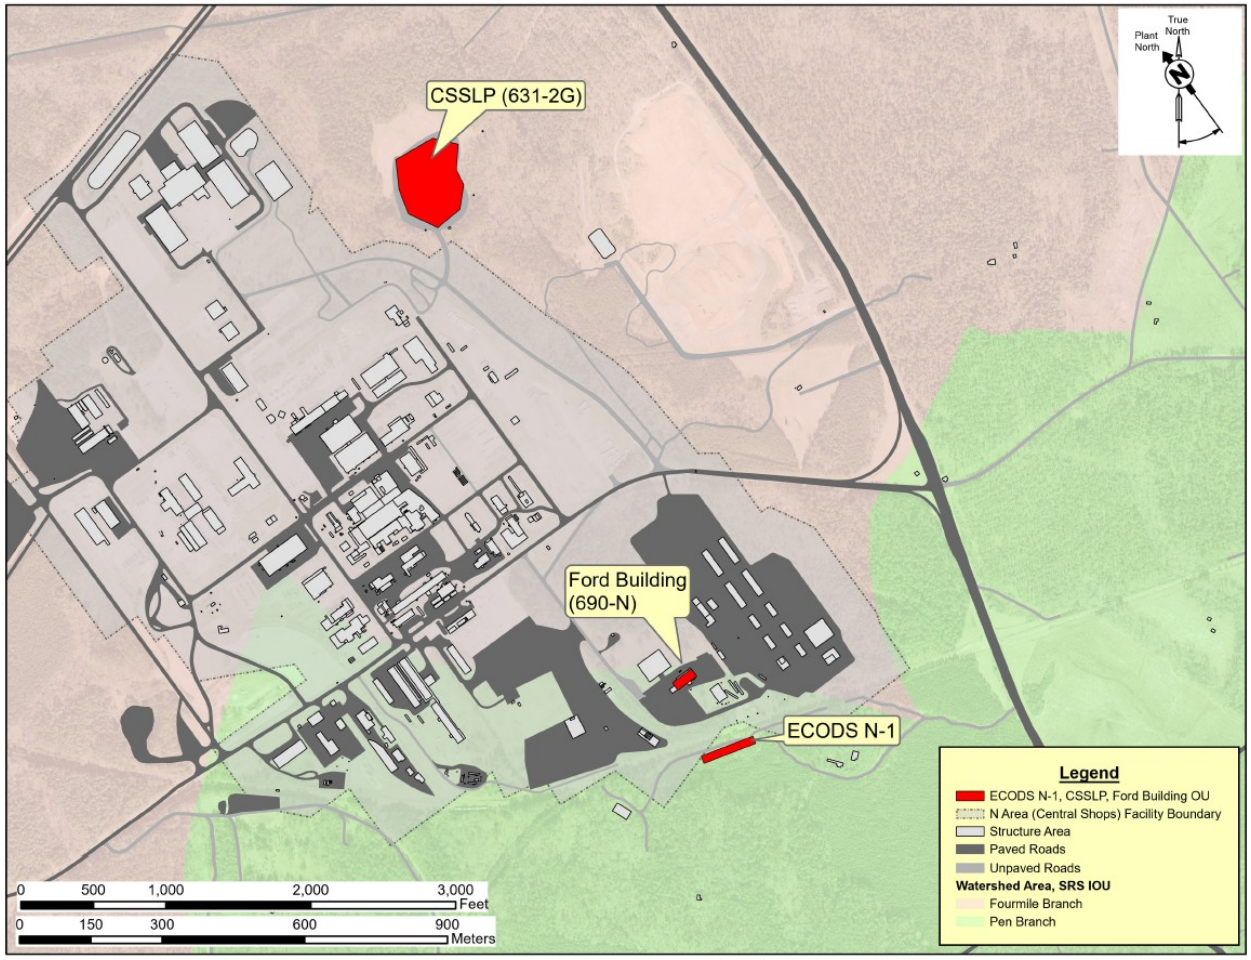
Figure 2. Location of the ECODS N-1, CSSLP, and Ford Building OU (N Area)

The OU consists of the following three subunits: ECODS N-1, CSSLP, and Ford Building as shown in Figure 2. These three subunits are located in three distinct locations within and near N Area (Central Shops) in an area of relatively flat terrain. The ECODS N-1, CSSLP, and Ford Building OU is located within an industrial area, and the future land use is reasonably anticipated to remain industrial.

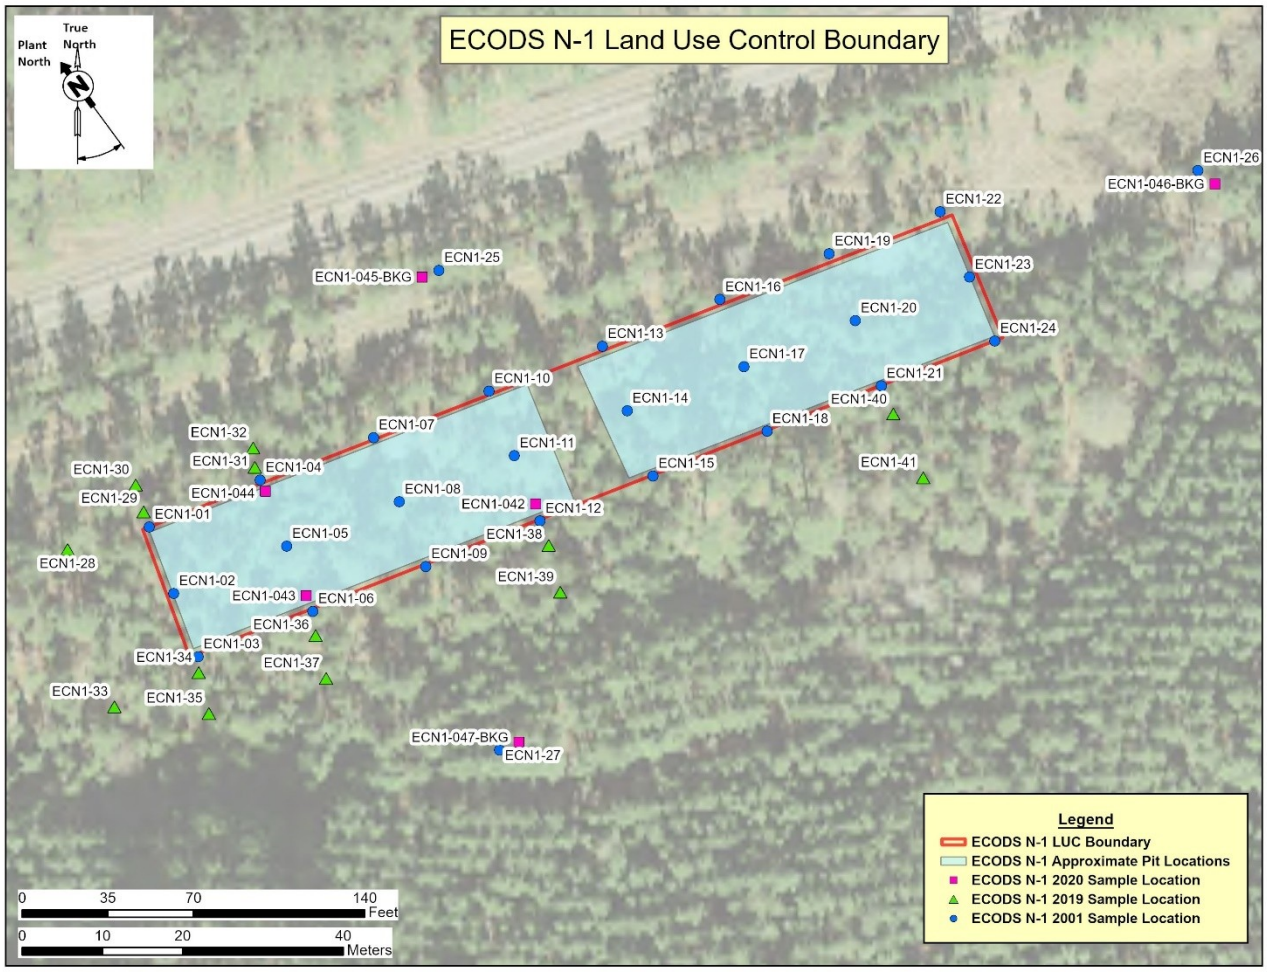
Figure 3. ECODS N-1 Land Use Control Boundary

There were no RCOCs identified at the ECODS N-1 subunit. However, asbestos was identified in subsurface soils that poses a risk for human exposure if land disturbance activities occur. Suspected asbestos-containing material (ACM) (fragments of cementitious paneling) was recovered by hand auger at a depth of ~1 m (3 ft). Two of the three samples collected at sampling location ECN1-044 were verified positive for asbestos, indicating the potential presence of ACM within the entire subunit boundary (Figure 3).

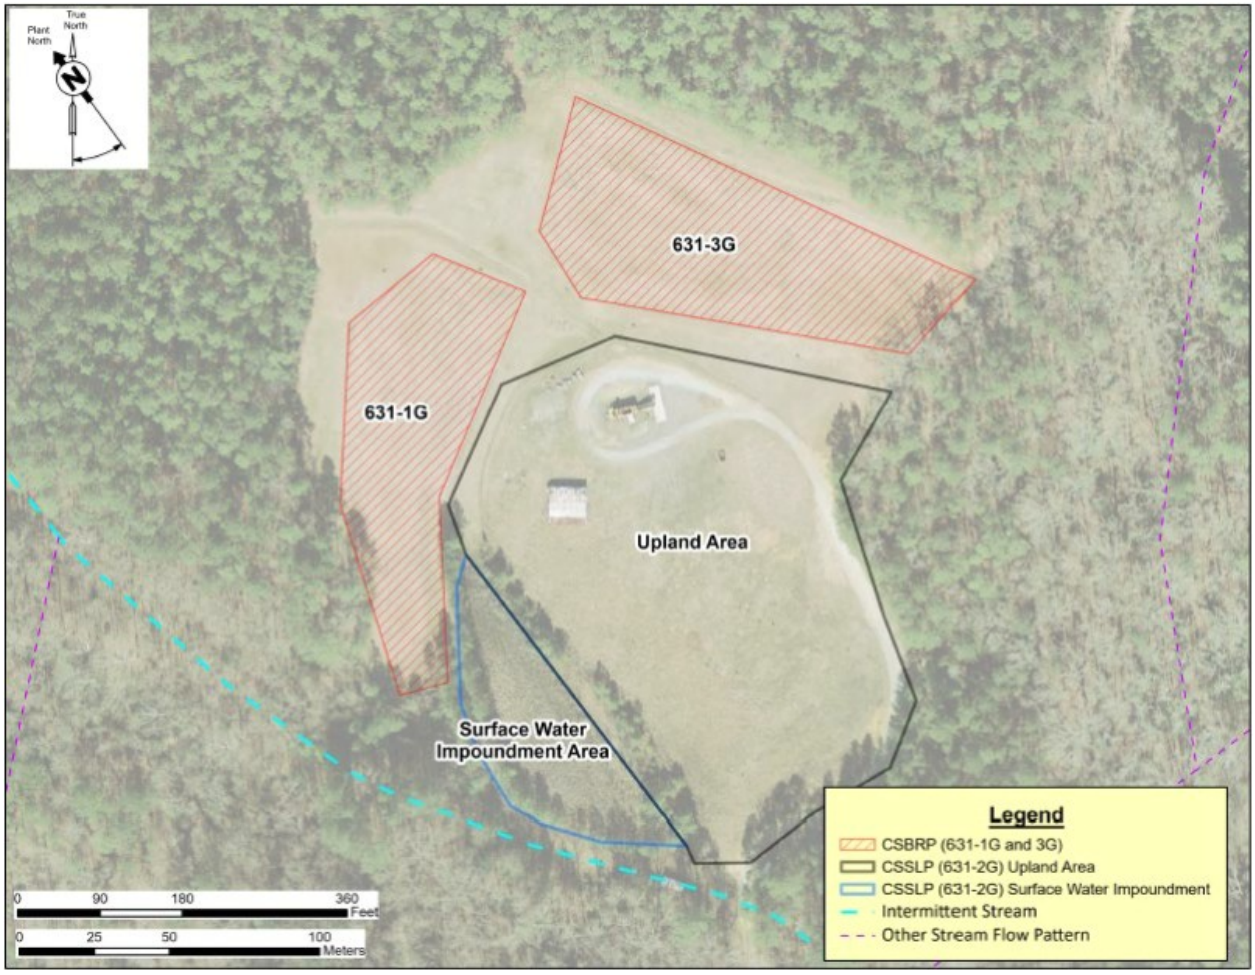
Figure 4. Location of the Upland Area and Surface Water Impoundment Area at the CSSLP

The CSSLP subunit is located in the Fourmile Branch watershed in N Area (Figure 2). The former scrap lumber pile lies in the southwestern sloping plain adjacent to the Central Shops Burning/Rubble Pits (631-1G and 631-3G) (CSBRP). The CSSLP subunit is segregated into two areas: the Upland Area (~1.3 hectares (ha) [3.3 acres (ac)]) and the Surface Water Impoundment Area (~0.41 ha [1.02 ac]) (Figure 4). A wetland and intermittent stream (located within the wetland area) is located south of the CSSLP subunit. The Upland Area was cleared in 1951 and used for equipment laydown and rubble storage in addition to being an area for burning construction-related material. Before 1951, the area was farmland. Starting in 1975, operating procedures called for the CSSLP to receive inert, nonhazardous materials, including items such as nails, hinges, scrap lumber, poles, crates, pallets, and unsalvageable wood products. Historically, the CSSLP was used to burn various unknown types and quantities of wood, which may have included treated lumber and creosote-treated wood. Historical burning at the CSSLP produced ash that was placed directly into CSBRPs, which were closed under a ROD in 2002 (WSRC 2002). Between 1992 and 1994, the Surface Water Impoundment Area was constructed in the southern portion of the CSSLP subunit to capture stormwater runoff from the CSSLP. Active burning at the CSSLP ended in the mid-2000s. The media associated with this unit are soil, sediment, and surface water.

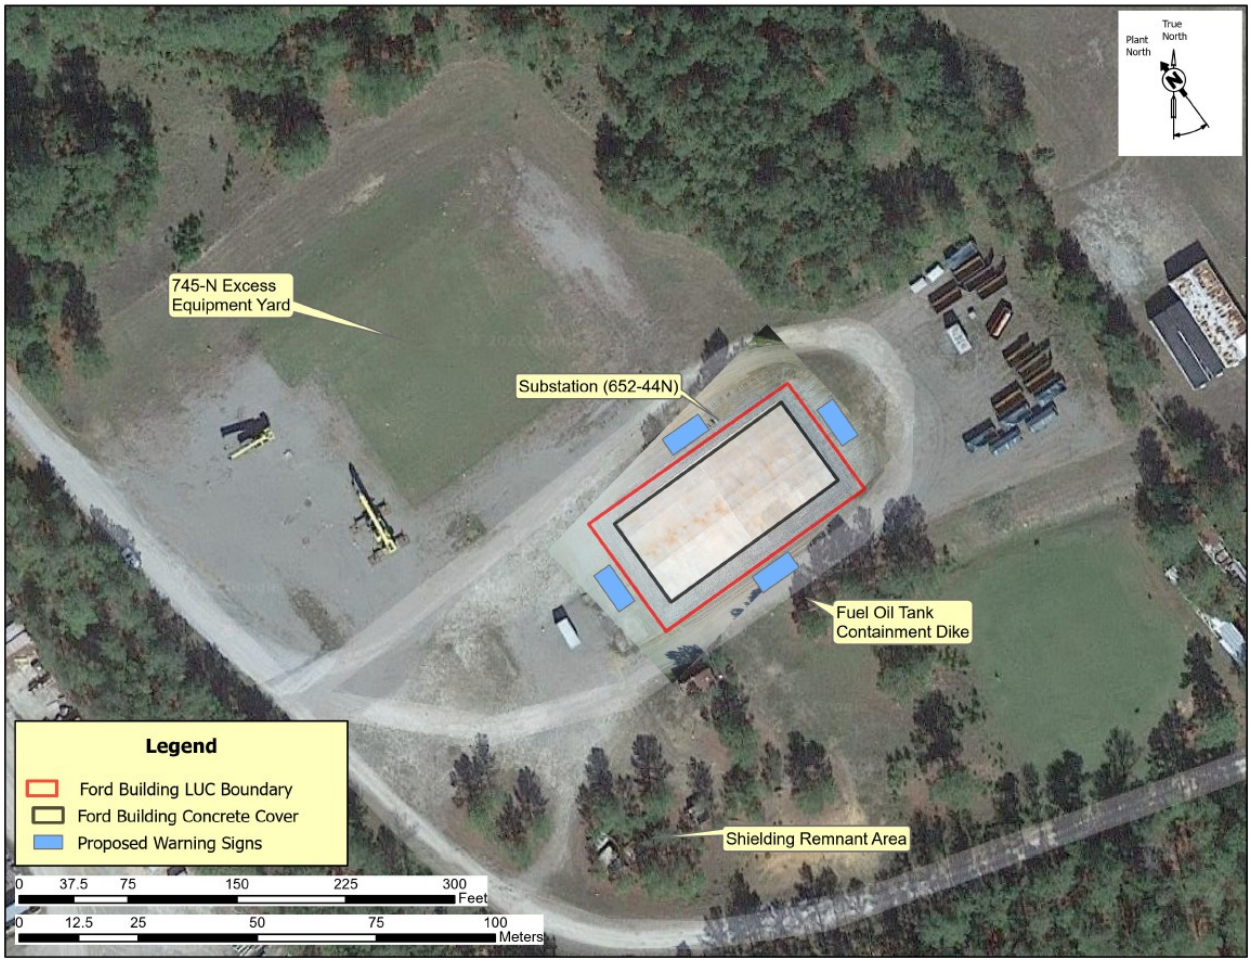
Figure 5. Ford Building Ancillary Equipment

The Ford Building subunit is located within the N Area facility boundary in the Pen Branch watershed (Figure 2) and is located in a relatively flat area that slopes gradually to the east. The Ford Building was a one-story metal frame structure on a concrete pad, covering 900 square meters (m^2) (9,700 square feet [ft^2]). Ancillary equipment and other areas are included in the Ford Building subunit, including the remnants of a 13.8 kilovolt Substation

(652-44N), a Fuel Oil Tank Containment Dike, a shielding remnant area, and the Excess Equipment Yard (745-N) (Figure 5). The Ford Building was constructed in the 1950s to test Ford Company-manufactured motor control packages for control rod drive mechanisms before they were installed in the SRS reactors. The primary area of the building consisted of a machine shop with offices, storage rooms, restrooms, and a service area. The media associated with this unit are soils and concrete.

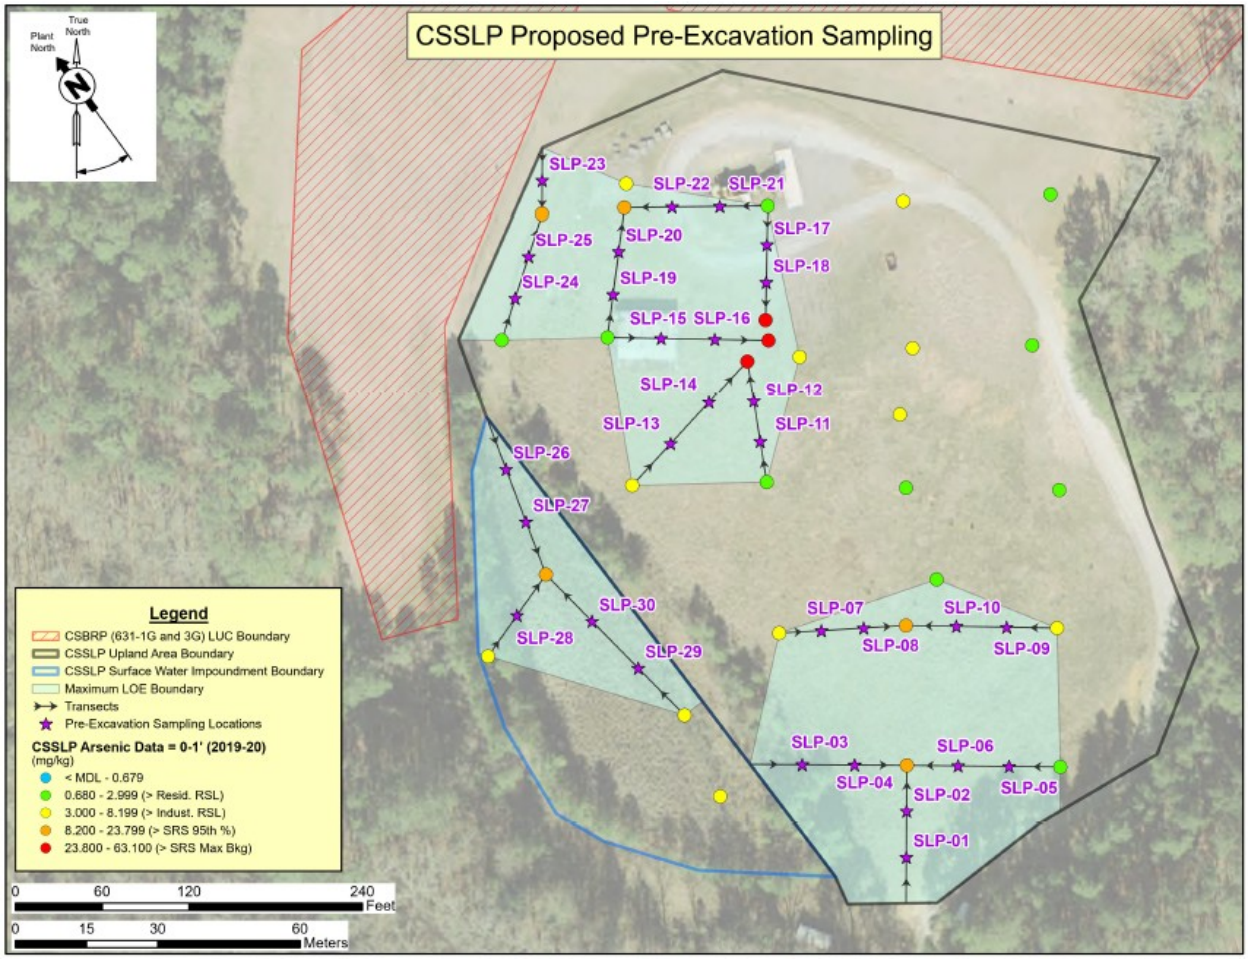
Figure 7. Pre-Excavation Sampling Locations to Refine the LOE

The CSSLP was used to burn various unknown types and quantities of wood, which may have included treated lumber and creosote-treated wood. The primary contaminants at the CSSLP (Figure 7) are the following:

- Arsenic is present in Upland Area surface soil (0 to 0.3 m [0 to 1 ft]) (exposure point concentration [EPC] = 16.4 milligram per kilogram [mg/kg]) exceeding 1E-06 risk level for the resident (risk = 2.4E-05) and industrial worker (risk = 5.5E-06) scenarios; and

- Arsenic is present in Surface Water Impoundment Area surface sediment (0 to 0.3 m [0 to 1 ft]) (EPC = 8.27 mg/kg) exceeding 1E-06 risk level for the resident (risk = 1.2E-05) and industrial worker (risk = 2.8E-06) scenarios.

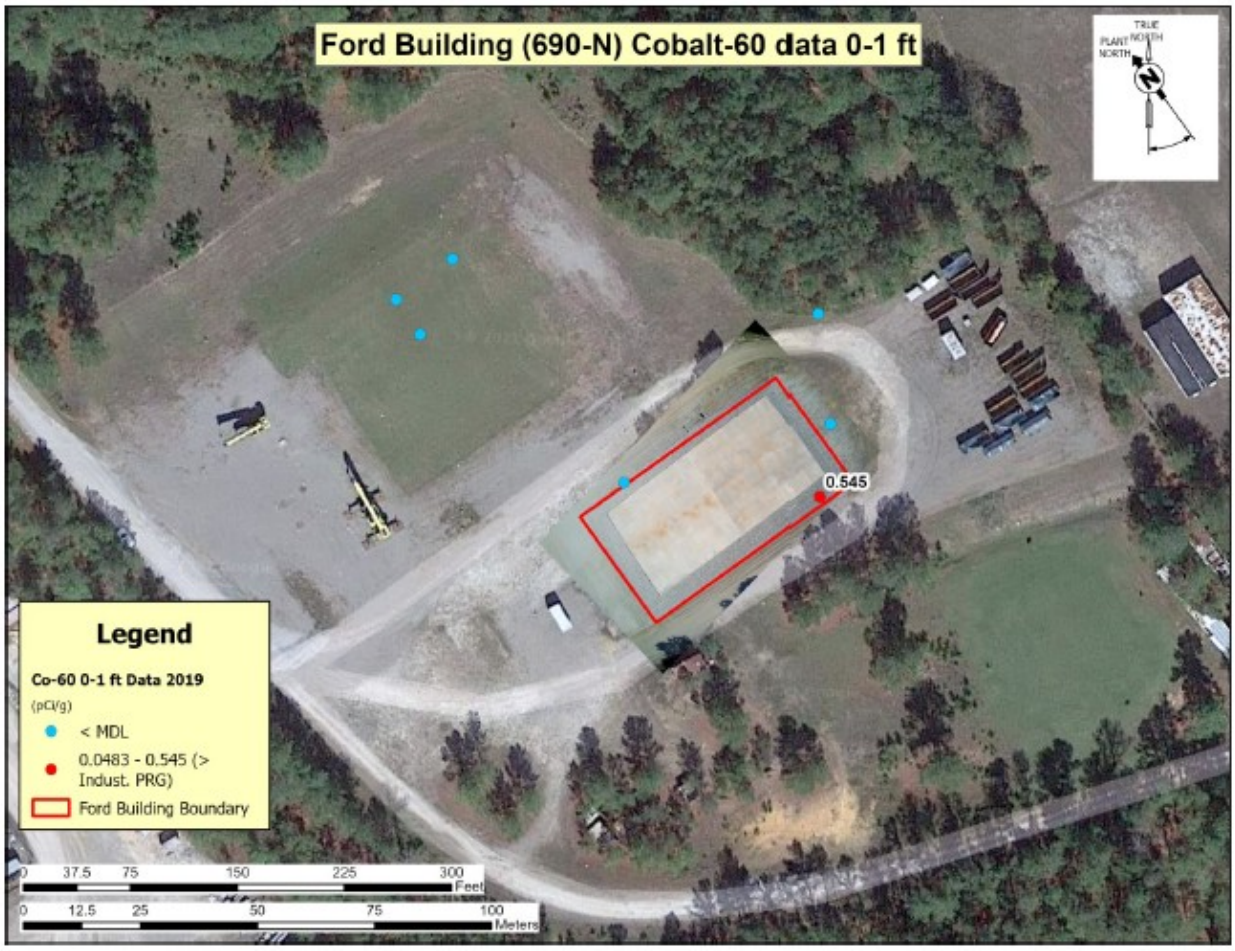
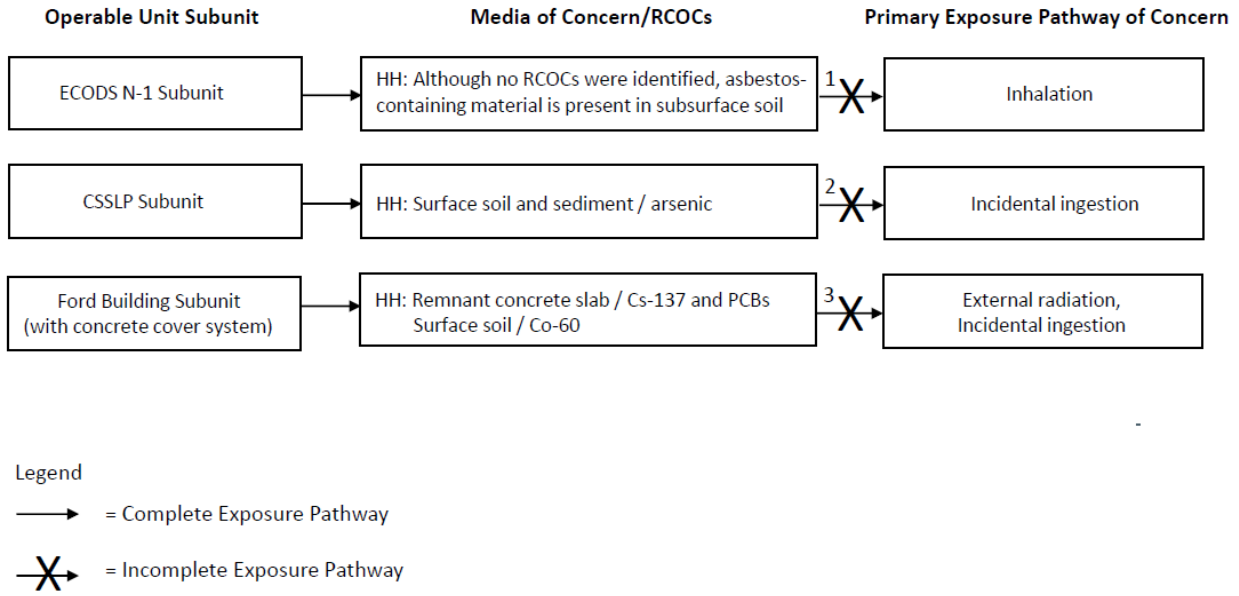
Figure 8. Cobalt-60 Data for Soil Media (0 to 0.3 m [0 to 1 ft]) at the Ford Building

Ford Building was used as a machine shop to test motor control packages for control rod drive mechanisms. Contaminants associated with the Ford Building Subunit are as follows (Figure 8):

- Cobalt-60 (Co-60) is present in surface soil (0 to 0.3 m [0 to 1 ft]) (EPC = 0.545 picocuries/gram [pCi/g]) exceeding 1E-06 risk level for the resident (risk = 5.5E-05) and industrial worker (risk = 1.1E-05) scenarios.

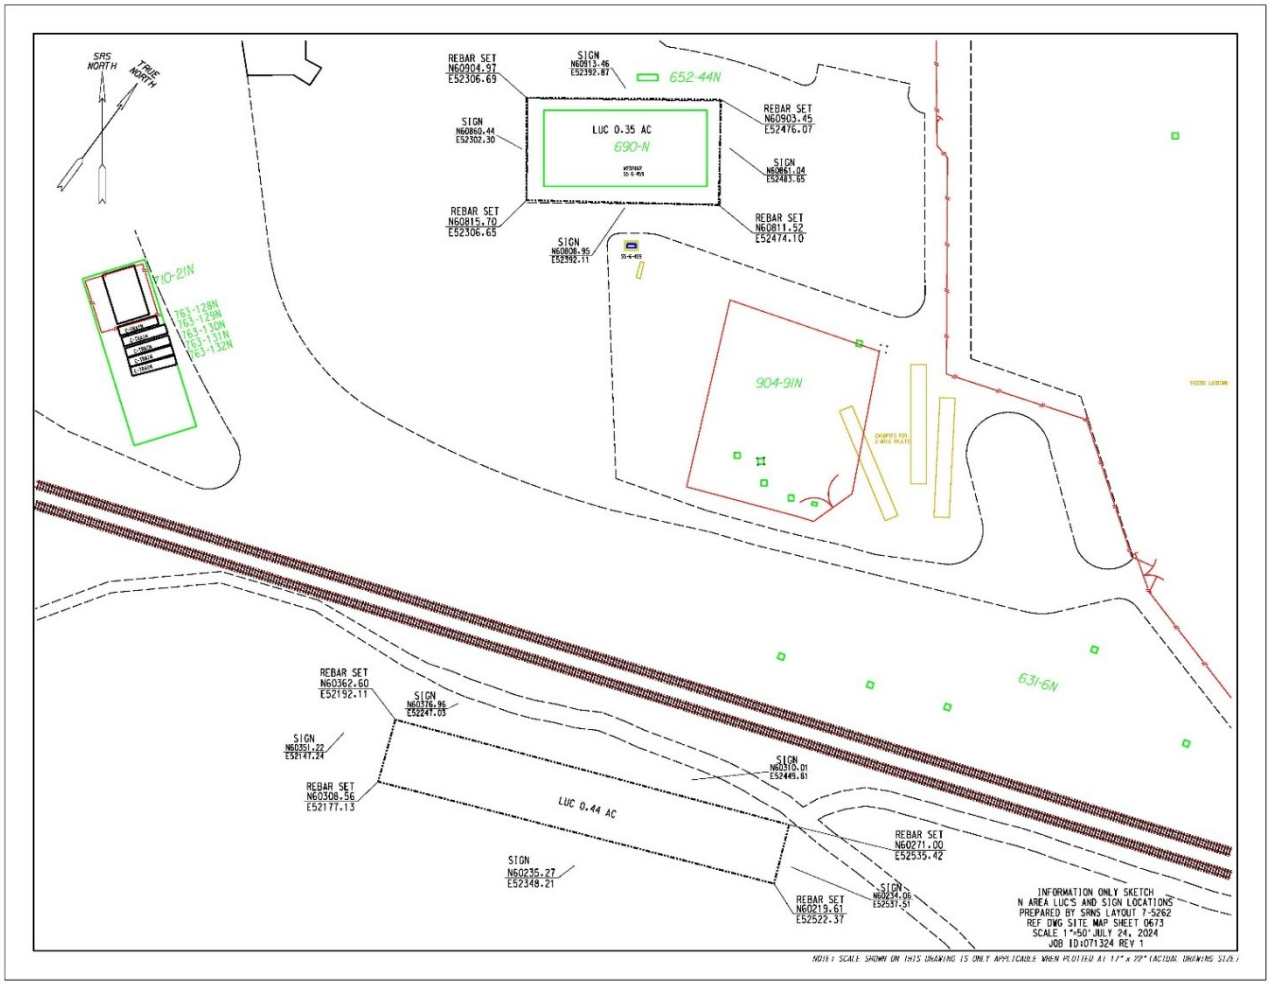
Figure 10. Location of Access Warning Signs and Corner LUC Boundary at ECODS N-1 and Ford Building Subunits

The ECODS N-1 and the Ford Building subunits' as-built drawing documenting the coordinates of both the sign locations and the boundary corners are included in Figure 10.

The construction of the remedial action included the installation of the warning signs and corner survey rebar markers at the ECODS N-1 (Figure 12) and the Ford Building (Figure 13) in June 2024. The survey as-builts were completed by SRNS in late July 2024.

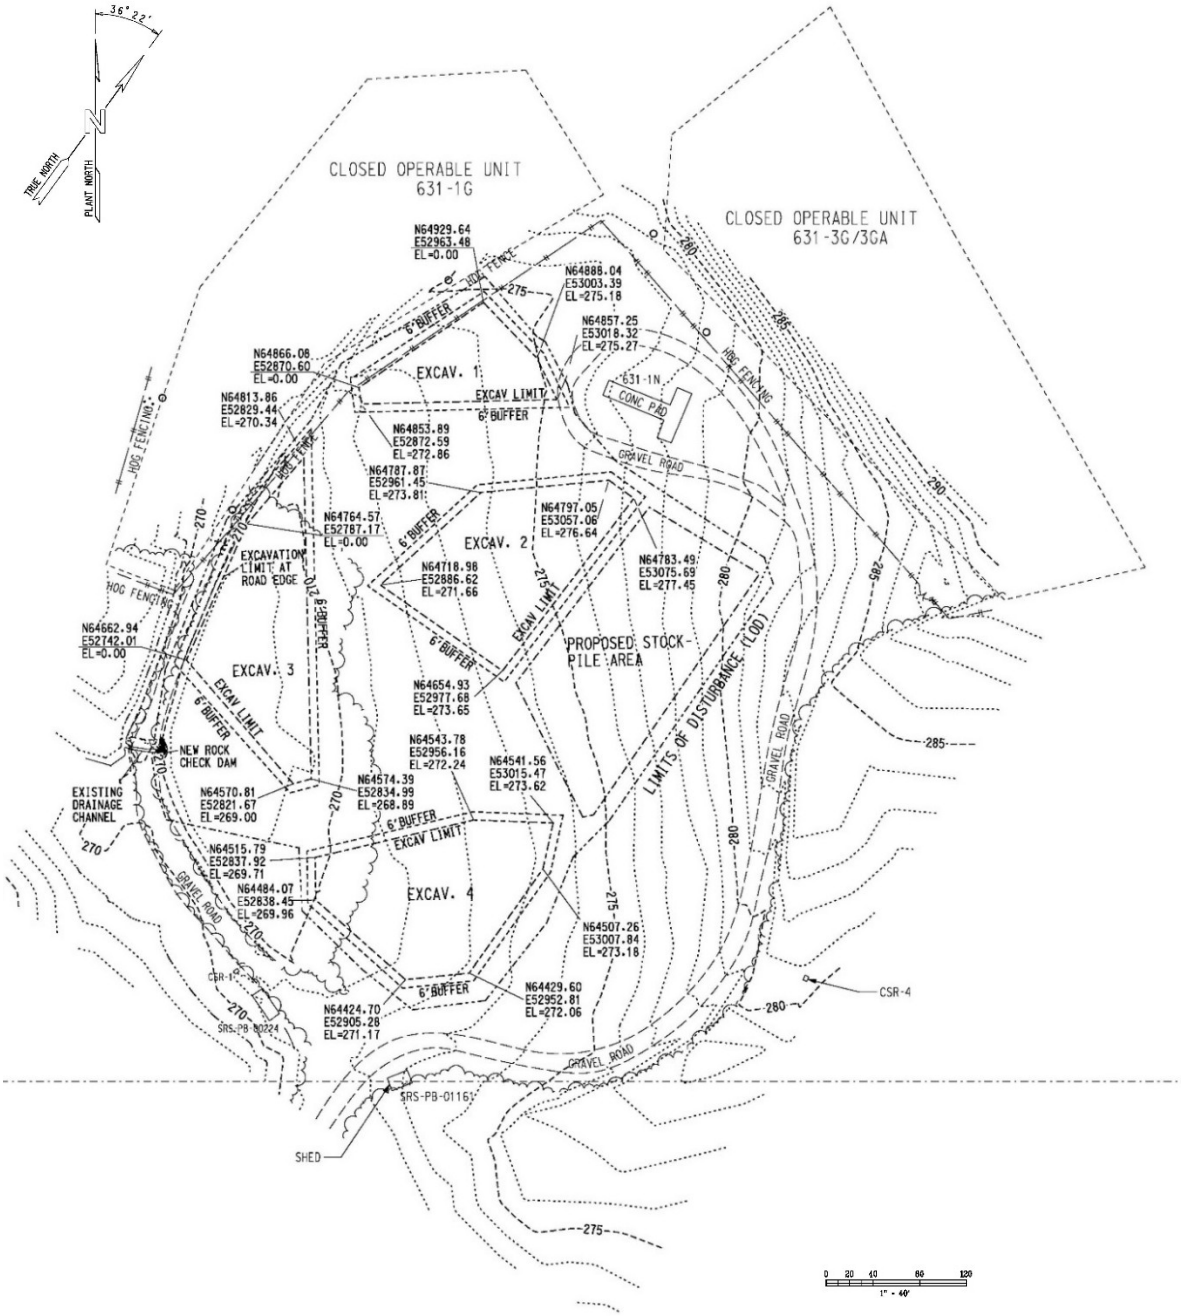
Figure 11. Location of CSSLP Excavation Areas 1, 2, 3, and 4

Savannah River Nuclear Solutions (SRNS) Site Survey performed the surveying of the LUC corner boundaries and sign locations for the ECODS N-1 and Ford Building subunits (Figure 10). The CSSLP excavation areas (EAs) were surveyed prior to excavation to delineate the boundaries of the four EAs which were staked with wood posts and survey flags (Figure 11). See Appendix C, Figure C-1 for the CSSLP pre-remedial action topographical survey. Temporary benchmarks for vertical and horizontal control within the project site were established, as necessary for execution of the specified tasks. The survey activities were performed in accordance with the SRNS Layout/Survey Measurement and Equipment Control Program Procedure. A Third Order/Class I survey accuracy as specified in Federal Geographic Data Committee STD-007.4 was used. The area of disturbance was more than 0.4 ha (1 ac). Therefore, a Storm Water Pollution Prevention Plan (SWPPP) was required and prepared.
