Annual Radioactive Waste Tank Inspection Program – 2022

June 2023

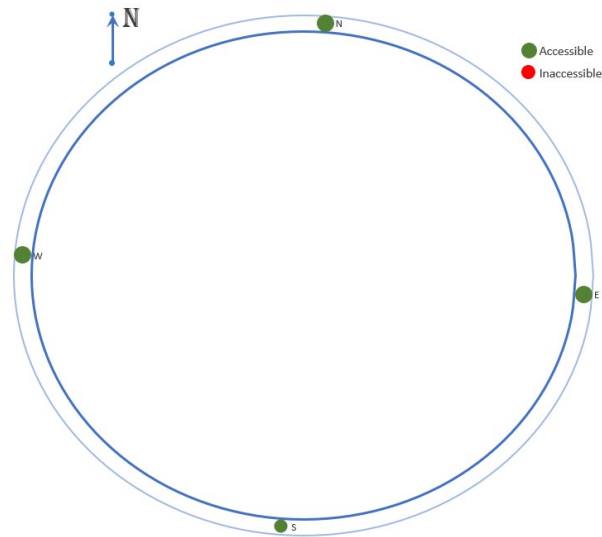
Annulus Inspection Location

Conclusions following 2022 Inspections: **No leakage, significant surface corrosion, or other anomalies were noted. The 2022 inspection confirmed the structural integrity and waste confinement capability of Tank 2.**

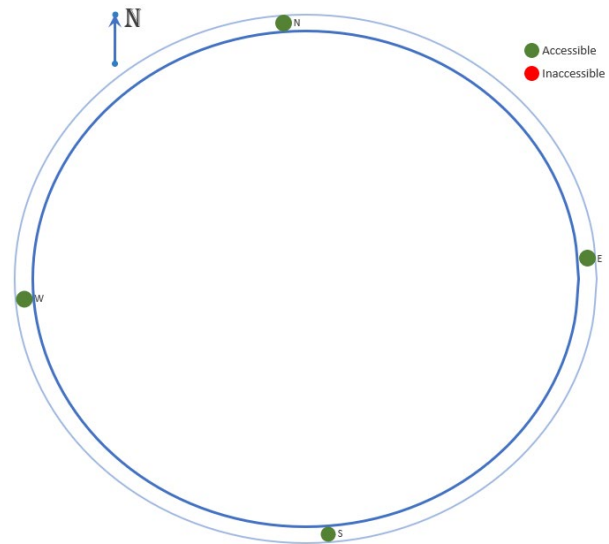
Annulus Inspection Location

Conclusions following 2022 Inspections: **No leakage, significant surface corrosion, or other anomalies were noted. The 2022 inspection confirmed the structural integrity and waste confinement capability of Tank 3.**

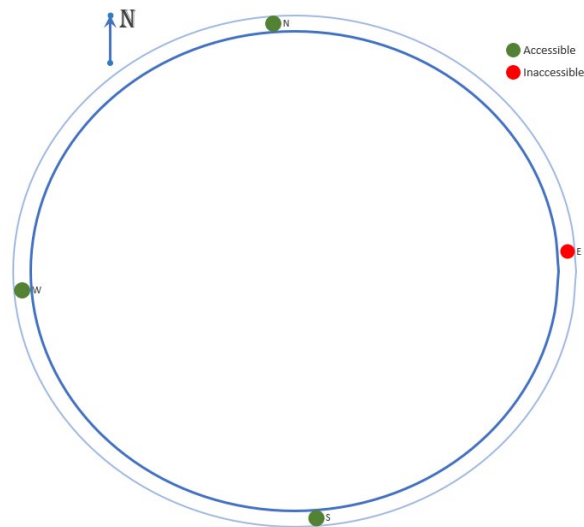
Annulus Inspection Location

Conclusions following 2022 Inspections: **No leakage, significant surface corrosion, or other anomalies were noted. The 2022 inspection confirmed the structural integrity and waste confinement capability of Tank 7.**

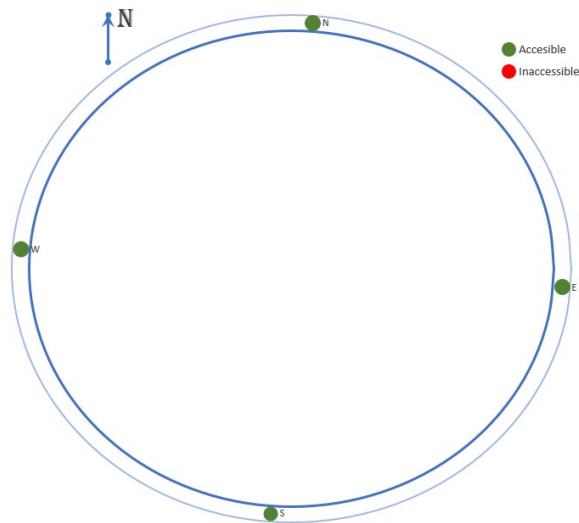
Annulus Inspection Location

Conclusions following 2022 Inspections: **No leakage, significant surface corrosion, or other anomalies were noted. The 2022 inspection confirmed the structural integrity and waste confinement capability of Tank 8.**

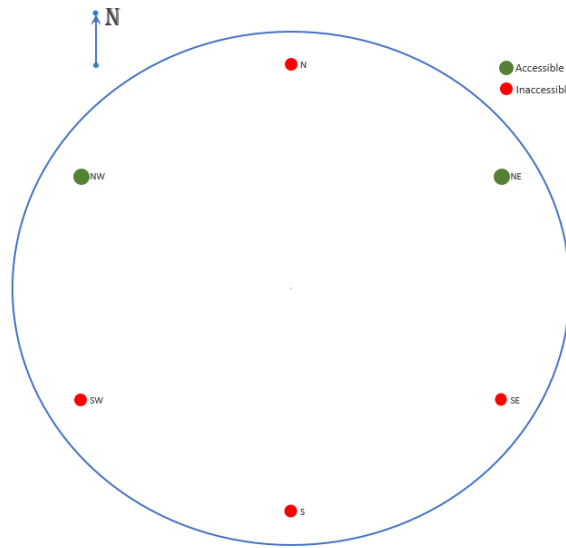
In-Tank Inspection Location

Summary of Visual Inspections: No areas of concern since last evaluated in 2021. Examination of concrete dome did not reveal any degradation; continues to meet ACI 318-95 code requirements.

Conclusions following 2022 Inspections: **No leakage, significant surface corrosion, or other anomalies were noted. The 2022 inspection confirmed the structural integrity and waste confinement capability of Tank 22.**

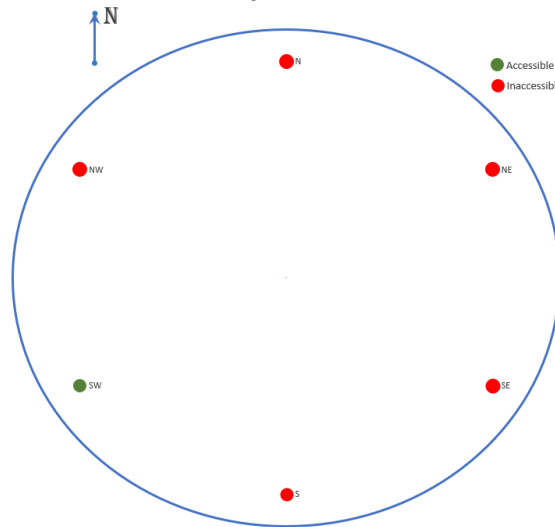
In-Tank Inspection Location

Summary of Visual Inspections: No areas of concern since last evaluated in 2021. Visual examinations of the steel liner have revealed corrosion, including rust and tubercles on the surface of the upper position of liner wall, but there is no evidence of failure. Broad and shallow pitting was observed. Examination of concrete dome did not reveal any degradation; continues to meet ACI 318-95 code requirements.

Conclusions following 2022 Inspections: **No leakage, additional surface corrosion, or other anomalies were noted. The 2022 inspection confirmed the structural integrity and waste confinement capability of Tank 23.**

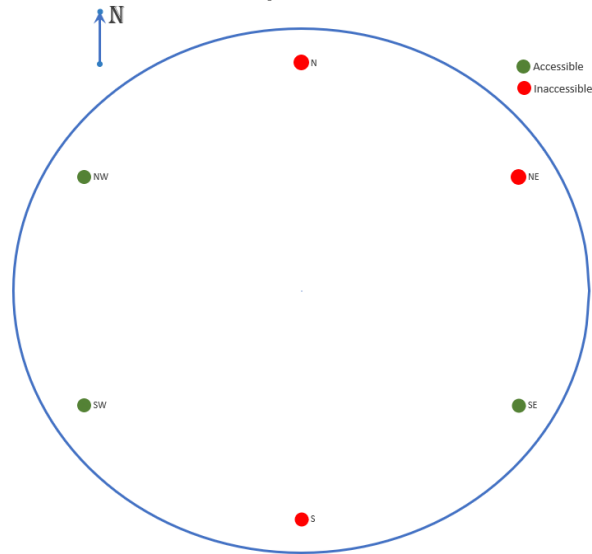
In-Tank Inspection Location

Summary of Visual Inspections: No areas of concern since last evaluated in 2021. Examination of concrete dome did not reveal any degradation; continues to meet ACI 318-95 code requirements.

Conclusions following 2022 Inspections: **No leakage, significant surface corrosion, or other anomalies were noted. The 2022 inspection confirmed the structural integrity and waste confinement capability of Tank 24.**

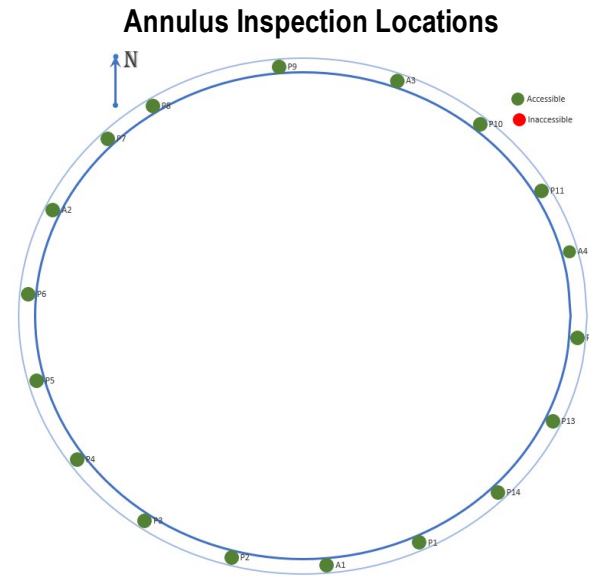
Ultrasonic Testing Inspections Results: No reportable thinning, pitting or stress corrosion cracking, or evidence of service-induced tank wall thinning on the primary tank wall. [ITIVS-ISI-FY2021]

Conclusions following 2022 Inspections: **No leakage, significant surface corrosion, or other anomalies were noted. The 2022 inspection confirmed the structural integrity and waste confinement capability of Tank 25.**

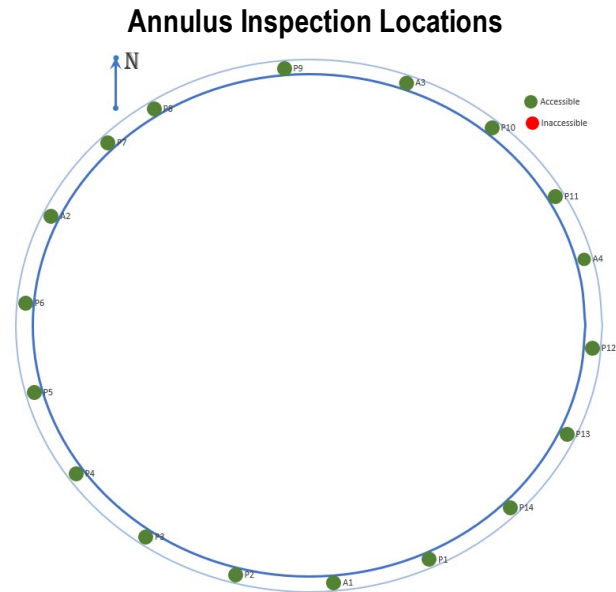
Ultrasonic Testing Inspections Results: No reportable thinning, pitting or stress corrosion cracking, or evidence of service-induced tank wall thinning on the primary tank wall.
[SRNL-STI-2019-00519]

Conclusions following 2022 Inspections: **No leakage, significant surface corrosion, or other anomalies were noted. The 2022 inspection confirmed the structural integrity and waste confinement capability of Tank 26.**

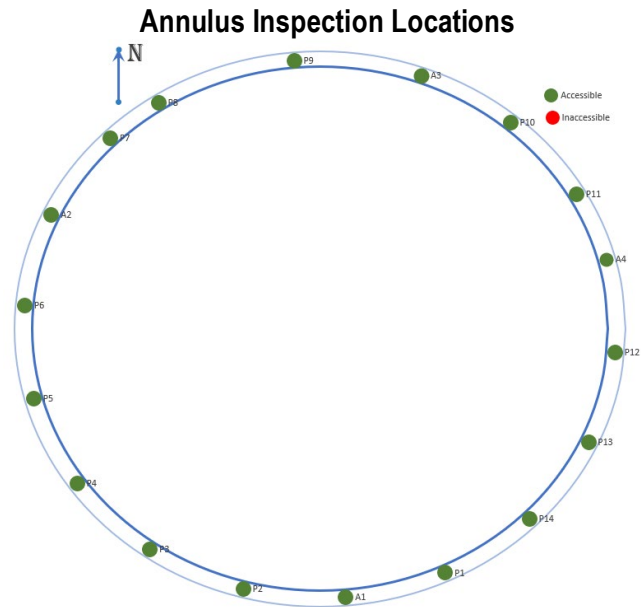
Ultrasonic Testing Inspections Results: No reportable thinning, pitting or stress corrosion cracking, or evidence of service-induced tank wall thinning on the primary tank wall.
[SRNL-STI-2014-00328]

Conclusions following 2022 Inspections: **No leakage, significant surface corrosion, or other anomalies were noted. The 2022 inspection confirmed the structural integrity and waste confinement capability of Tank 27.**

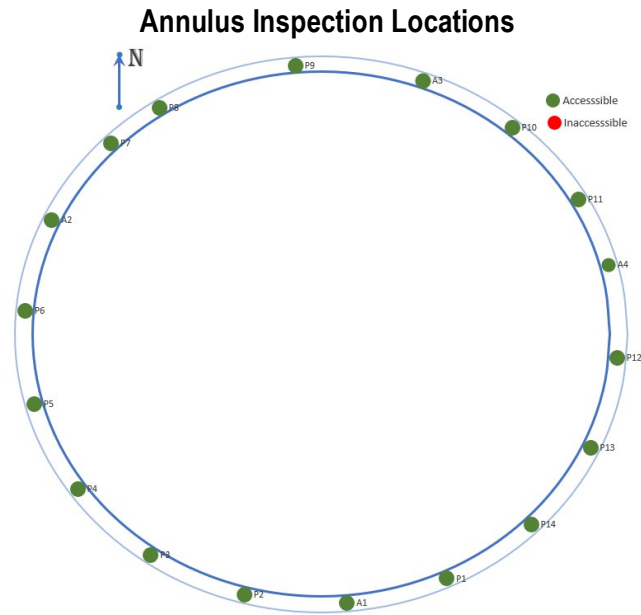
Ultrasonic Testing Inspections Results: No reportable thinning, pitting or stress corrosion cracking, or evidence of service-induced tank wall thinning on the primary tank wall.
[SRNL-STI-2014-00328]

Conclusions following 2022 Inspections: **No leakage, significant surface corrosion, or other anomalies were noted. The 2022 inspection confirmed the structural integrity and waste confinement capability of Tank 28.**

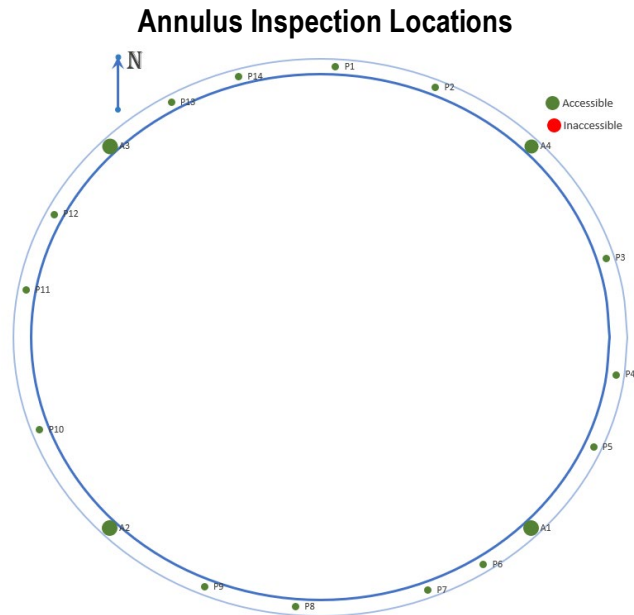
Ultrasonic Testing Inspections Results: No reportable thinning, pitting or stress corrosion cracking, or evidence of service-induced tank wall thinning on the primary tank wall. Incipient pitting was detected in several locations, with the deepest pit measuring 0.063" deep. [SRNL-STI-2018-00457]

Conclusions following 2022 Inspections: **No leakage, significant surface corrosion, or other anomalies were noted. The 2022 inspection confirmed the structural integrity and waste confinement capability of Tank 29.**

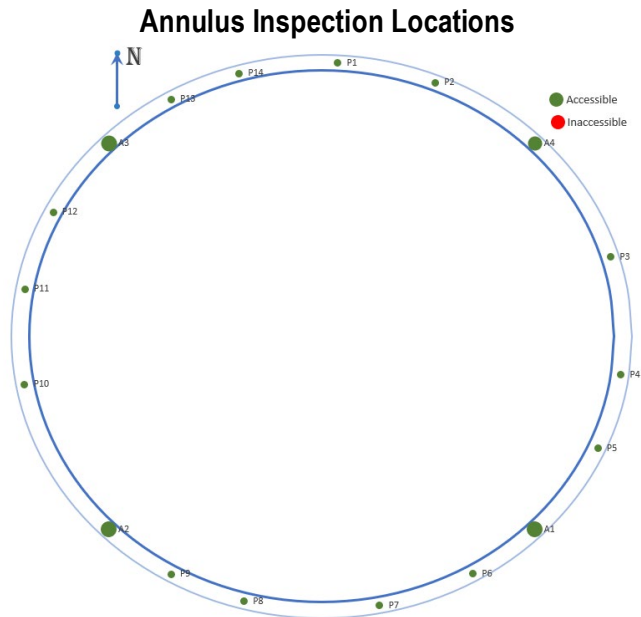
Ultrasonic Testing Inspections Results: No reportable thinning, pitting or stress corrosion cracking, or evidence of service-induced tank wall thinning on the primary tank wall. Ten incipient pits were documented; however, all of the pits are consistent with pre-service pitting with no evidence of active corrosion or growth.
[SRNL-STI-2018-00457]

Conclusions following 2022 Inspections: **No leakage, significant surface corrosion, or other anomalies were noted. The 2022 inspection confirmed the structural integrity and waste confinement capability of Tank 30.**
