SRMC-STI-2022-00154
Revision 0

Annual Radioactive Waste Tank Inspection Program – 2021

June 2022

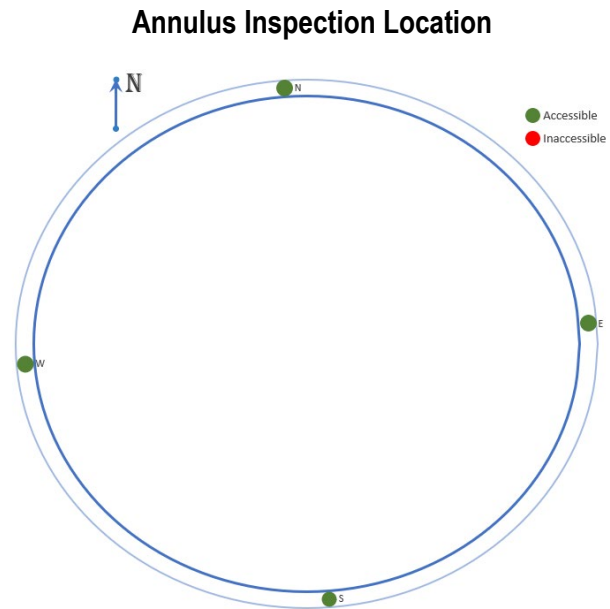
Annulus Risers Available for Inspection: 4

Inspection Capability: 25%

Number of Known Leak Sites	Date of Discovery	Waste on Annulus Floor	Location	Elevation from Tank Bottom
No known leak sites	n/a	n/a	n/a	n/a

Conclusions following 2021 Inspections: **No leakage, significant surface corrosion, or other anomalies were noted. The 2021 inspection confirmed the structural integrity and waste confinement capability of Tank 3.**

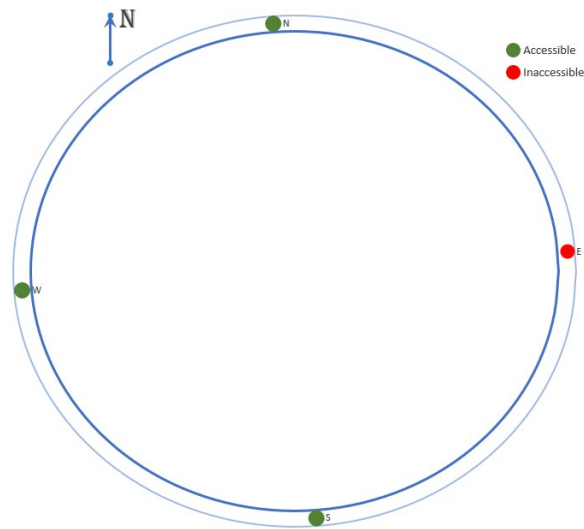
Annulus Inspection Location

Annulus Risers Available for Inspection: 3

Inspection Capability: 19%

Number of Known Leak Sites	Date of Discovery	Waste on Annulus Floor	Location	Elevation from Tank Bottom
No known leak sites	n/a	n/a	n/a	n/a

Conclusions following 2021 Inspections: **No leakage, significant surface corrosion, or other anomalies were noted. The 2021 inspection confirmed the structural integrity and waste confinement capability of Tank 7.**

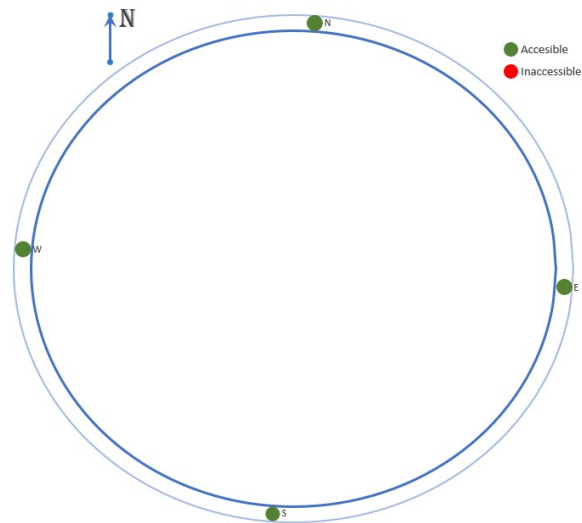
Annulus Inspection Location

Annulus Risers Available for Inspection: 4

Inspection Capability: 25%

Number of Known Leak Sites	Date of Discovery	Waste on Annulus Floor	Location	Elevation from Tank Bottom
No known leak sites	n/a	n/a	n/a	n/a

Conclusions following 2021 Inspections: **No leakage, significant surface corrosion, or other anomalies were noted. The 2021 inspection confirmed the structural integrity and waste confinement capability of Tank 8.**

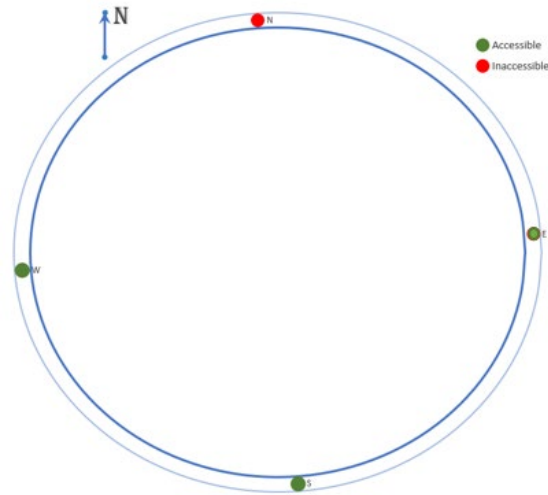
Annulus Inspection Location

Annulus Risers Available for Inspection: 3

Inspection Capability: 19%

Summary of Visual Inspections: No changes were noted since the inspections in 2020.

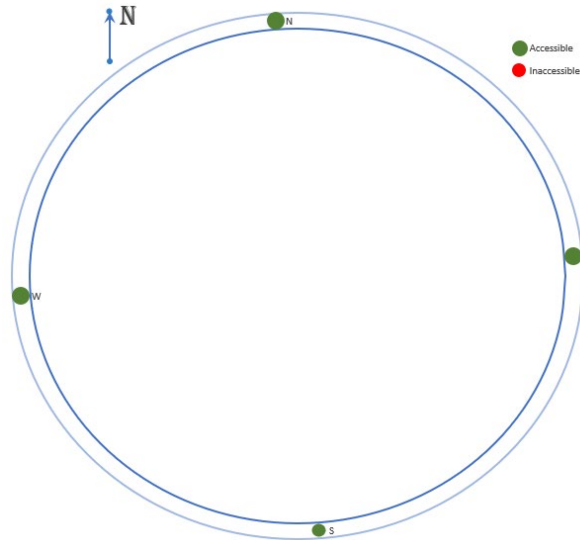
Annulus Inspection Location

Annulus Risers Available for Inspection: 4

Inspection Capability: 25%

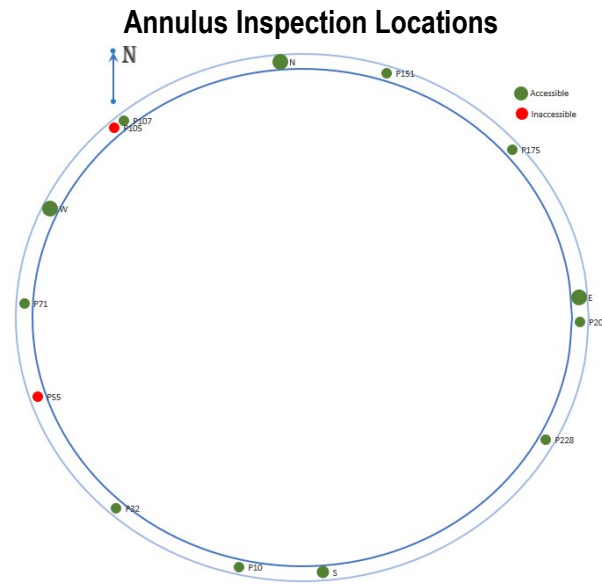
Annulus Inspection Ports Available: 12

Inspection Capability: 90%

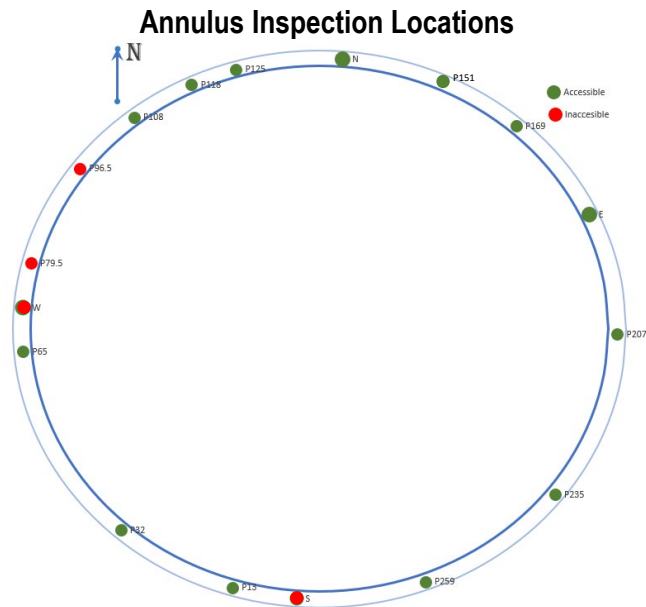
Annulus Inspection Ports Available: 13

Inspection Capability: 89%

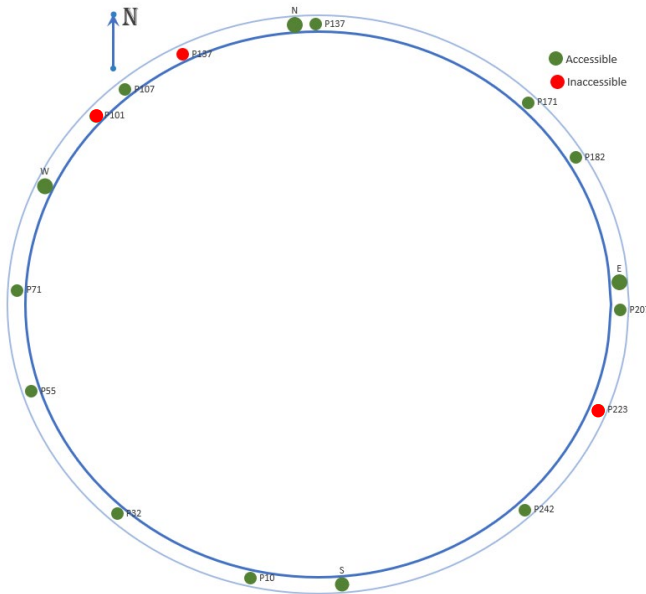
Annulus Inspection Locations

Annulus Inspection Ports Available: 14

Inspection Capability: 96%

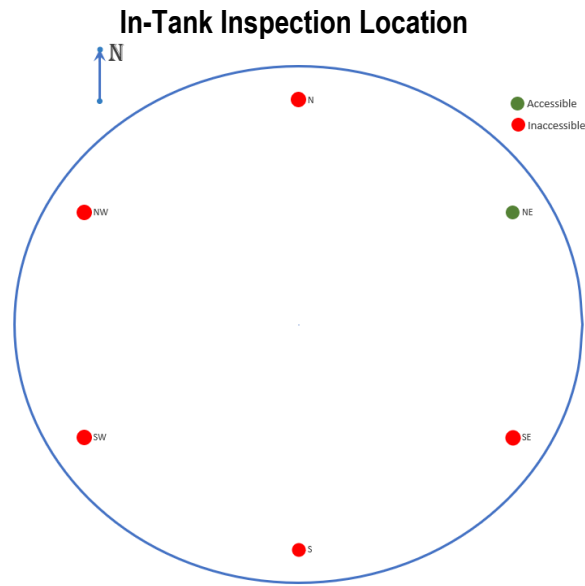
Exposed Wall Inspection Capability: 100%

Number of Known Leak Sites	Date of Discovery	Waste on Annulus Floor	Location	Elevation from Tank Bottom
No known leak sites	n/a	n/a	n/a	n/a

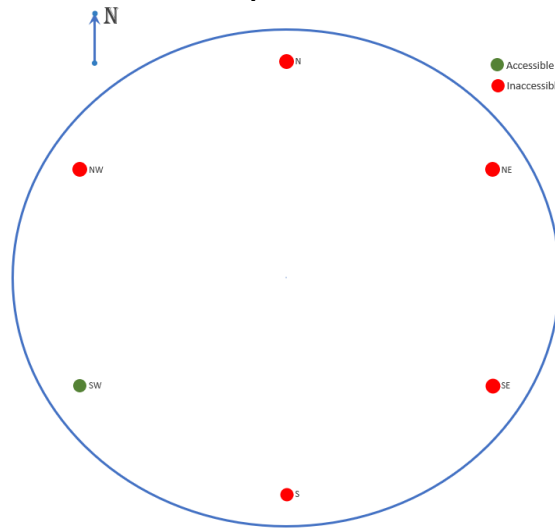
In-Tank Inspection Location

Exposed Wall Inspection Capability: 100%

Number of Known Leak Sites	Date of Discovery	Waste on Annulus Floor	Location	Elevation from Tank Bottom
No known leak sites	n/a	n/a	n/a	n/a

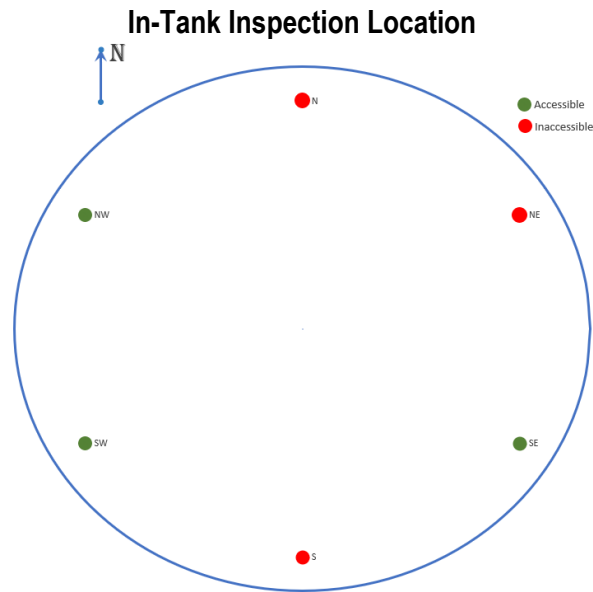
Summary of Visual Inspections: No areas of concern since last evaluated in 2020. Examination of concrete dome did not reveal any degradation; continues to meet ACI 318-95 code requirements.

Conclusions following 2021 Inspections: **No leakage, significant surface corrosion, or other anomalies were noted. The 2021 inspection confirmed the structural integrity and waste confinement capability of Tank 24.**

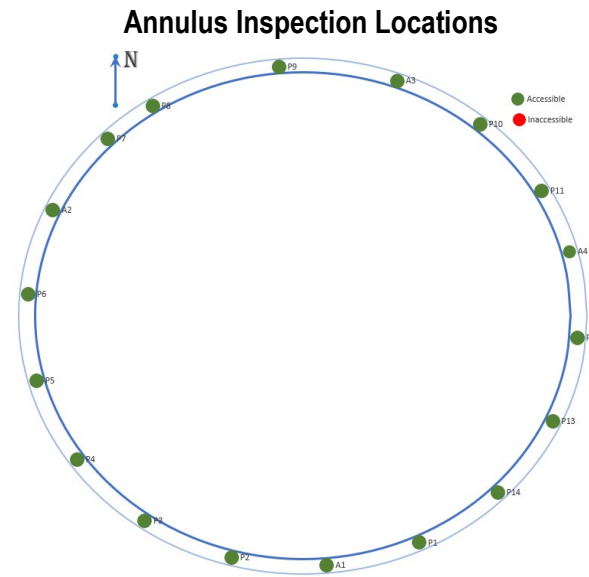
Ultrasonic Testing Inspections Results: No reportable thinning, pitting or stress corrosion cracking, or evidence of service-induced tank wall thinning on the primary tank wall. [ITIVS-ISI-FY2021]

Conclusions following 2021 Inspections: **No leakage, significant surface corrosion, or other anomalies were noted. The 2021 inspection confirmed the structural integrity and waste confinement capability of Tank 25.**

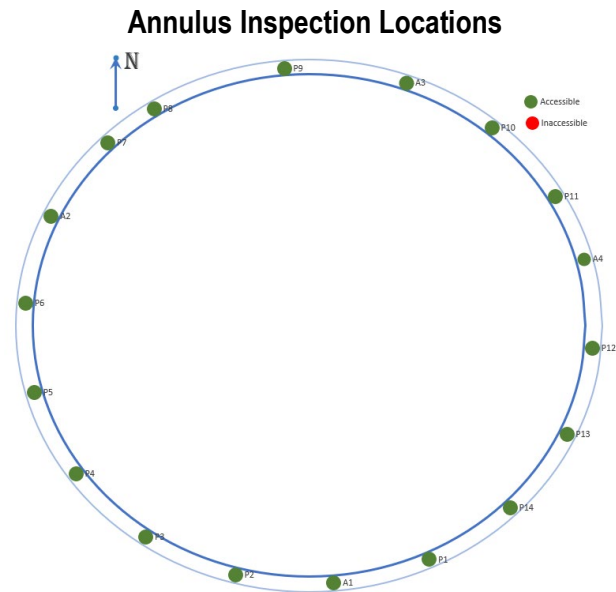
Ultrasonic Testing Inspections Results: No reportable thinning, pitting or stress corrosion cracking, or evidence of service-induced tank wall thinning on the primary tank wall. [SRNL-STI-2019-00519]

Conclusions following 2021 Inspections: **No leakage, significant surface corrosion, or other anomalies were noted. The 2021 inspection confirmed the structural integrity and waste confinement capability of Tank 26.**

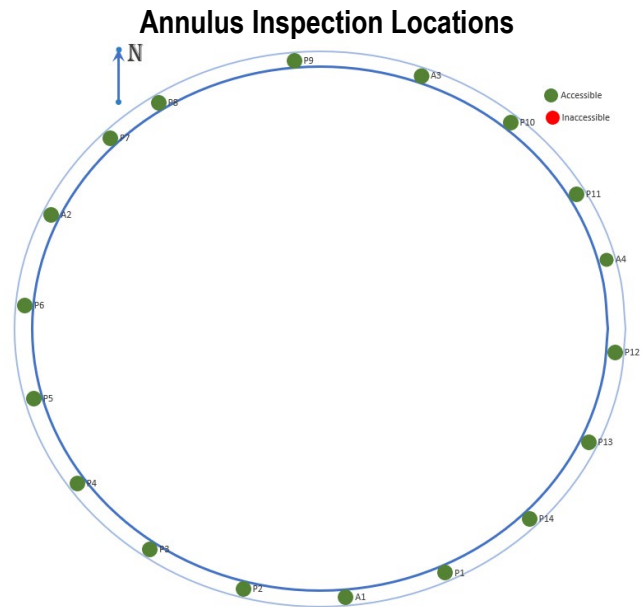
Ultrasonic Testing Inspections Results: No reportable thinning, pitting or stress corrosion cracking, or evidence of service-induced tank wall thinning on the primary tank wall. [SRNL-STI-2014-00328]

Conclusions following 2021 Inspections: **No leakage, significant surface corrosion, or other anomalies were noted. The 2021 inspection confirmed the structural integrity and waste confinement capability of Tank 27.**

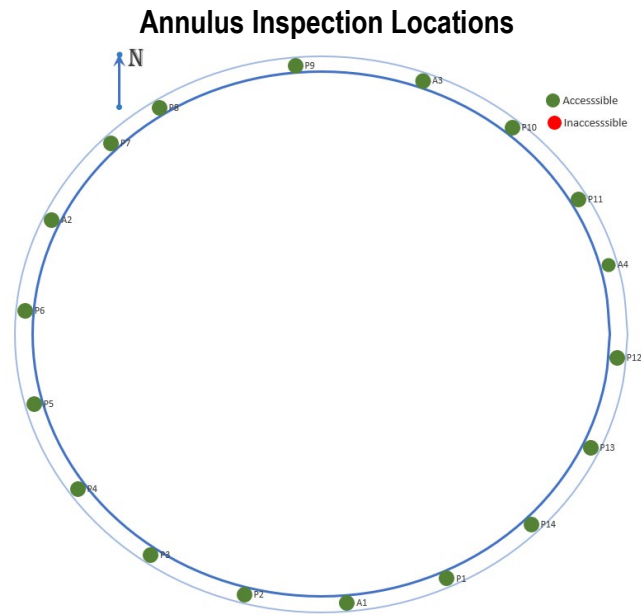
Ultrasonic Testing Inspections Results: No reportable thinning, pitting or stress corrosion cracking, or evidence of service-induced tank wall thinning on the primary tank wall. [SRNL-STI-2014-00328]

Conclusions following 2021 Inspections: **No leakage, significant surface corrosion, or other anomalies were noted. The 2021 inspection confirmed the structural integrity and waste confinement capability of Tank 28.**

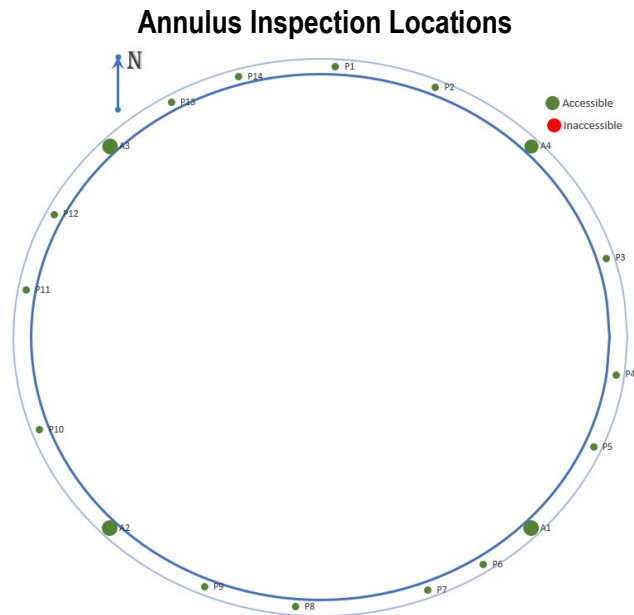
Ultrasonic Testing Inspections Results: No reportable thinning, pitting or stress corrosion cracking, or evidence of service-induced tank wall thinning on the primary tank wall. Incipient pitting was detected in several locations, with the deepest pit measuring 0.063" deep. [SRNL-STI-2018-00457]

Conclusions following 2021 Inspections: **No leakage, significant surface corrosion, or other anomalies were noted. The 2021 inspection confirmed the structural integrity and waste confinement capability of Tank 29.**

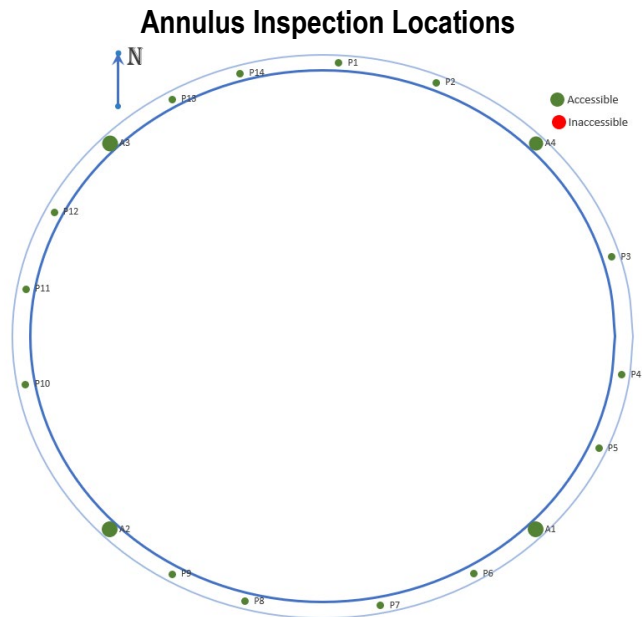
Ultrasonic Testing Inspections Results: No reportable thinning, pitting or stress corrosion cracking, or evidence of service-induced tank wall thinning on the primary tank wall. Ten incipient pits were documented; however, all of the pits are consistent with pre-service pitting with no evidence of active corrosion or growth. [SRNL-STI-2018-00457]

Conclusions following 2021 Inspections: **No leakage, significant surface corrosion, or other anomalies were noted. The 2021 inspection confirmed the structural integrity and waste confinement capability of Tank 30.**

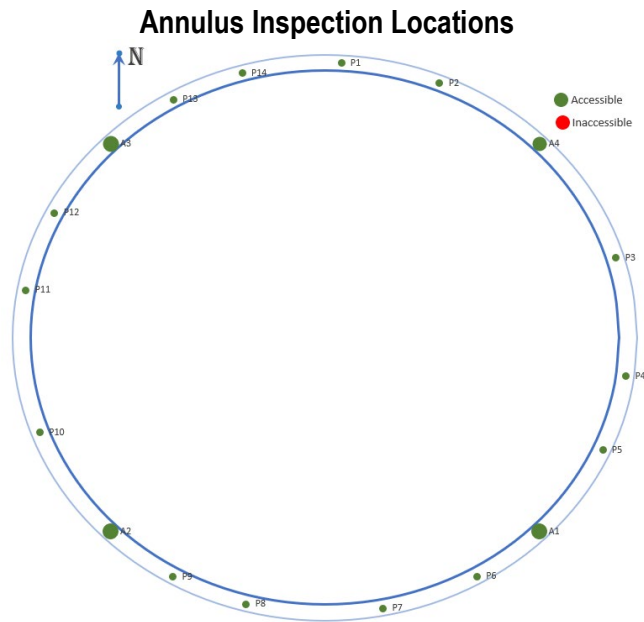
Ultrasonic Testing Inspections Results: No reportable thinning, pitting or stress corrosion cracking, or evidence of service-induced tank wall thinning on the primary tank wall. Nine incipient pits were documented; however, all of the pits are consistent with pre-service pitting with no evidence of active corrosion or growth. [SRNL-STI-2018-00457]

Conclusions following 2021 Inspections: **No leakage, significant surface corrosion, or other anomalies were noted. The 2021 inspection confirmed the structural integrity and waste confinement capability of Tank 31.**
