Manual: C3
 Procedure: ER-IDS-019-065
 Revision: 3
 Effective Date: 10/25/2016
 Type-Class: Form
 Page: 1 of 37 ^{cal} 10-23-18

P-AREA OPERABLE UNIT REACTOR BUILDING AND DISASSEMBLY BASIN FIELD INSPECTION CHECKLIST

P-REACTOR BUILDING COMPLEX AND DISASSEMBLY BASIN

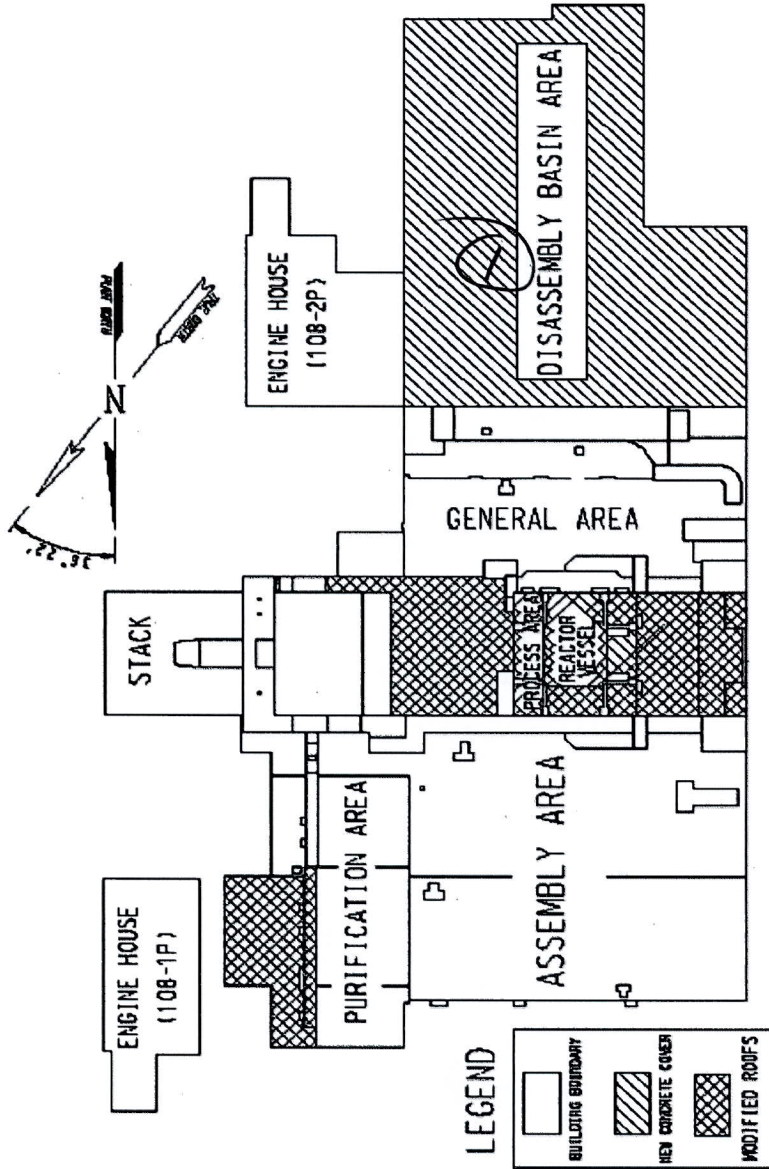
D-CARRY OVER ITEM: WORK PACKAGE WILL BE DEVELOPED TO REPAIR CAULKING IN EXPANSION JOINTS ON THE DISASSEMBLY BASIN COVER.

The 2018 inspection utilized an Unmanned Aerial System for the inspection. Video footage is stored on a data disk in EC&ACP Document Control. No further degradation of the reactor and associated roofs was observed. Standing water and vegetation is still present.
