Q-SDD-Engineering Survey & Interference Report for Building 704-7D, D-Area Maintenance Building

Prepared by: W.B. Griffin Date: 11/3/2020
W.B. Griffin
EC&ACP Engineering
Environmental Compliance & Area Completion Projects

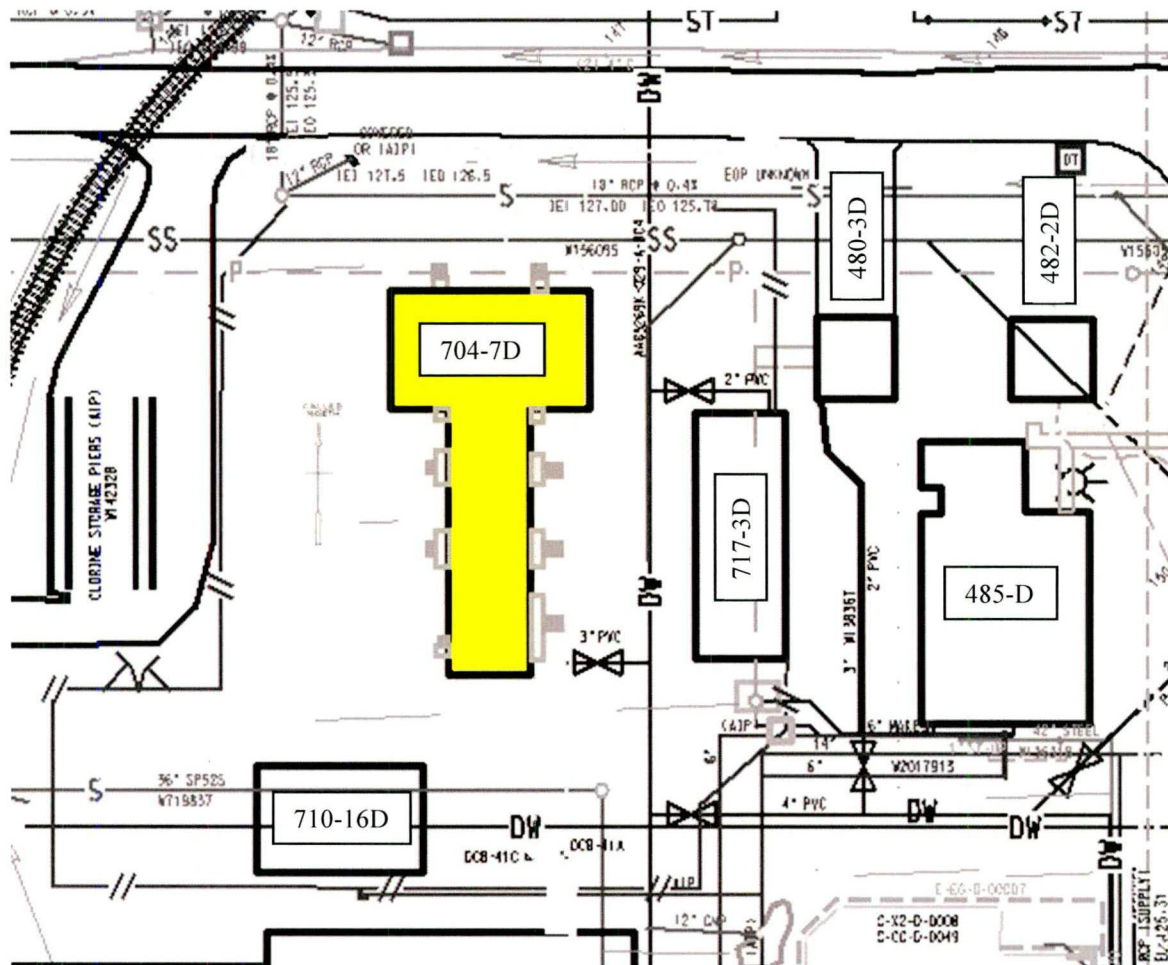
Figure 4: Building 704-7D and Surrounding Buildings/Facilities

- There are no potential hazards from other structures in the area.
- There are no overhead or underground powerlines proximate the building.
- Any underground lines in the general vicinity of the building are deep enough that there is no potential for damage due to heavy equipment.
- There are no fall hazards associated with Building 704-7D.
