**Title: MONITORING OF CLOSED WASTE TANKS FOR HTF
AND FTF**

Closed Waste Tank Annual Inspection Checklist Cover Sheet

Inspection Year: 2019

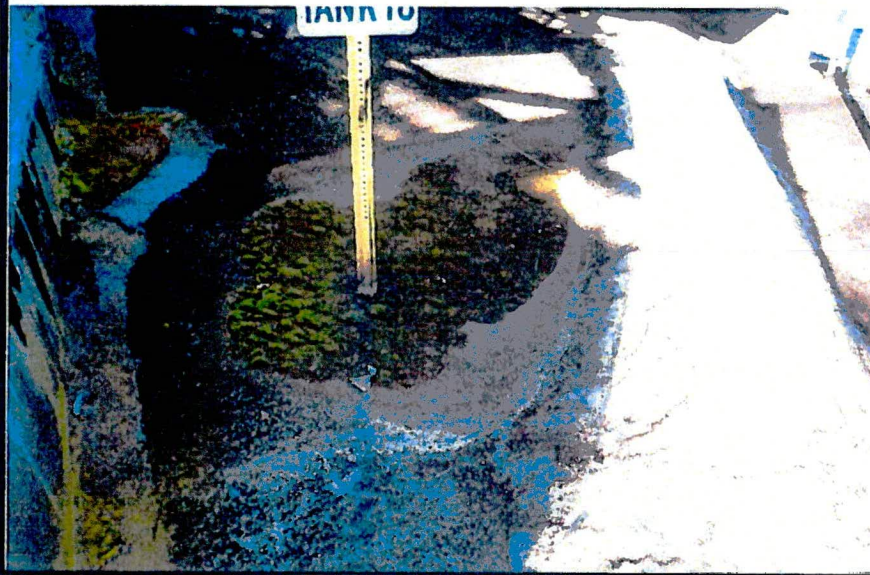
Tank 18, Depression North of East Riser

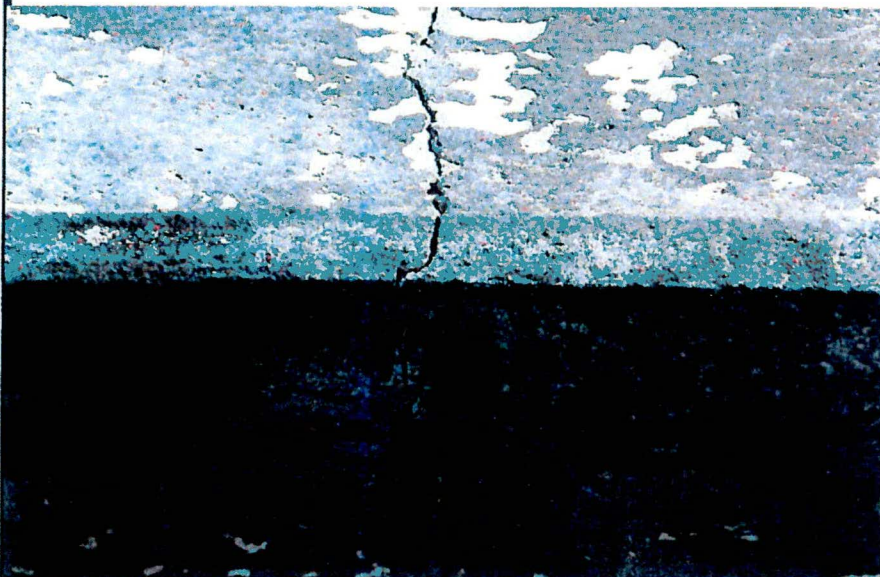
Tank 19, Northwest Riser, West Side

Comments:
 1. Three cracks noted on Tank 19 NW riser cap: W side, E side and S side
 2. Riser degradation unchanged
 BGM
