P-AREA OPERABLE UNIT REACTOR BUILDING AND DISASSEMBLY BASIN FIELD INSPECTION
CHECKLIST

P-Area Operable Unit Reactor Building and Disassembly Basin

SRNS-E3520-2017-00008-SM, Revision 1

105-P ACTUATOR TOWER ROOF SLAB FLAW AT THE SOUTHEAST CORNER

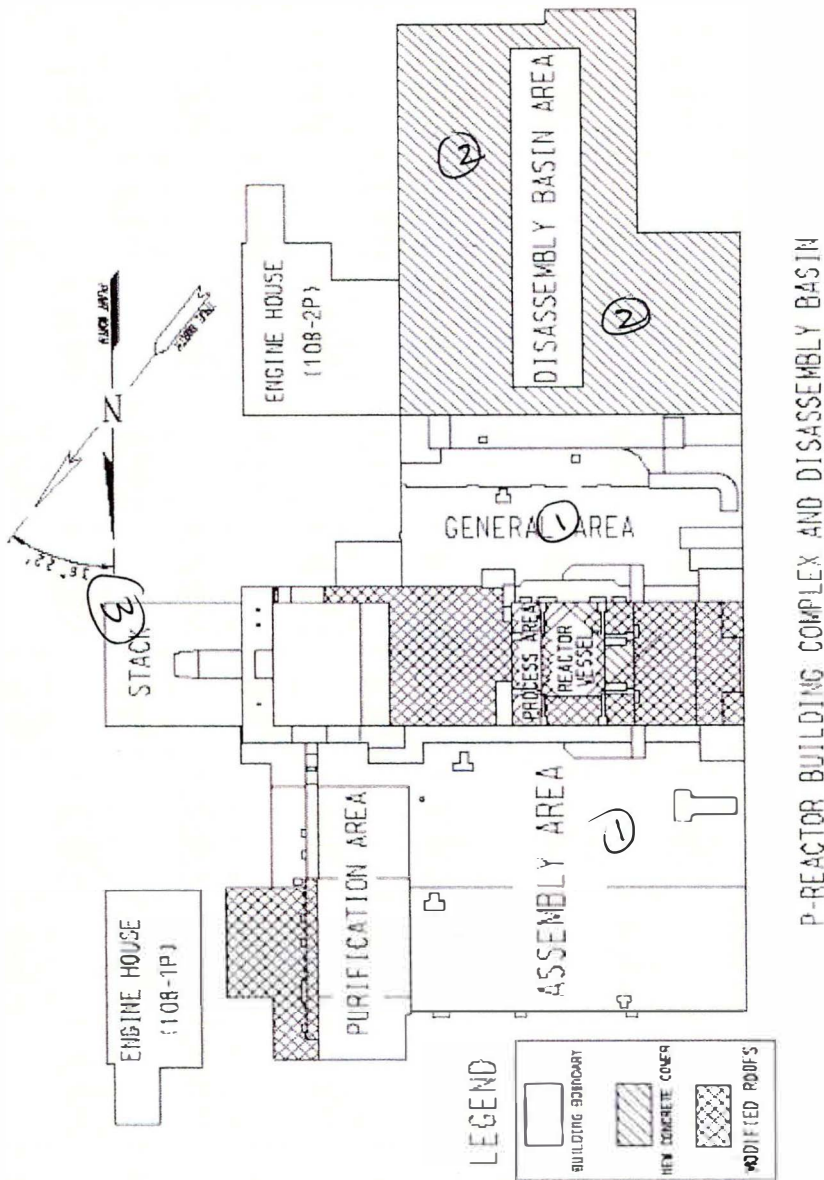
Remote Worker
S2 - E4

NOTES: ①- VEGETATION GROWING ON ROOF. ACP IS CURRENTLY DEVELOPING A WORK PACKAGE TO CLEAN SILT, SAND, DEBRIS AND REMOVE VEGETATION.
② SEVERAL AREAS OF CAULKING IN EXPANSION JOINTS NEED REPAIR ACP WILL DEVELOP A WORK PACKAGE TO REPAIR CAULKING JOINTS ON THE DISASSEMBLY BASIN COVER
SEE ATTACHED CTF REVIEW BLOMMENTS

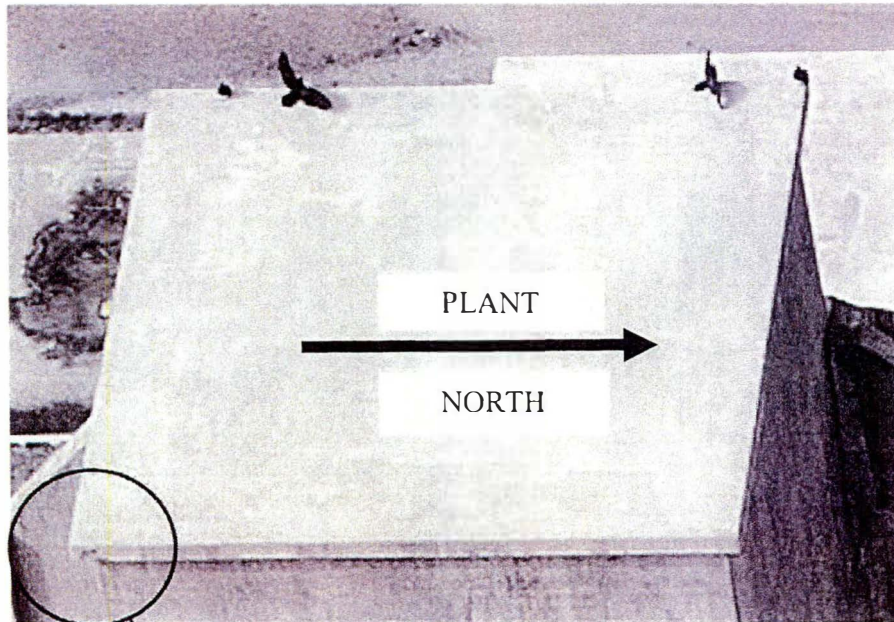
September 14, 2012

7. The "105-P Aerial Taken 9-14-12" (attached) shows this flaw was visible one year after the slab placement in 2011.

The observations of the surface texture indicate the flaw is a void in the concrete that had a thin veneer on the surface. The thin veneer was likely stripped away when the forms were removed, leaving the void exposed. Thus, the flaw is deemed a product of construction, which is corroborated by the attached "105-P Aerial Taken 9-14-12", showing the flaw was present a year after the slab was constructed.

Continue to surveille the flaw on an annual basis for signs of degradation. If it is seen the exposed bar is corroding, or if the corner is degrading further it would be prudent to consider applying a repair mortar with corrosion inhibitor.
