ENVIRONMENTAL COMPLIANCE & AREA COMPLETION PROJECTS (EC&ACP) STANDARD OPERATING PROCEDURES, VOL. I

Manual: C3
 Procedure: ER-IDS-019-063
 Revision: 4
 Effective Date: 1/08/2020
 Type-Class: Checklist
 Page: 1 of 25

R-AREA OPERABLE UNIT REACTOR BUILDING AND DISASSEMBLY BASIN FIELD INSPECTION CHECKLIST

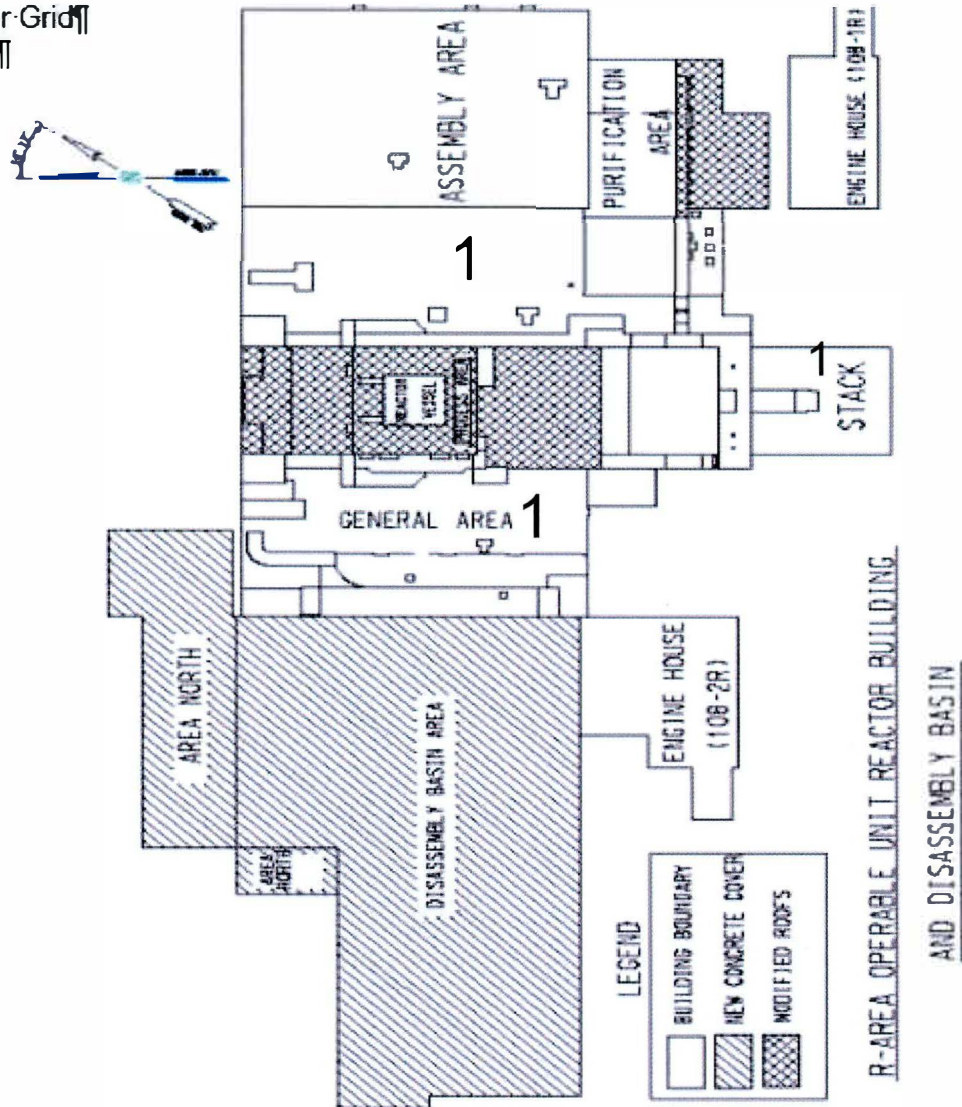
Map of R-Area Operable Unit Reactor Building and Disassembly Basin

Remote Worker Grid
N-2--E4
