# **Scoping Summary for the Automotive Repair Shop (716-A) and Paint Shop Building (725-A) Operable Unit (U)**

**(RI Work Plan Characterization)**

**SRNS-RP-2023-00820**

**October 2023 (Final)**

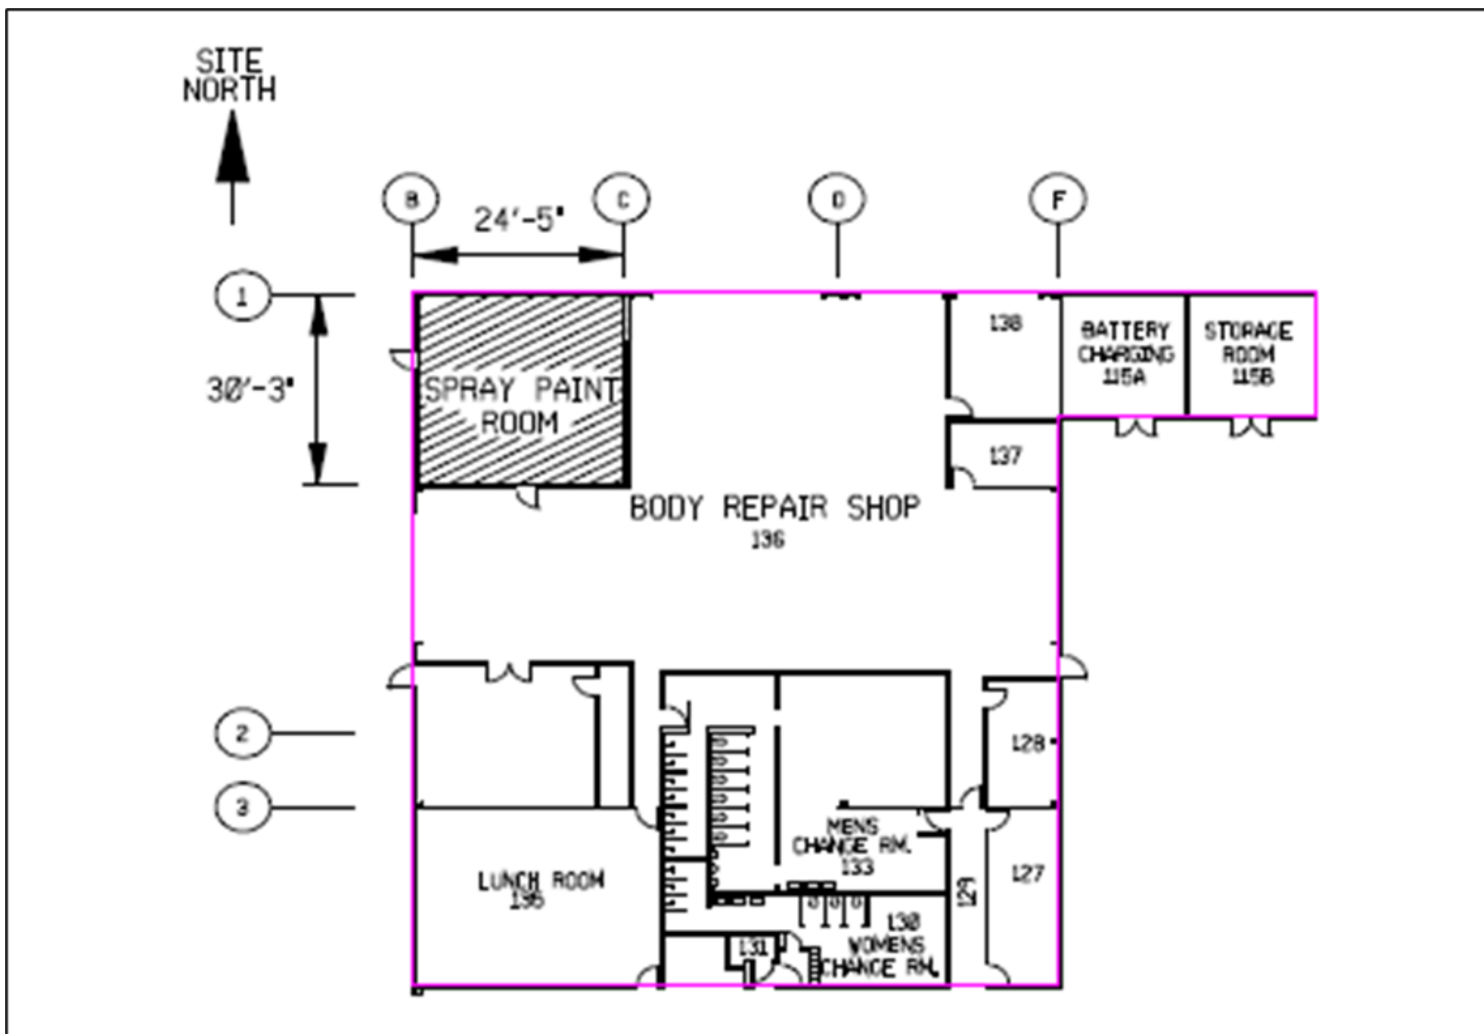
Figure 5. Location of Spray Paint Room in Northwest Corner of Building 716-A

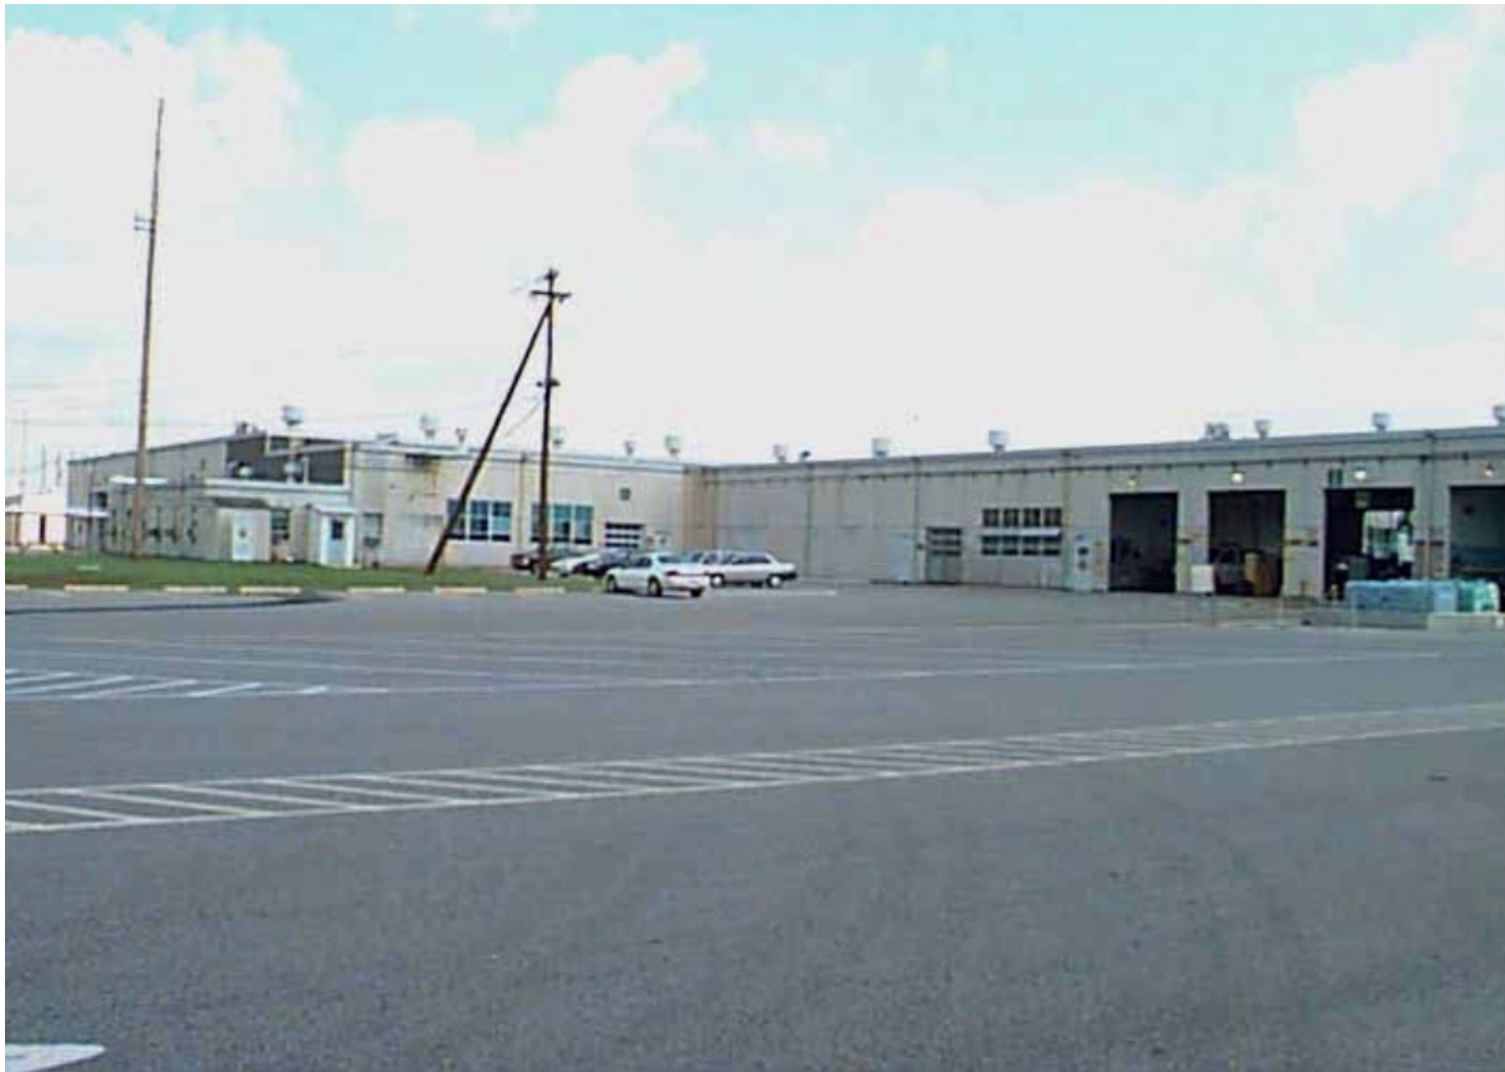
Figure 6. Building 716-A, Before Decommissioning

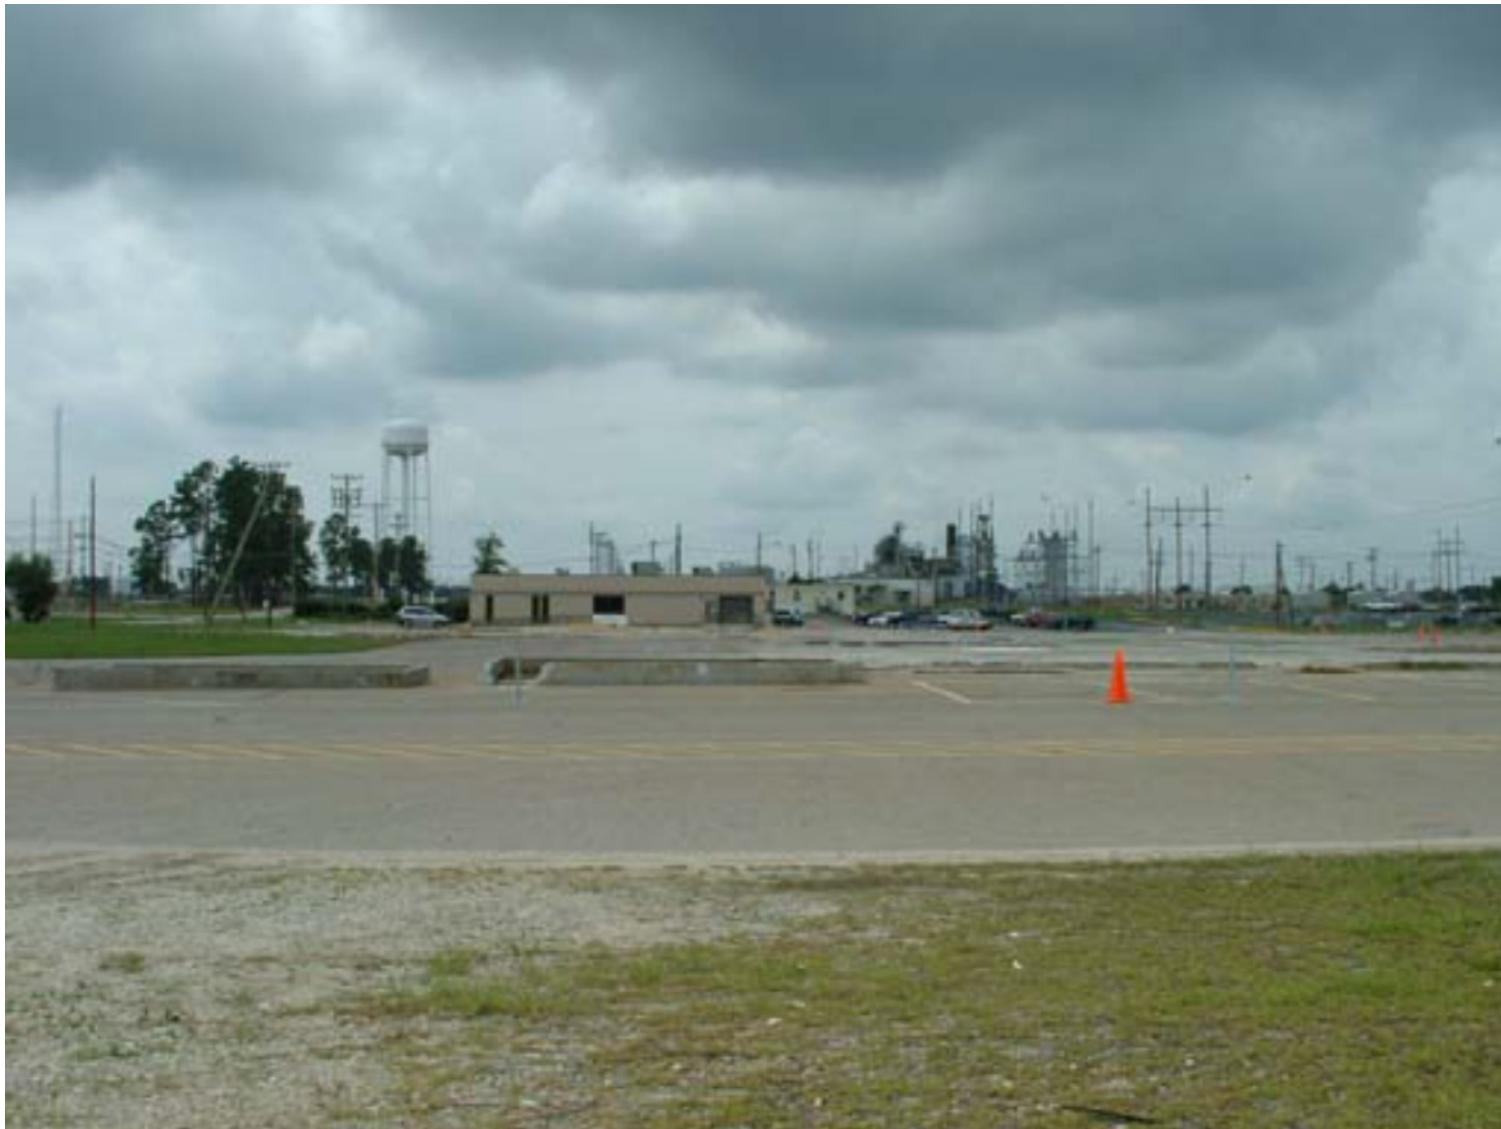
Figure 7. Building 716-A Slab, After Decommissioning

The DPFR concluded the building structure decommissioning activities have been completed, including waste disposal in accordance with federal and state regulations. The building structure was demolished to the foundation. The clean concrete slab remains on its original footprint. The concrete slab remains in place and penetrations greater than 2 inches in diameter were grouted, including all pits associated with the automotive hydraulic lift systems. Before and after photographs of the decommissioning activities are captured in Figures 6 and 7, respectively. The DPFR concluded that the remaining structure was free of hazards, both physical and chemical, and therefore, warrants no further action. No long-term stewardship activities were identified for the structure because it posed no threat to human health or the environment.

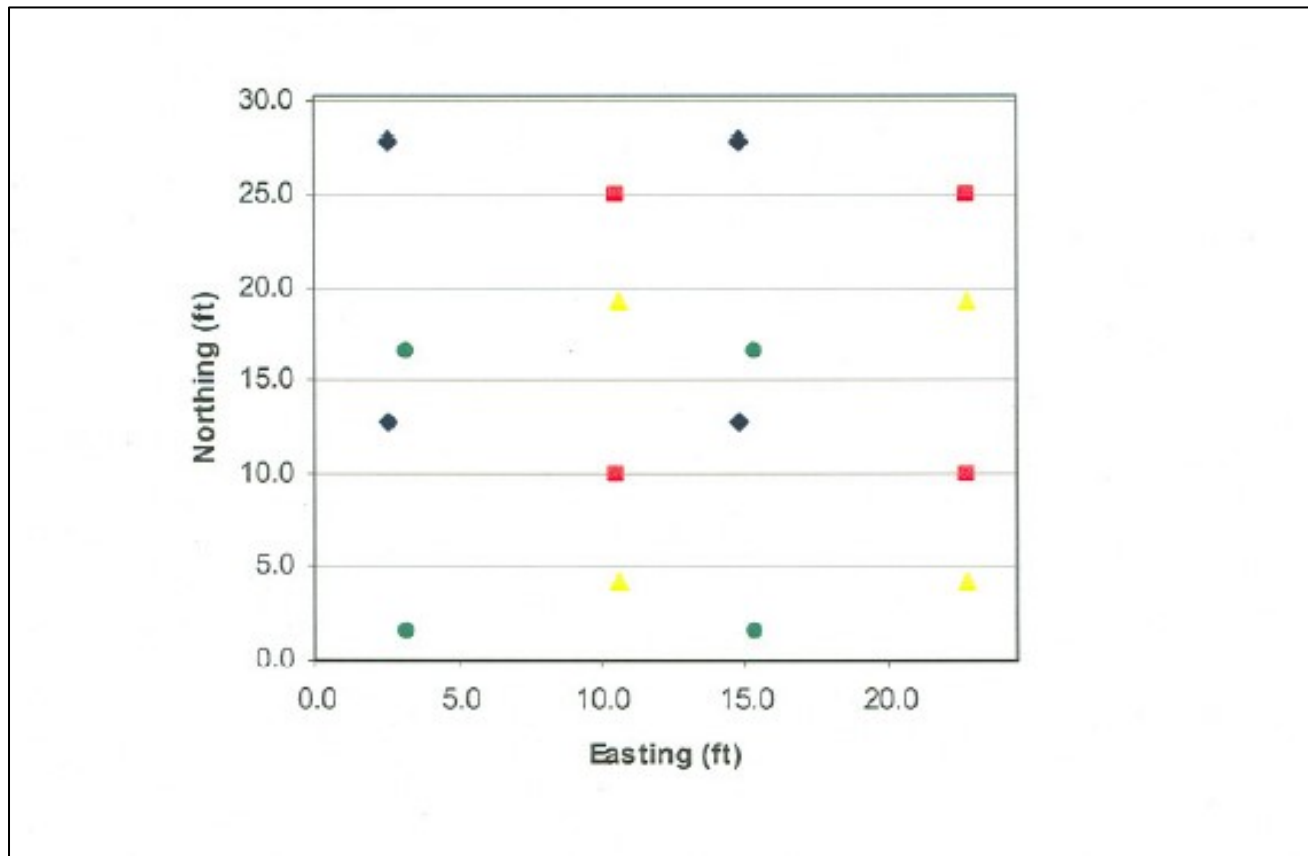
**Figure 8. Sample Locations for RCRA Metals at Building 716-A Spray Paint Room (WSRC 2005d)**

Note: Each color/shape represents the set of four samples used for each composite sample.

The final verification survey included 16 sample locations, which were composited in 4 sets of 4 samples and were obtained from the Spray Paint Room exposure area for RCRA metals analysis (arsenic, barium, cadmium, chromium, lead, mercury [elemental], mercury [compounds], selenium, and silver) (Figure 8). Nine single samples were taken for VOC analysis in the exposure area (Figure 9). The sample locations depicted on Figures 8 and 9 were all measured in feet from the southwest corner of the Spray Paint Room or point (0, 0). On Figure 8, each color represents the set of four samples used for each composite sample.

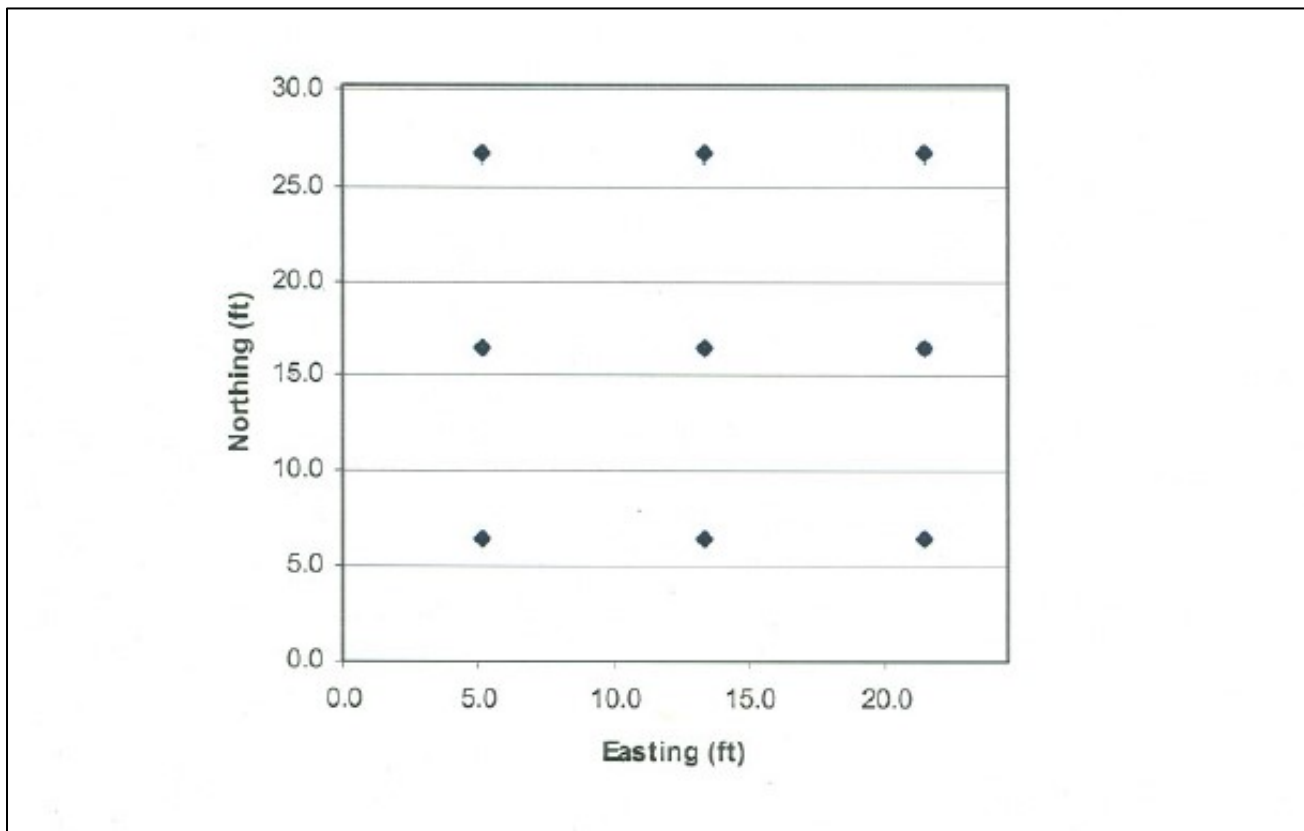
Figure 9. Sample Locations for VOCs at Building 716-A Spray Paint Room (WSRC 2005d)

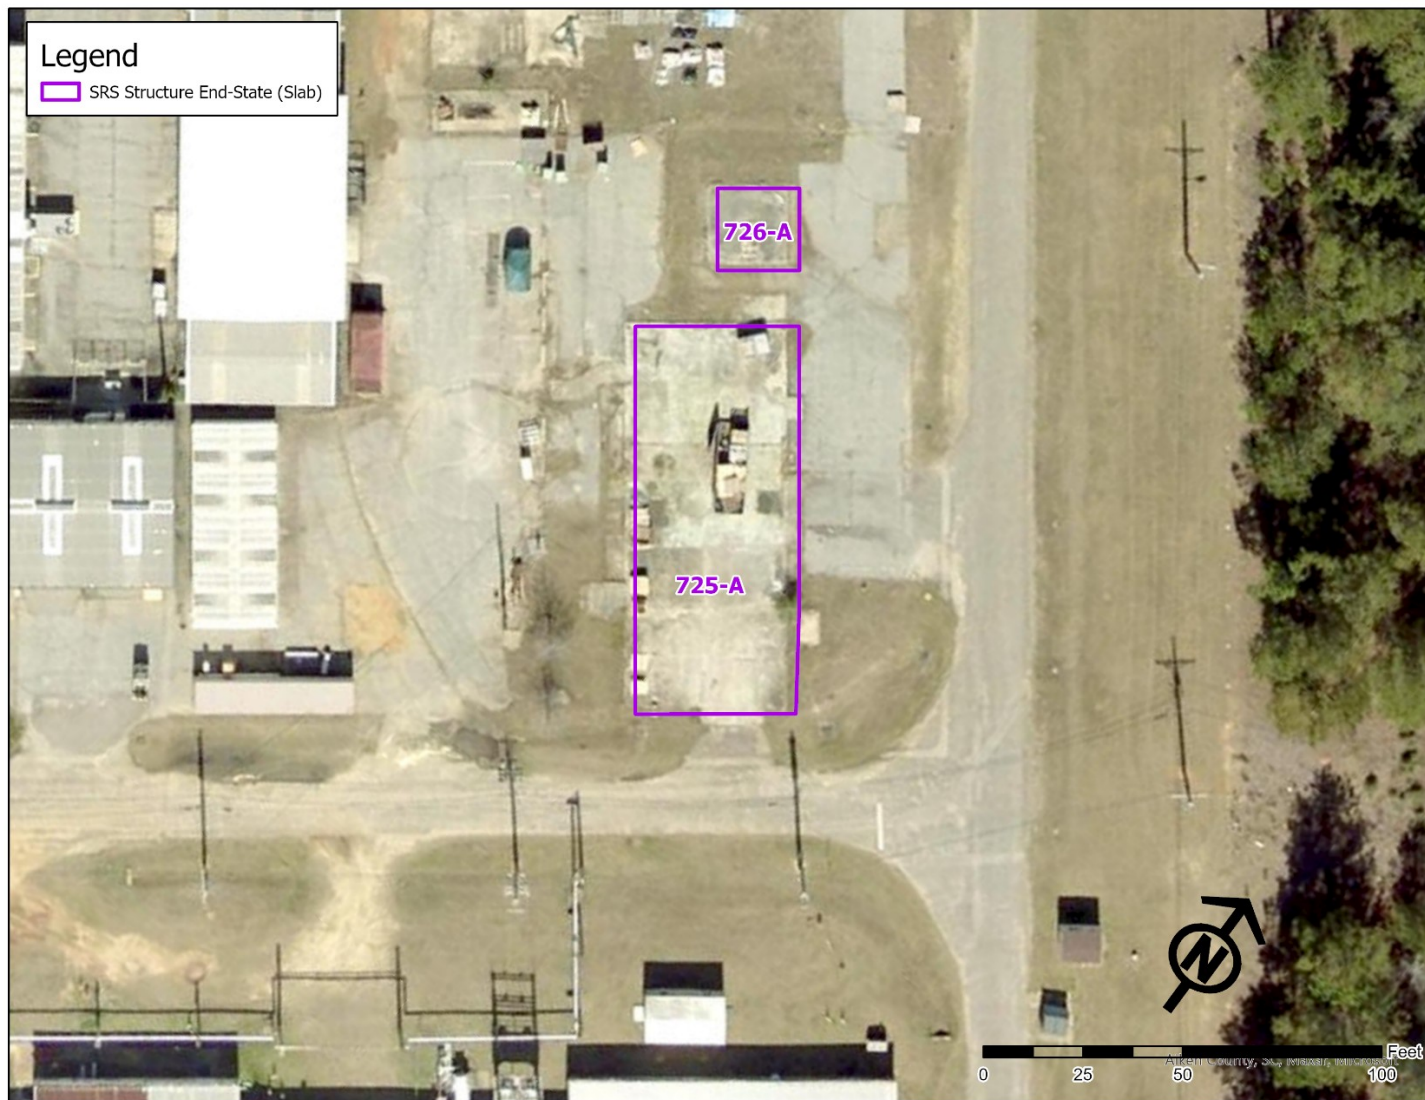
Figure 10. Location of Paint Shop Building (725-A)

Building 725-A was located in A Area at SRS (Figure 10). Originally constructed in 1953 and subsequently added to in 1979, the facility was a single-story structure on a reinforced concrete slab foundation. The building’s overall dimensions were 40 ft by 72 ft. The original building was 41 ft by 40 ft by 18 ft high at the ceiling peak and 10 ft high at the eaves. It was a metal frame structure, with asbestos cement board (transite) exterior walls, lead fasteners, and a corrugated asbestos roof. A steel-sided paint spray booth with a fire curtain and exhaust fan were located in this part of the structure. A 4 ft by 7 ft by 2 ft 8 inches (in) deep pit for a flash tank was located in the janitor’s closet in this part of the structure. The 1979 expansion added 31 ft to the north of the original facility. The addition is a metal frame structure with corrugated metal exterior walls and roof. There was a 26 ft by 40 ft metal canopy at the south end of the facility. Building 725-A had a total area of 3,920 ft<sup>2</sup>.

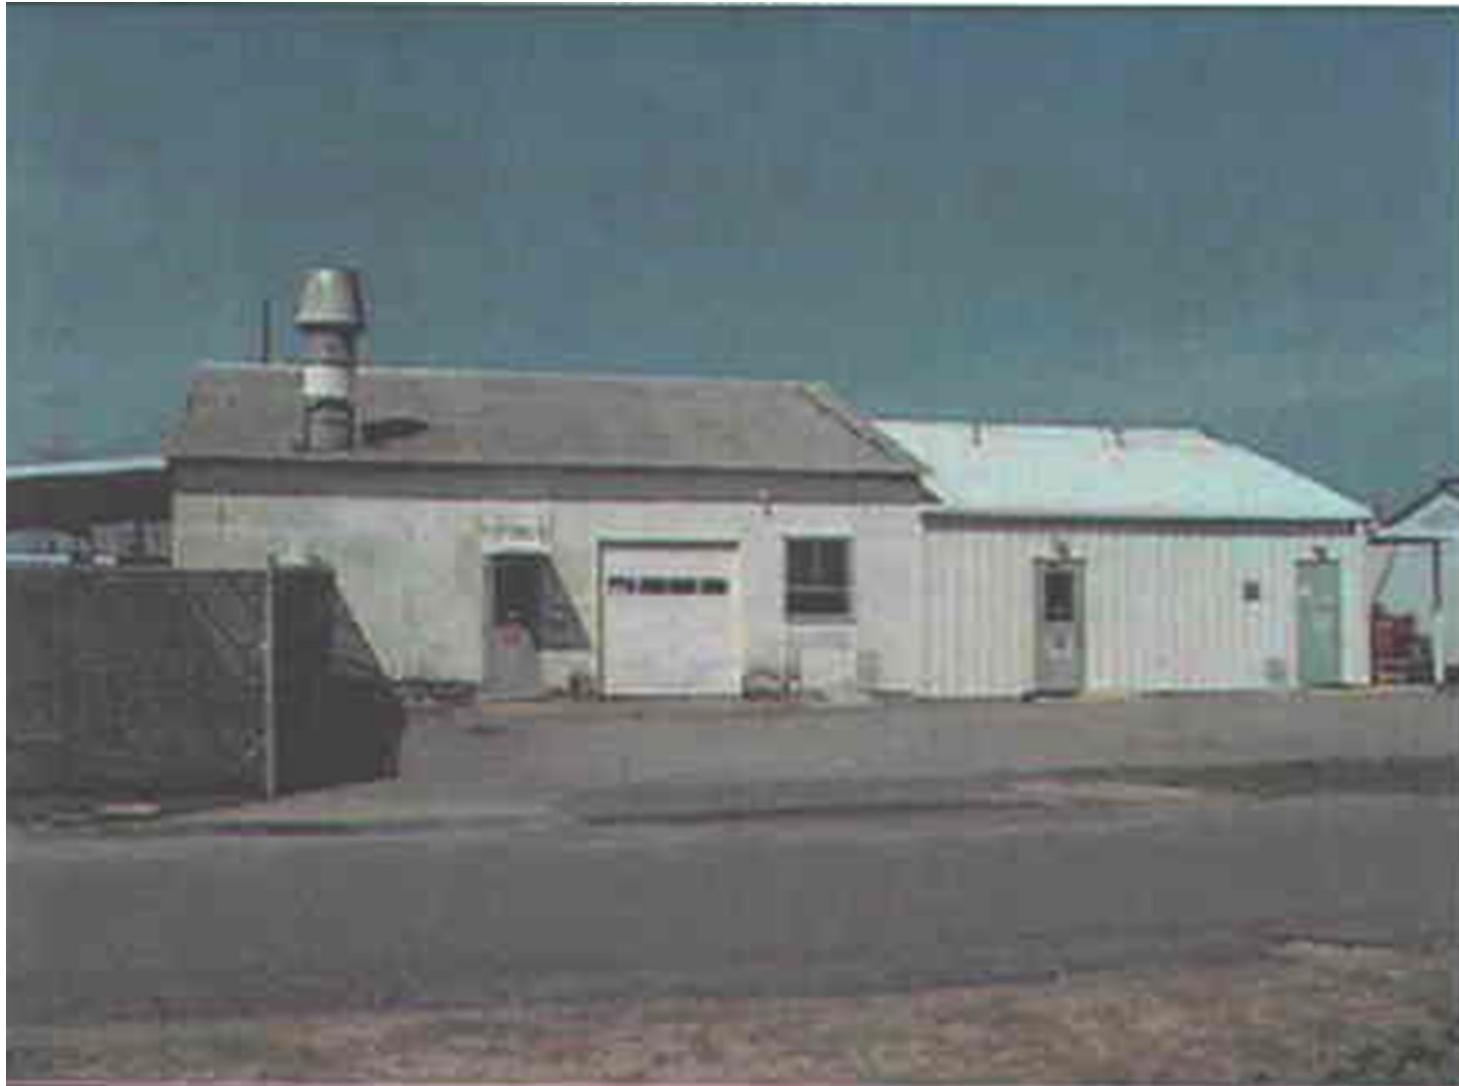
Figure 11. Building 725-A, Before Decommissioning

place and penetrations greater than two inches in diameter were grouted. Before and after photographs of the decommissioning activities are captured in Figures 11 and 12, respectively. The remaining concrete slabs have been prepared to drain, all protrusions have been cut, and open ends have been permanently closed. A below grade sump in the janitor's closet was filled with gravel. The sump was not in the process area and contained a steam condensate tank. Only steam condensate was managed in the sump. By process knowledge, there are no COCs associated with this sump. An evaluation of the residual chemical contamination present in the foundation has determined that the risk level is acceptable under the industrial worker scenario. The remaining structure is free of physical hazards, and the project cleanliness criteria have been met. Therefore, the DPFRR concluded that further action by SRS is not warranted. No long-term stewardship activities were identified for the structure because it poses no threat to human health or the environment.

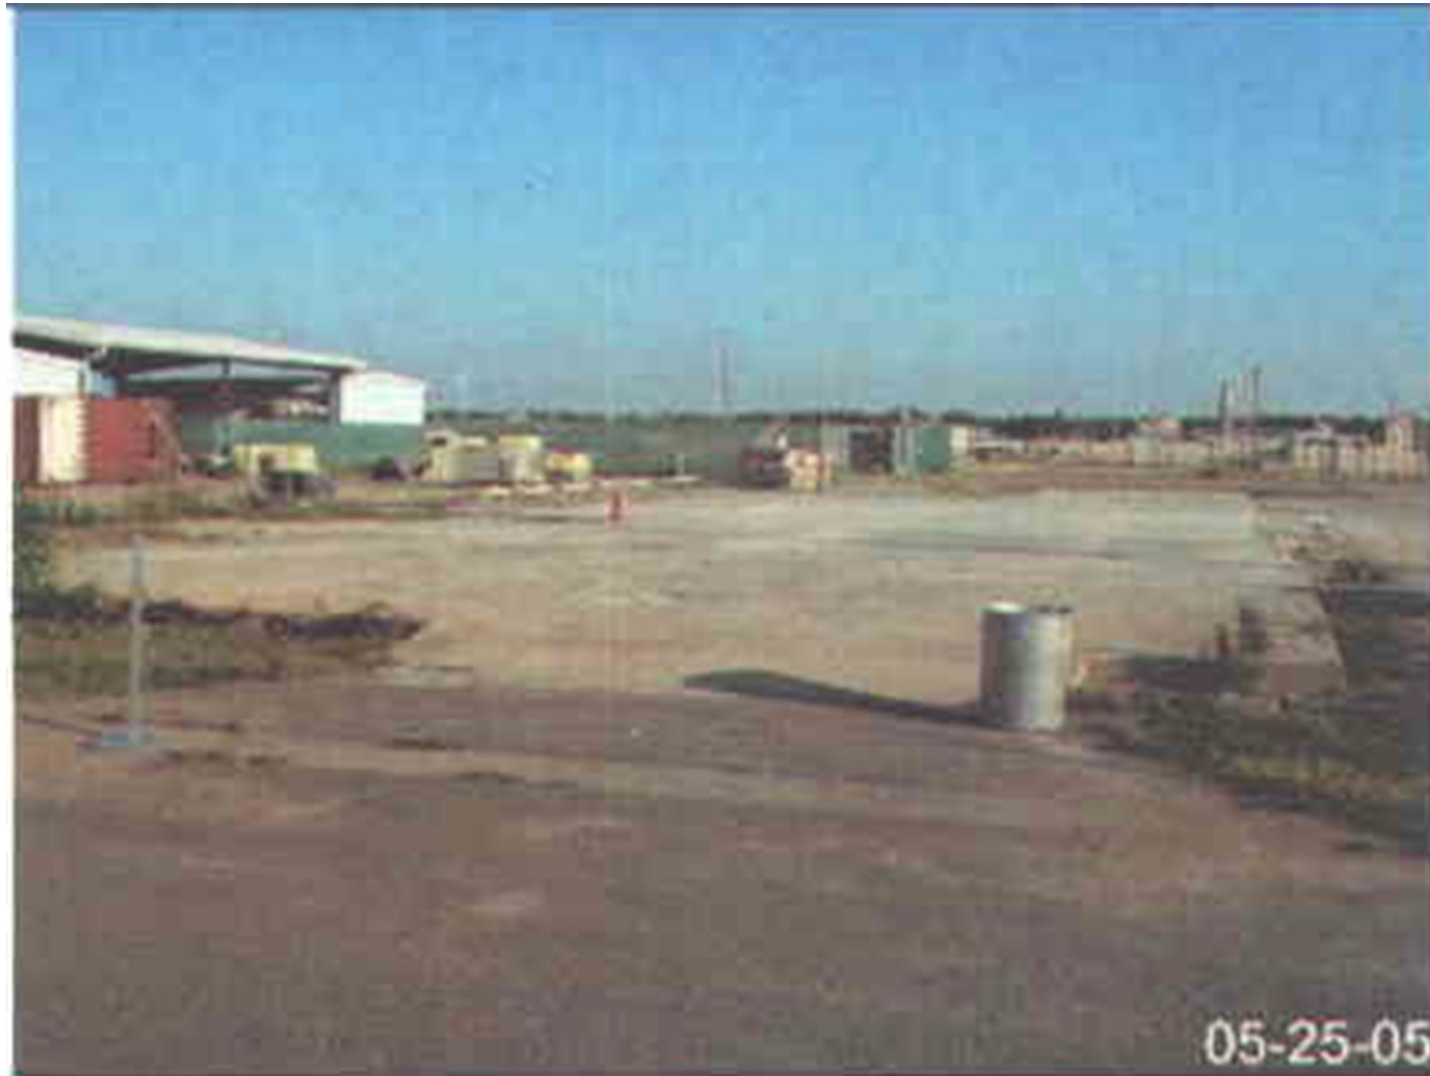
Figure 12. Building 725-A, After Decommissioning

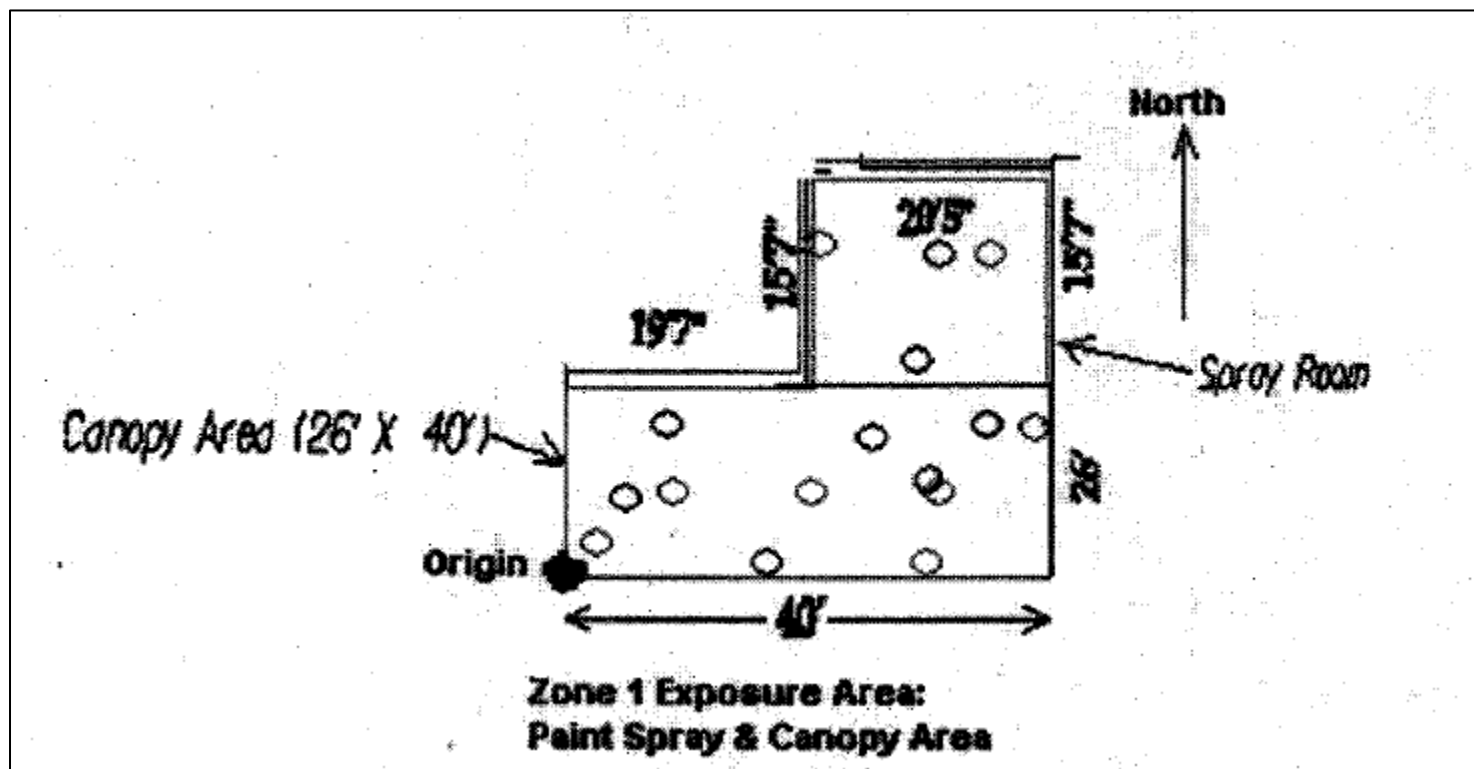
Figure 13. Sample Locations in Zone 1 Exposure Area for Building 725-A (WSRC 2005e)

Zone 1, Zone 2, and Zone 3 exposure areas are shown in Figures 13, 14, and 15, respectively.

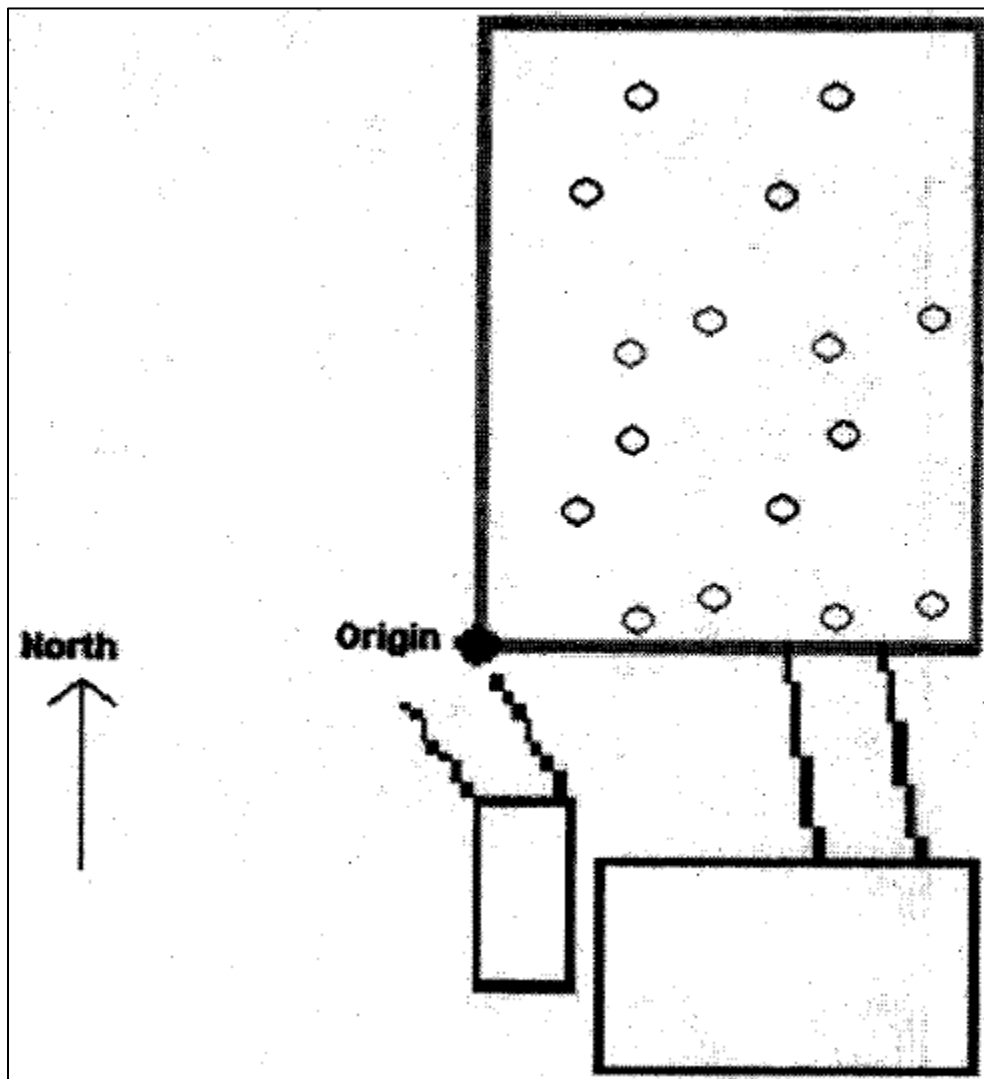
Figure 15. Sample Locations in Zone 3 Exposure Area for Building 726-A (WSRC 2005e)
