Scoping Summary for the Automotive Repair Shop (716-A) Operable Unit (U) (Post-Work Plan Characterization)

SRNS-RP-2023-00820

June 2025 (Final)

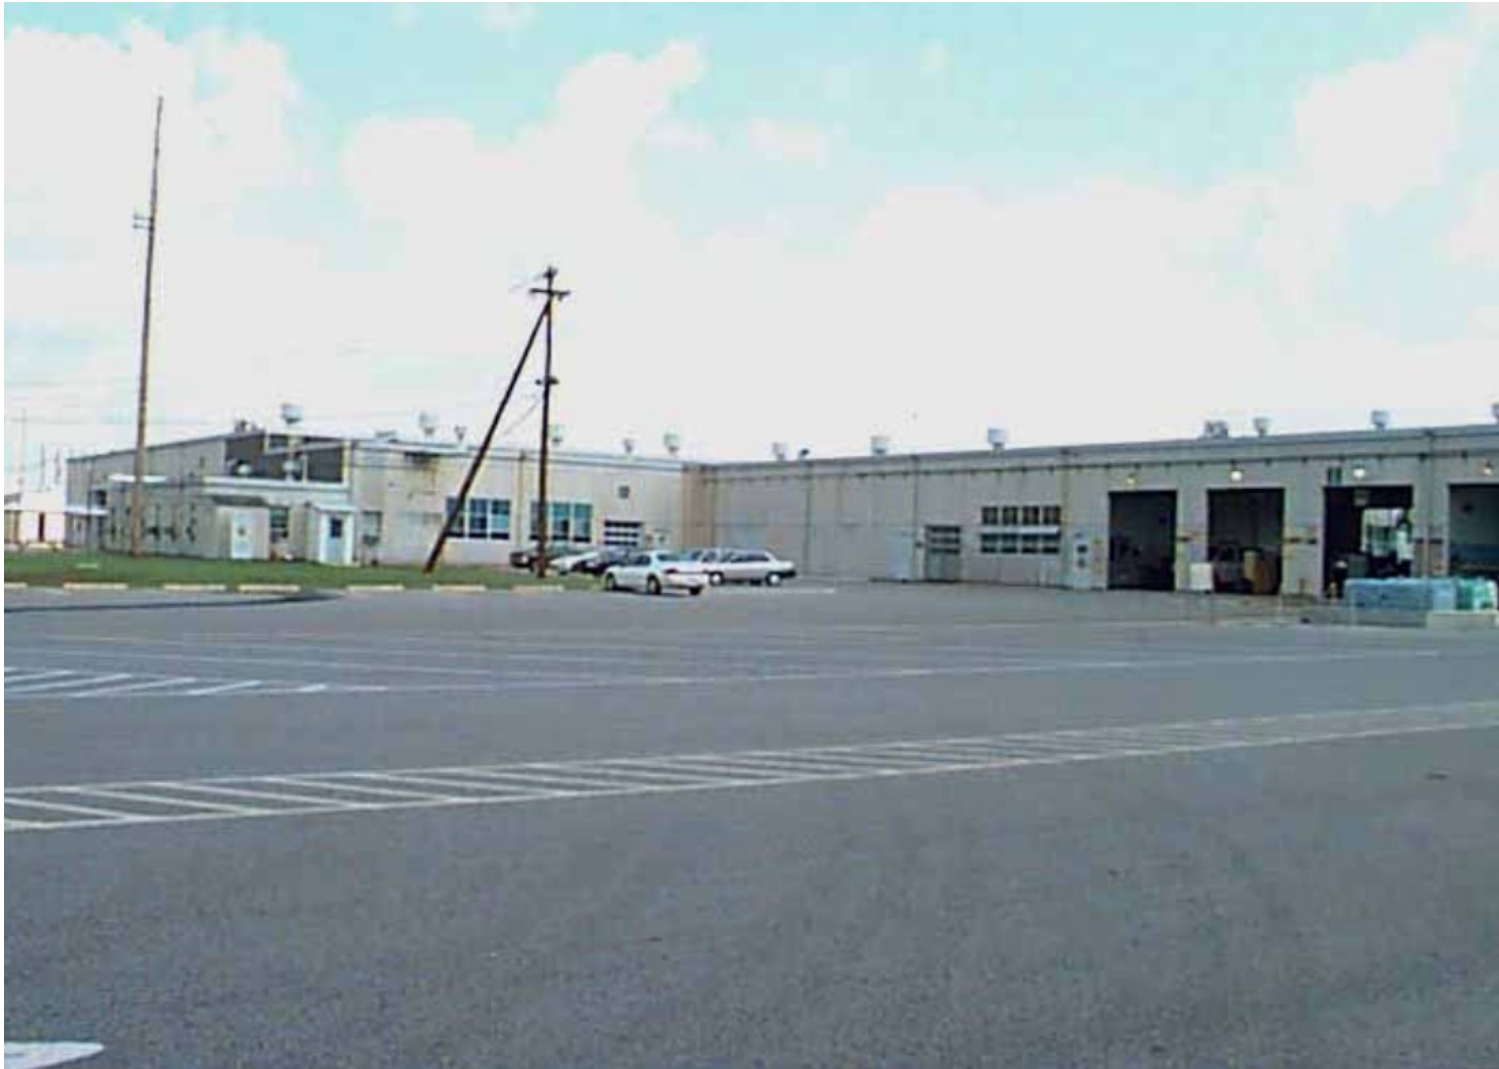
Figure 4. Automotive Repair Shop (716-A) OU Before Decommissioning

The *Facility Decommissioning Evaluation Automotive Repair Shop, 716-A* (Westinghouse Savannah River Company [WSRC] 2005b) categorized the building as an “Other Industrial” Hazard Category facility and identified the ISM as the appropriate decommissioning model for this potentially contaminated facility. Characterization was accomplished using a combination of process knowledge/historical release information, verification walkdowns, and sampling, as appropriate. A review of the Occurrence Reporting and Processing System/Site Item Reportability Issue Management database from 1993 to 2005 indicated no evidence of any spills to the environment. However, motor oil stains were found in the maintenance areas, lubrication pit (Room 103) (Figure 3), side trench, hydraulic lifts, cylinders, and narrow trenches. Fluid/oil stains were removed during decommissioning and the trenches and sumps were sampled to verify contaminants were less than the applicable Savannah River National Laboratory Derived Concentration Guideline Levels (DCGLs) (WSRC 2005a). Based on process knowledge, chemical operations took place only in the spray paint room (Figure 3). Therefore, the post-decommissioning final verification survey would be restricted to the spray paint room. Contaminants of concern (COCs) included lead, chromium, and volatile organic compounds (VOCs).

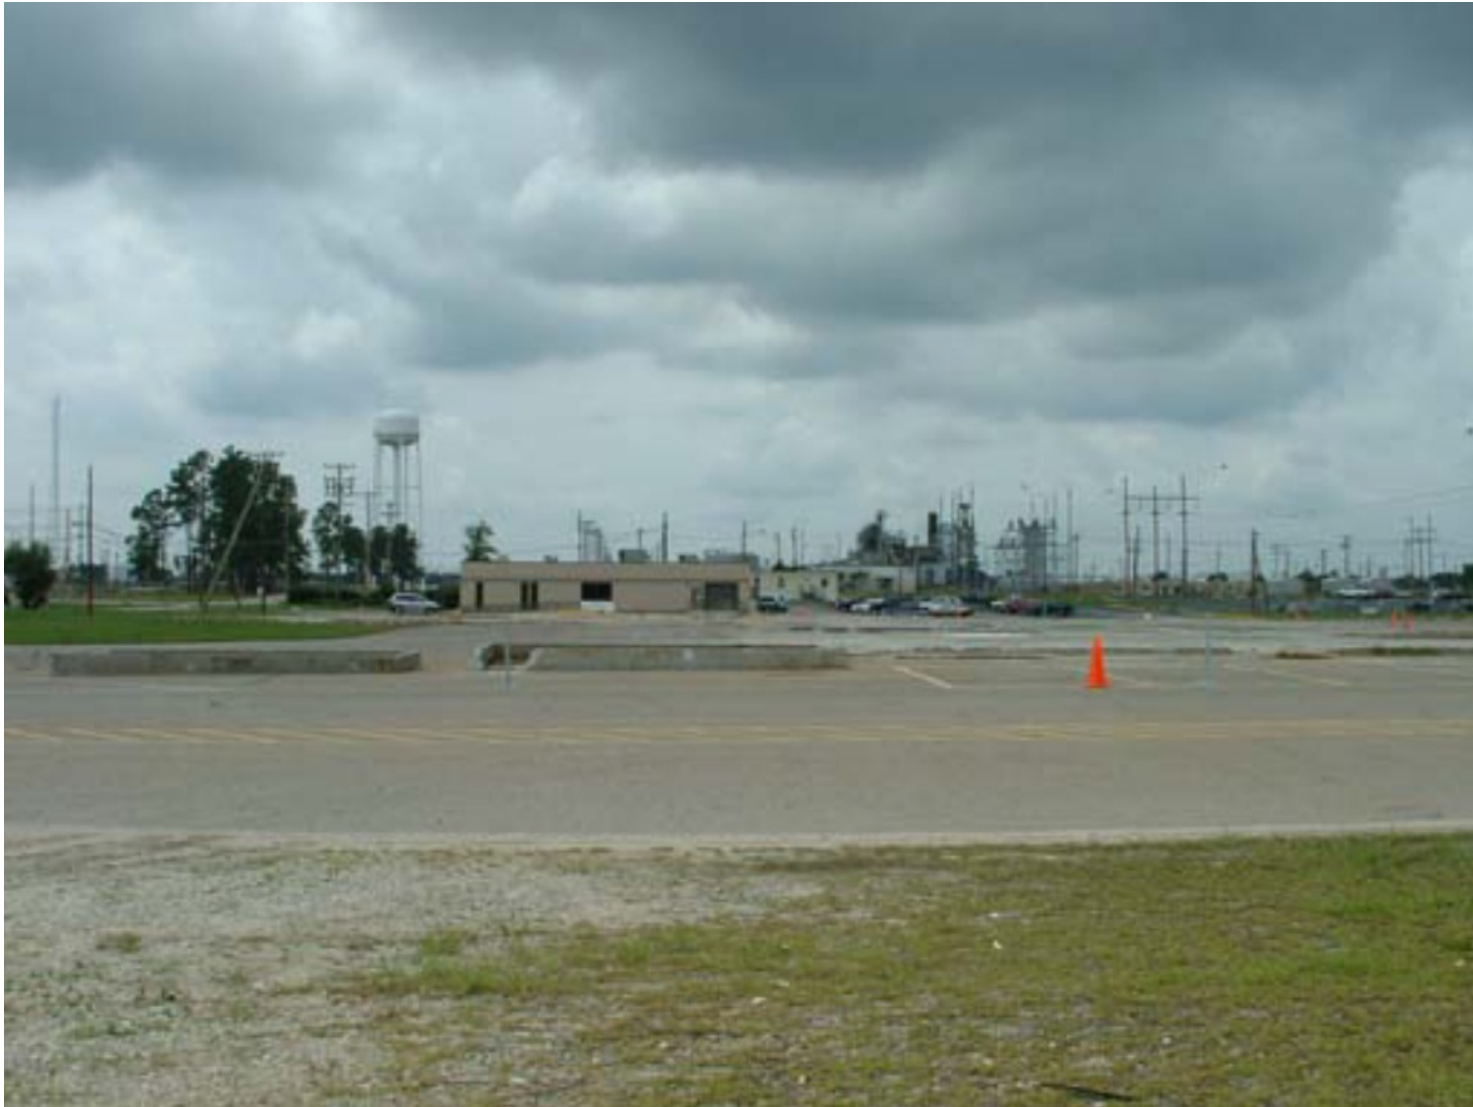
Figure 5. Automotive Repair Shop (716-A) OU Slab After Decommissioning

The DPFR concluded the building structure decommissioning activities have been completed, including waste disposal in accordance with federal and state regulations. The building structure was demolished to the foundation. The clean concrete slab remains on its original footprint and penetrations greater than 2 inches in diameter were grouted, including all pits associated with the automotive hydraulic lift systems. Before and after photographs of the decommissioning activities are captured in Figure 4 and Figure 5, respectively. The DPFR concluded that the remaining structure was free of hazards, both physical and chemical, and therefore, warrants no further action. No long-term stewardship activities were identified for the structure because it posed no threat to human health or the environment.

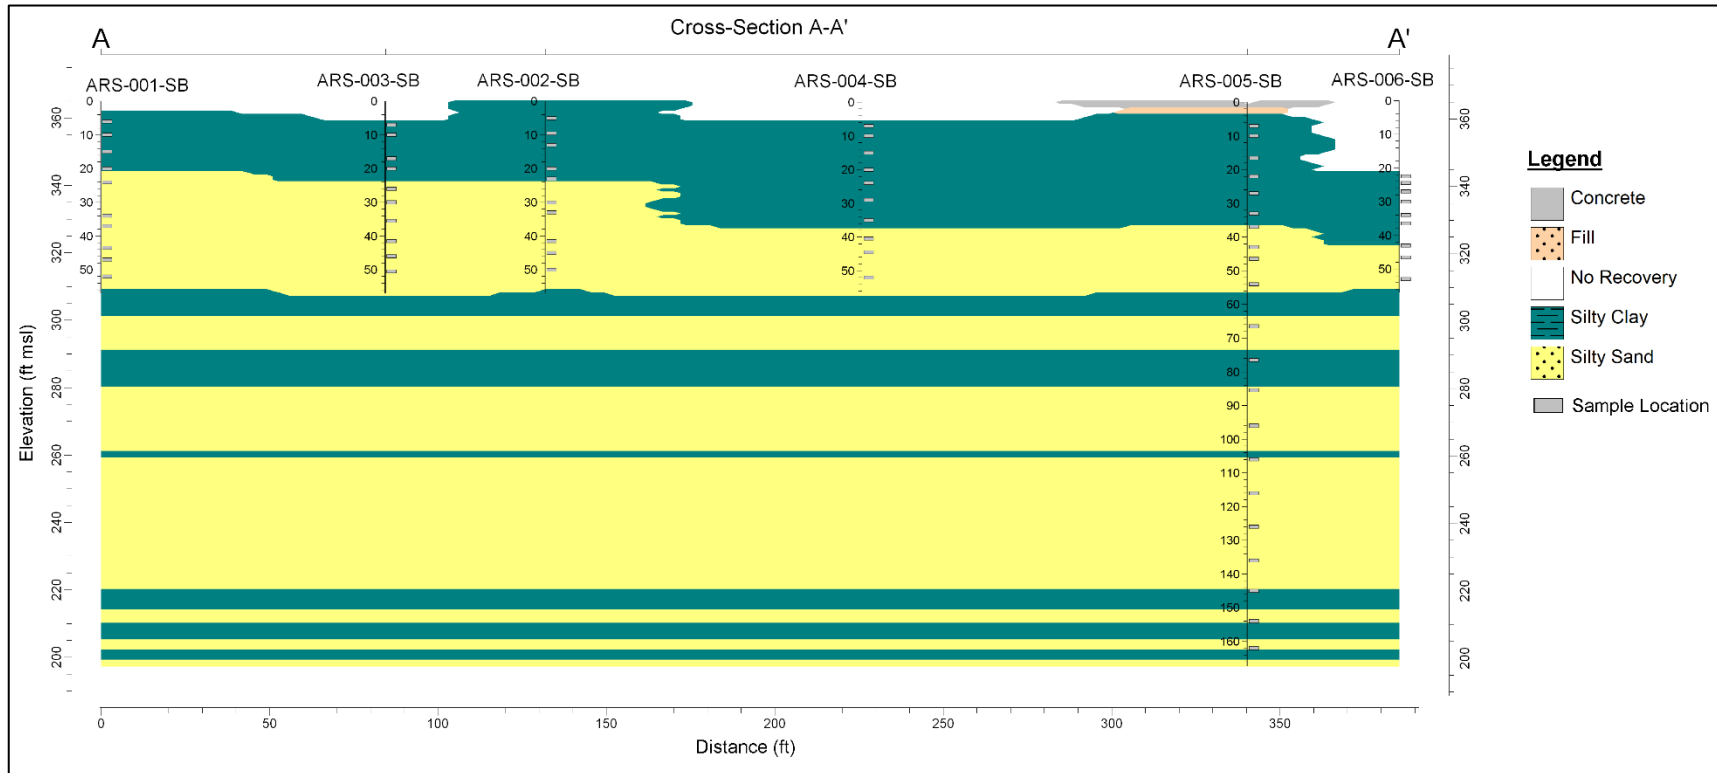
Figure 7. Automotive Repair Shop (716-A) OU Soil Cross-Section with Sample Depths
