Decommissioning Project Final Report Building 454-D, D-Area Diesel Fuel Tank

Appendix A – Before and After Photos of the Facility/Structure

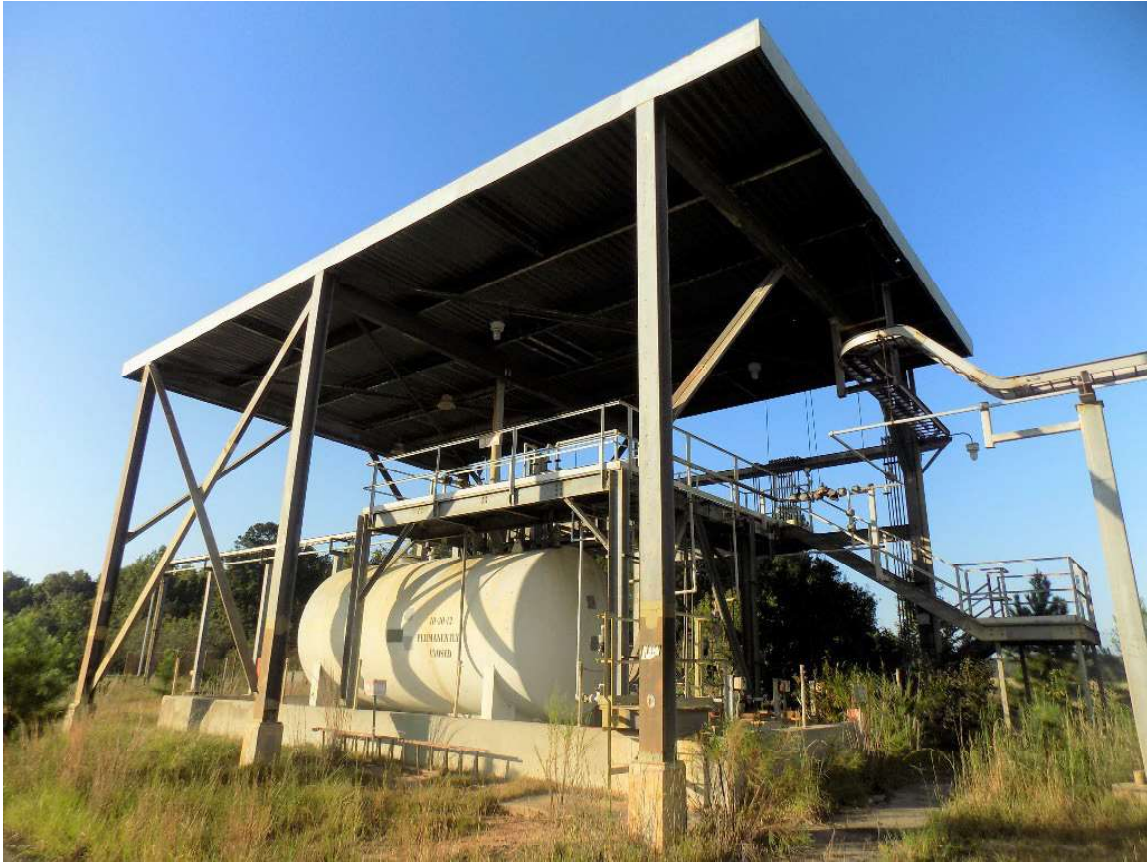
Figure A-1. Building 454-D (Looking East) Before

Building 454-D was erected circa 1990. The fuel oil tank was a 15,000-gal, carbon steel tank. The tank was mounted on two cradle mounts inside a containment dike. The containment dike was cast-in-place concrete. The inner dimensions of the containment dike were approximately (~) 20 feet (ft)-6 inches (in.) by 43 ft-4 in. The walls of the containment dike were ~12 in. thick while the slab was ~8 in. thick. The sump walls and floor were 12 in. thick all around. The fuel oil tank was mounted on separate foundation supports above the slab of the containment structure. The foundation supports extended below the slab of the containment. The bottom of the containment dike slopes to the northwest corner with an approximate slope of 1/8 in. per ft. The sump in the northwest corner of the containment dike was ~3 ft wide on each side and 3 ft deep. The sump pump was off-center to the northwest in the sump. Within the confines of the containment dike were three transfer pumps (removed during deactivation in 2014) for the fuel oil, three discharge filters and associated piping, fittings, and conduit (Reference 8.04). Controls and indications were outside the containment dike. There was a mezzanine above the fuel oil tank for access to the flanges at the top of the tank. The tank also had a 24-in. manhole at the south end of the mezzanine. Access to the mezzanine, as well as the confinement area itself, was via steps and stairs in appropriate locations. There were two sets of steps over the containment dike to allow access within the containment area. The whole of the structure had a pole supported roof that provided some protection from the elements. Lighting was installed in the roof of the structure. The major materials of construction for the mezzanine and roof, as well as supports for each, were galvanized and painted carbon steel.

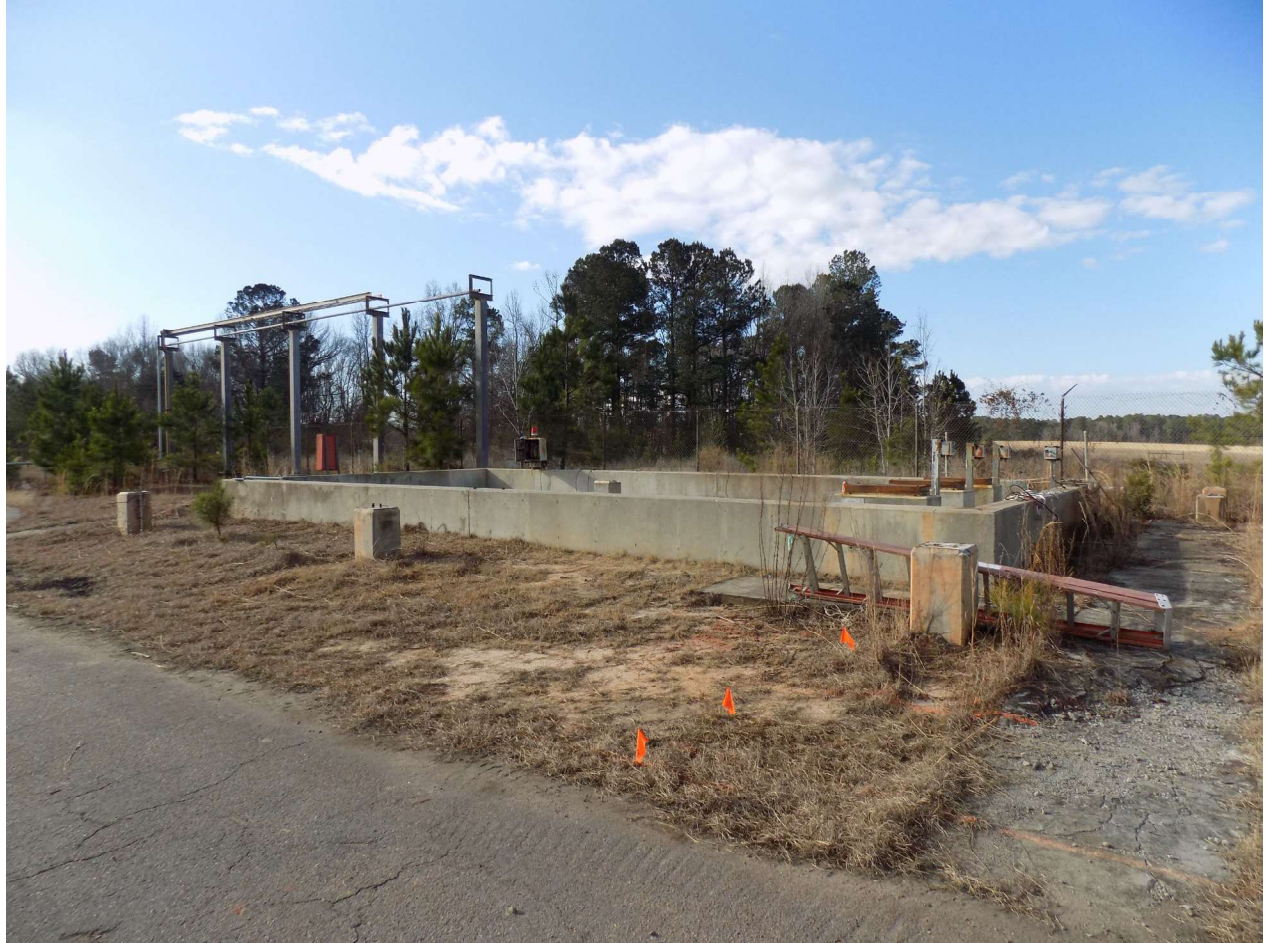
Figure A-2. Building 454-D (Looking East) After Partial Decommissioning by CRO

Building 454-D was partially decommissioned by CRO in accordance with their agreement with the Department of Energy Savannah River Site Operations Office (DOE-SR). The 454-D mezzanine structure and diesel fuel tank were D&R down to the concrete slab by CRO. The remaining decommissioning activities for Building 454-D and its ancillaries were completed by CTI and Associates, Inc. All appurtenances and the cable trays and conduit/piping supports were D&R to grade or concrete slab, as applicable. The concrete slabs were verified to be free of equipment, structure, rubble, waste, and debris. The 454-D and 454-1D sumps were filled to the top of sump elevation with gravel. All interfacing utilities were isolated, disconnected, and plugged. Resulting holes were plugged and grouted. Any surrounding soil that was disturbed during decommissioning was raked and cleared of debris. The decommissioning was confirmed complete in the FAI-51 walkdown performed on 6/15/2022 (Reference 8.02).

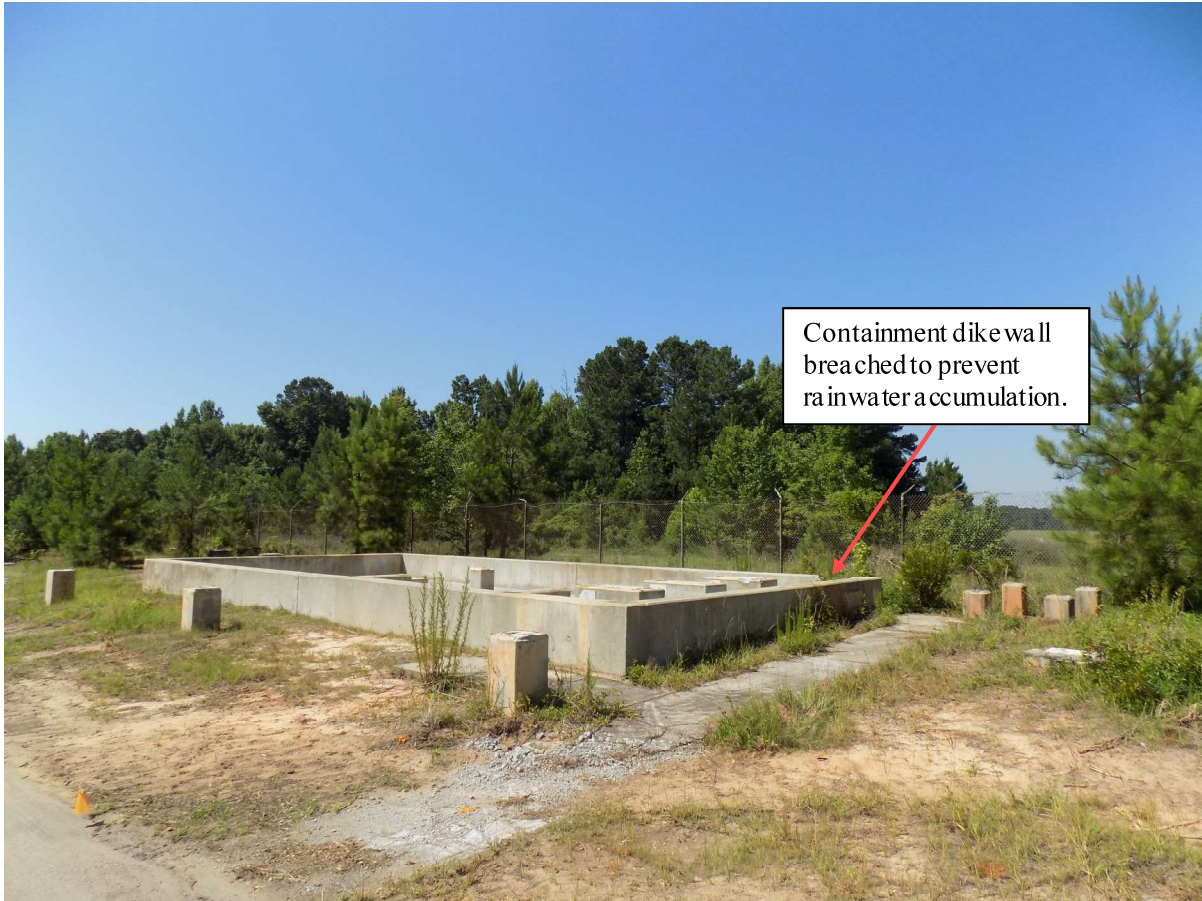
Figure A-3. Building 454-D (Looking East) After Final Decommissioning

The remaining structures (concrete slabs, concrete tank bases, concrete pump bases, and surrounding concrete dikes/curbs) are free of physical, chemical, and radiological hazards; therefore, they need no further decommissioning action. No surveillance and maintenance (S&M) activities were identified for the remaining structures because they pose no threat to human health or the environment while awaiting area completion.

Building 454-D and its ancillaries were demolished and the remaining concrete slabs, concrete tank bases, concrete pump bases, and surrounding concrete dikes/curbs have been left in place. All decommissioning activities have been completed in accordance with federal and state regulations, and CRO's agreement with the DOE-SR. The remaining structures are free of physical, chemical, and radiological hazards; therefore, they need no further decommissioning action. No S&M activities were identified for the remaining structures because they pose no threat to human health or the environment while awaiting area completion.

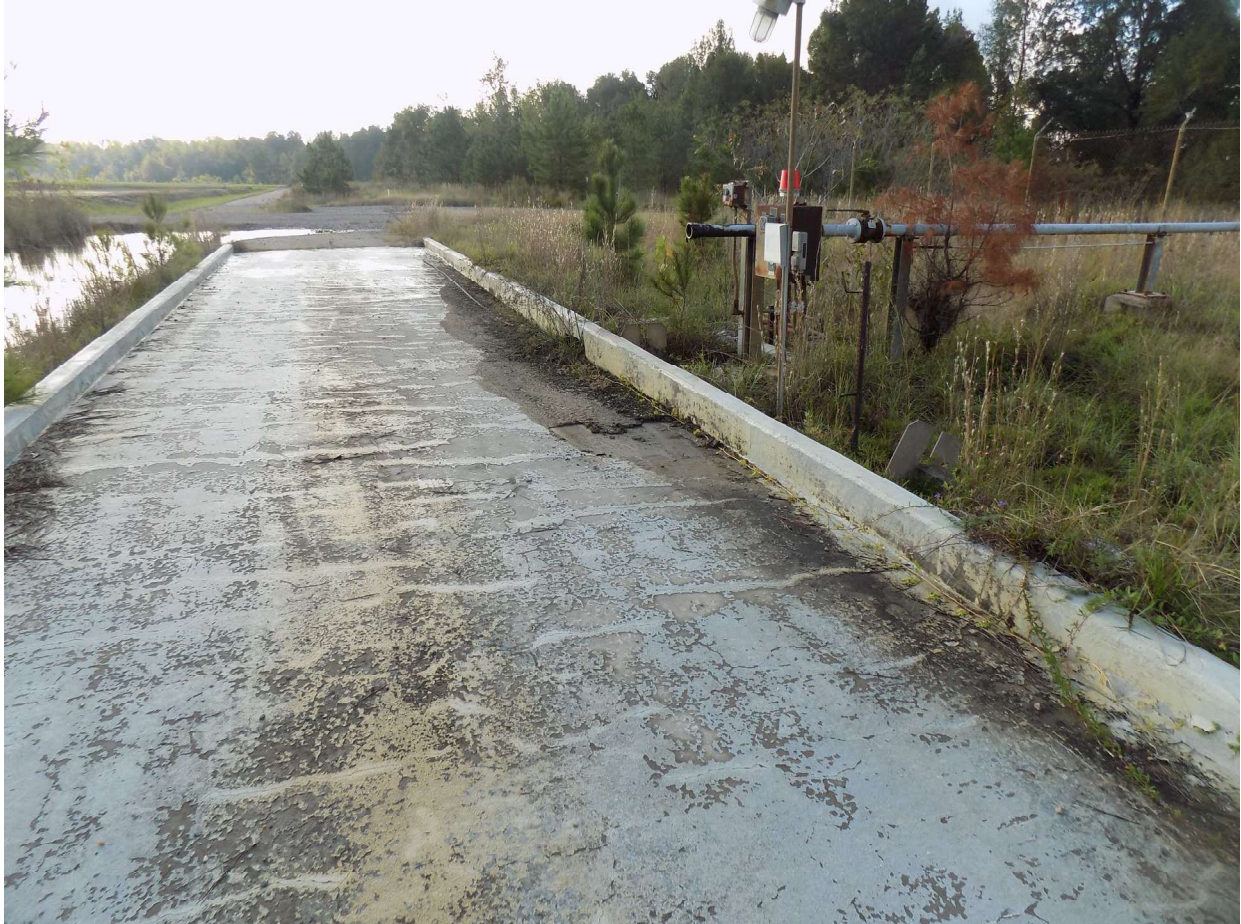
Figure A-4. Building 454-1D (Looking South) Before

The 454-1D Diesel Fuel Unloading Facility was also erected circa 1990. The concrete pad for the unloading station was ~63 ft long by 13 ft wide. Included in the width were 6 in. wide curbs that ran the length of the pad on either side. The curbs were 6 in. high at the ends of the pad and maintained a constant elevation the length of the pad. The unloading facility equipment was ~26 ft-6 in. south of the north end of the pad, on the west side. This included the tanker connection, a spill box for catching small amounts of fuel oil spilled during connecting and disconnecting the tank truck, and a sump for catching spills of fuel oil from the pad. The entire pad at the unloading station slopes to the location of the sump. The opening in the curb that passes to the sump was 6 in. below the elevation at the north and south ends of the unloading station slab as well as the east side. The unloading facility sump was 4 ft on each of the sides and 4 ft deep. The sump pump was centered in the sump. Other than reinforced concrete, the major materials of construction were painted and galvanized steel. Controls and indications were located at the station. Power to the facility was disconnected during deactivation (Reference 8.04).

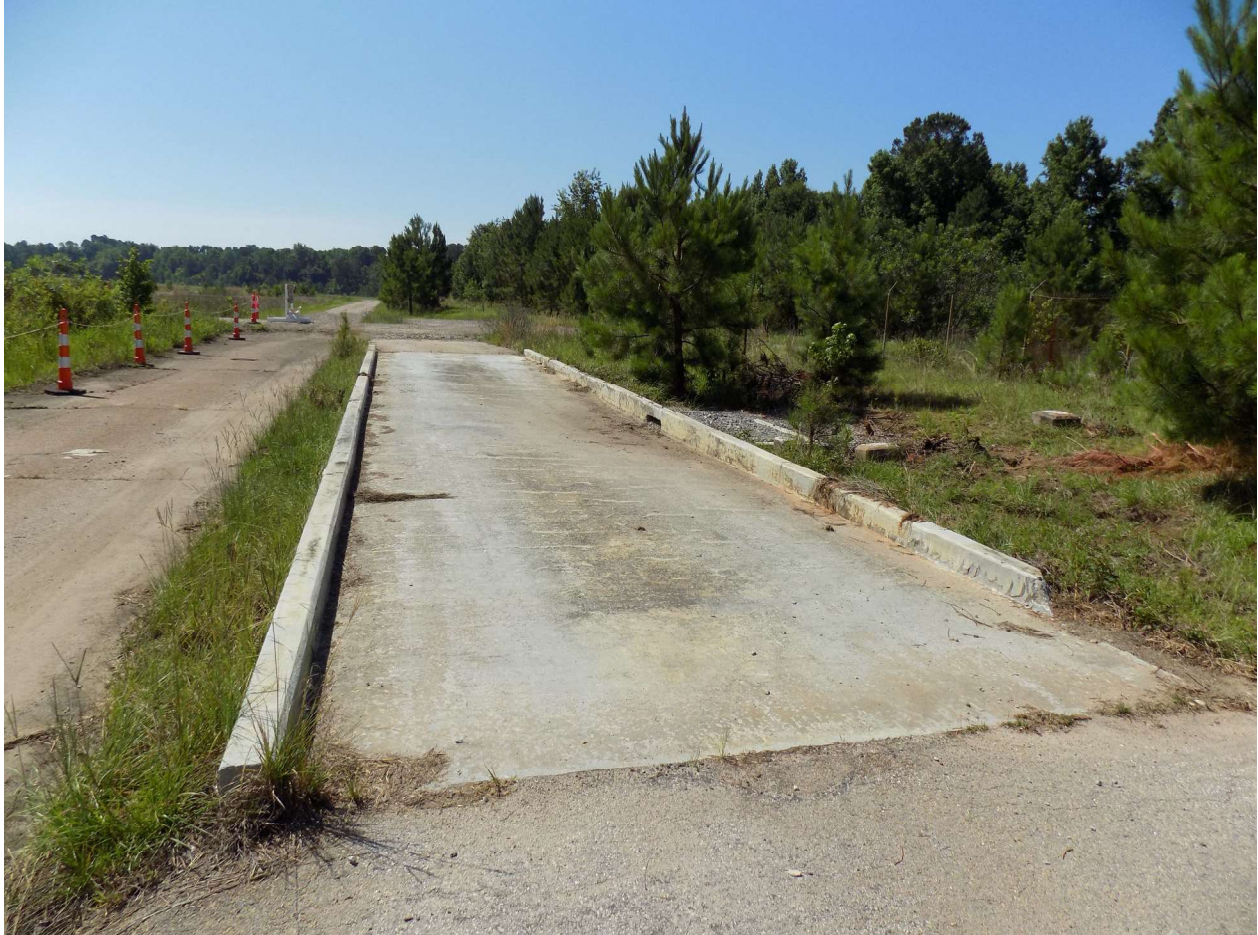
Figure A-5. Building 454-1D (Looking South) After
