EC&ACP Sampling Platform Proposal

Proposal

Attachment 1 – Sampling Platform Photos

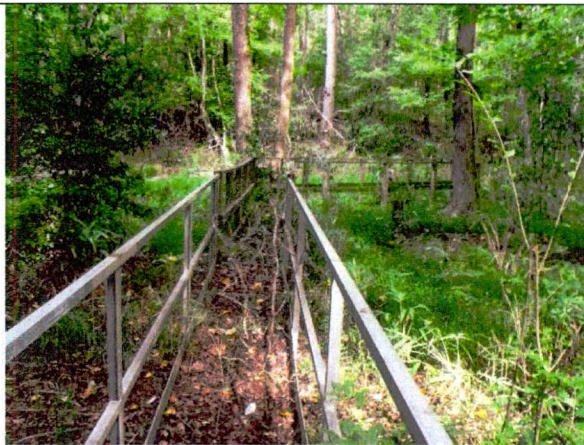
606-23G (Metal and Wood Platforms)

- 606-23G – no walkdown, only viewed photographs provided by others. Photographs indicate the elevated walkway may be located in jurisdictional waters at an unknown wetland location.
- 904-105G – located in the D Area Discharge Canal, no jurisdictional waters.
