## Facility Decommissioning Evaluation Building 484-9D, D-Area Valve House

This is a Simple Model Decommissioning per Facility Disposition Manual 1C

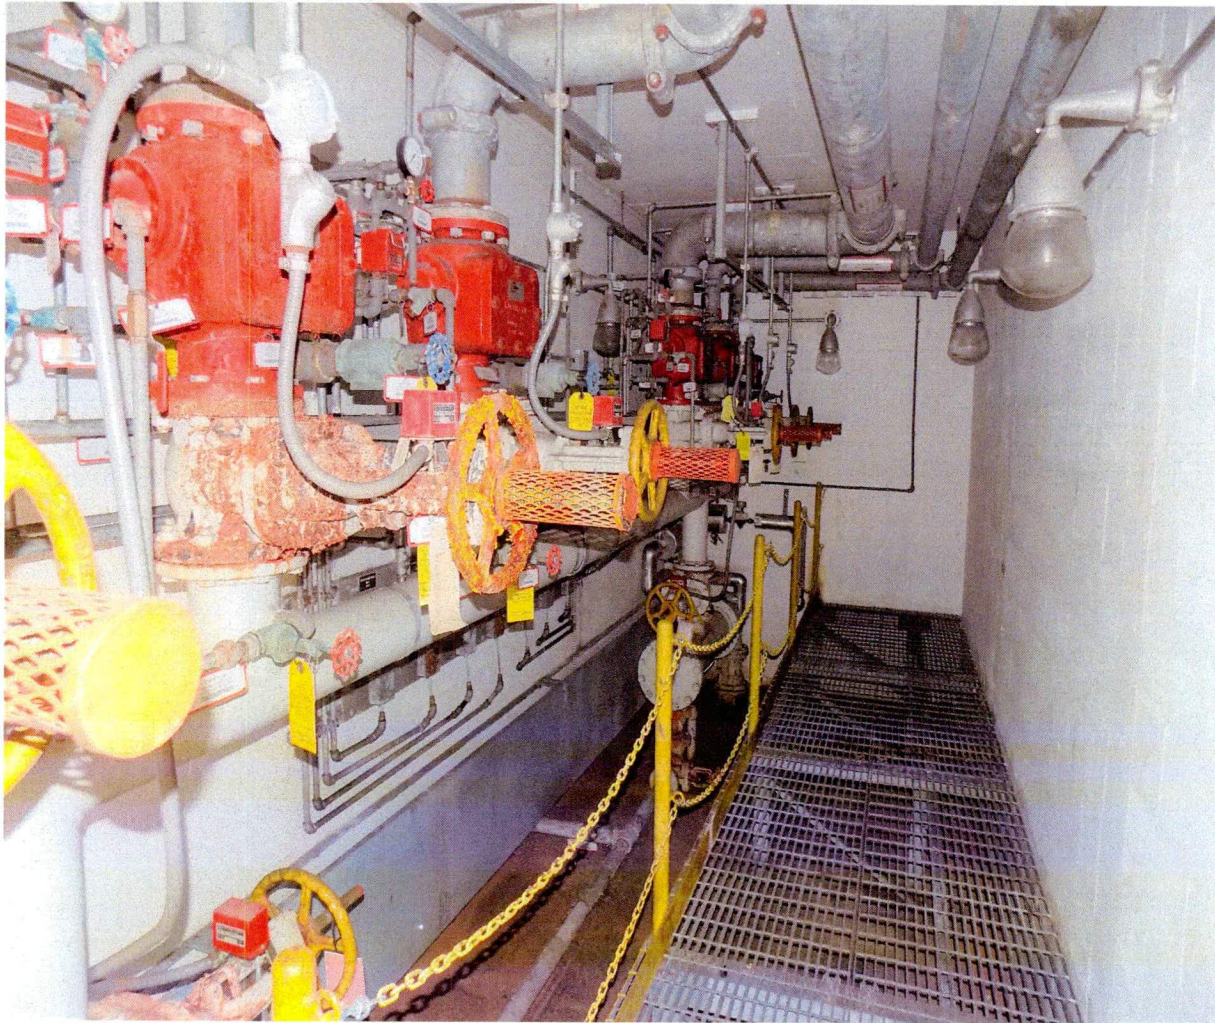
**Figure 6. 484-9D Valve Room (Looking East)**

The valve room (Figures 4 & 6) has a catwalk running along the south wall. Along the north wall are the fire water deluge pipes and valves, pressure switches, instrument air system lines and steam lines. The fire water lines, cat walk, pipe hangers, and personnel shield for the steam piping and radiators are galvanized steel. The steam lines are carbon steel and are partially insulated. The air lines are carbon steel. The 6" fire water control valves were air actuated with electrical position indicators. There is a wall mounted space heater (electric), which has been electrically isolated, above the entrance to the valve room. Lighting in the valve room was provided by eight (8) wall-mounted incandescent lights, which have been electrically isolated.

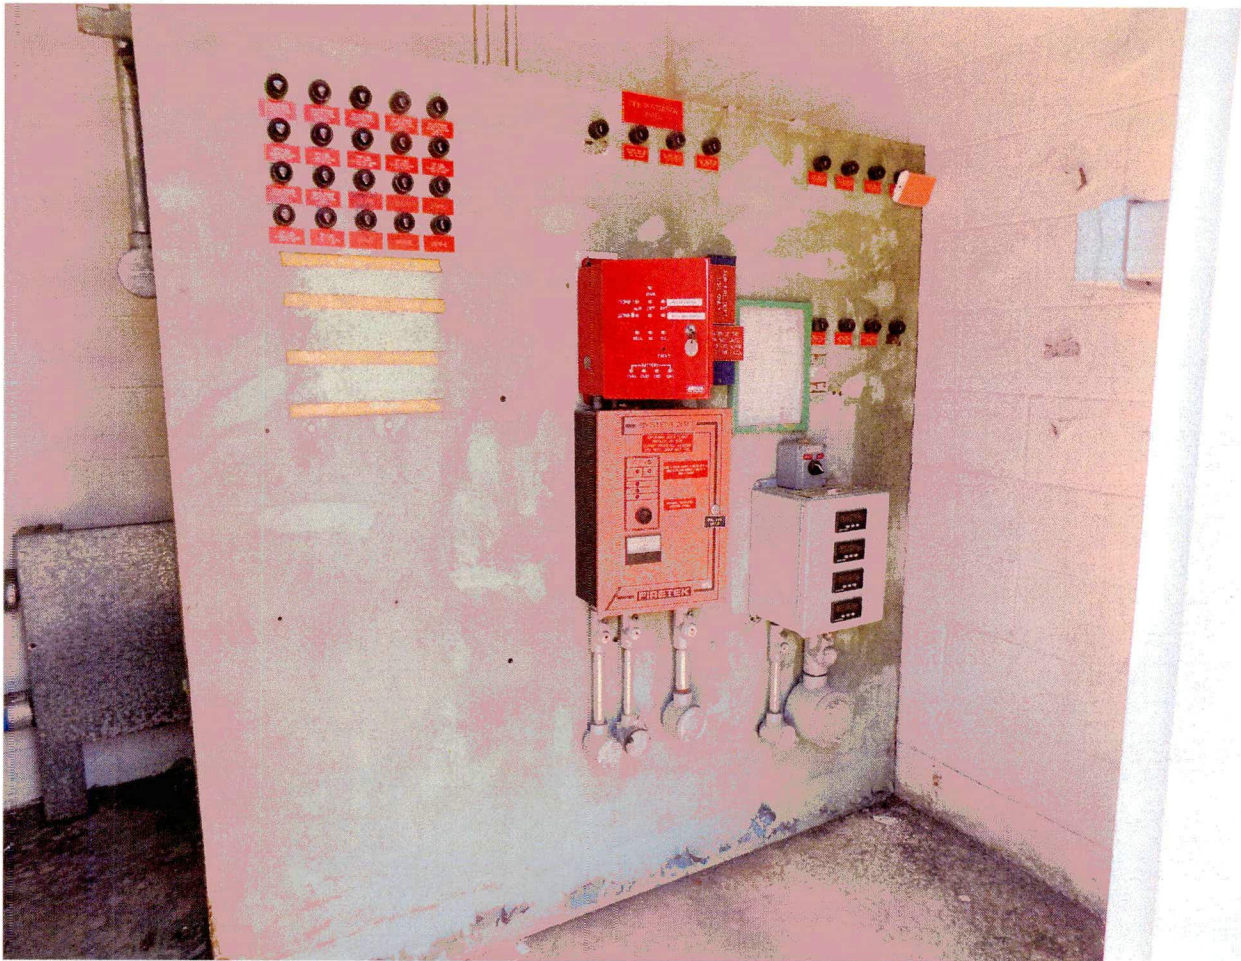
**Figure 7. Fire Panel and Control Room (Looking Northeast)**

The Alarm Panel and Control Room (Figures 4 & 7) contains the Panalarm® fire control panels, pull stations, system annunciator panels, battery backups, switches and relays, and other fire control devices necessary for the system, all of which are now isolated, but not “air-gapped” to render the facility “cold and dark.” A single ceiling-mounted incandescent light, which has also been electrically isolated, provided lighting for the Alarm Panel and Control Room. There is a leak in the ceiling of the Alarm Panel and Control Room.

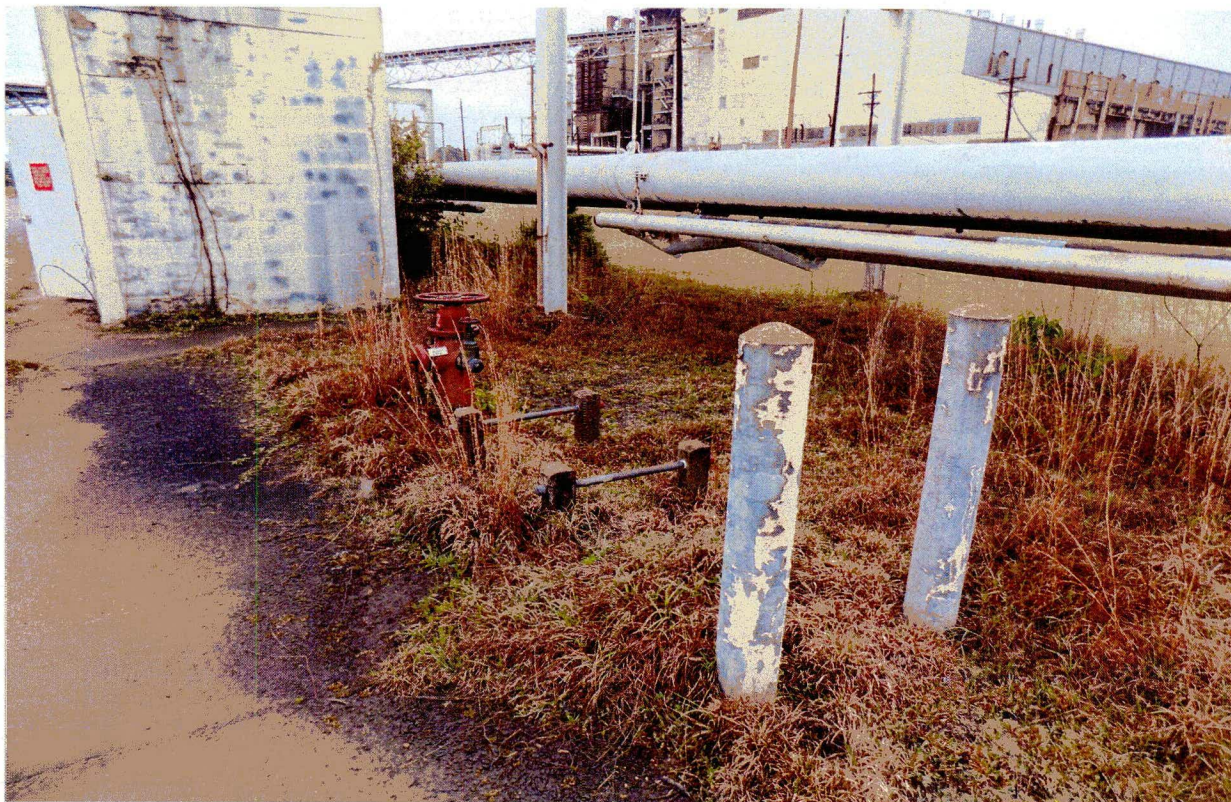
**Figure 8. Building 484-9D Hydrant, Support Frame and Bollards**

To the east of Building 484-9D is a fire hydrant, a support frame for a fire hose box, and two bollards (Figure 8). The hydrant is a standard fire hydrant. The hose box supports consist of steel bars running between reinforced concrete posts. The bollards are standard 4" galvanized, concrete-filled pipe bollards extending about 42" above grade. The hydrant, support frame and bollards are ancillary to Building 484-9D and within the scope of this decommissioning.
