**H-AREA HAZARDOUS WASTE MANAGEMENT FACILITY (BLDGS. 904-44G, 904-45G, 904-46G AND  
904-56G) FIELD INSPECTION CHECKLIST**
**WORKING COPY**

MAP OF H-AREA HAZARDOUS WASTE MANAGEMENT FACILITY  
 BLDG. 904-44G, 904-45-G 904-46-G & 904-56G

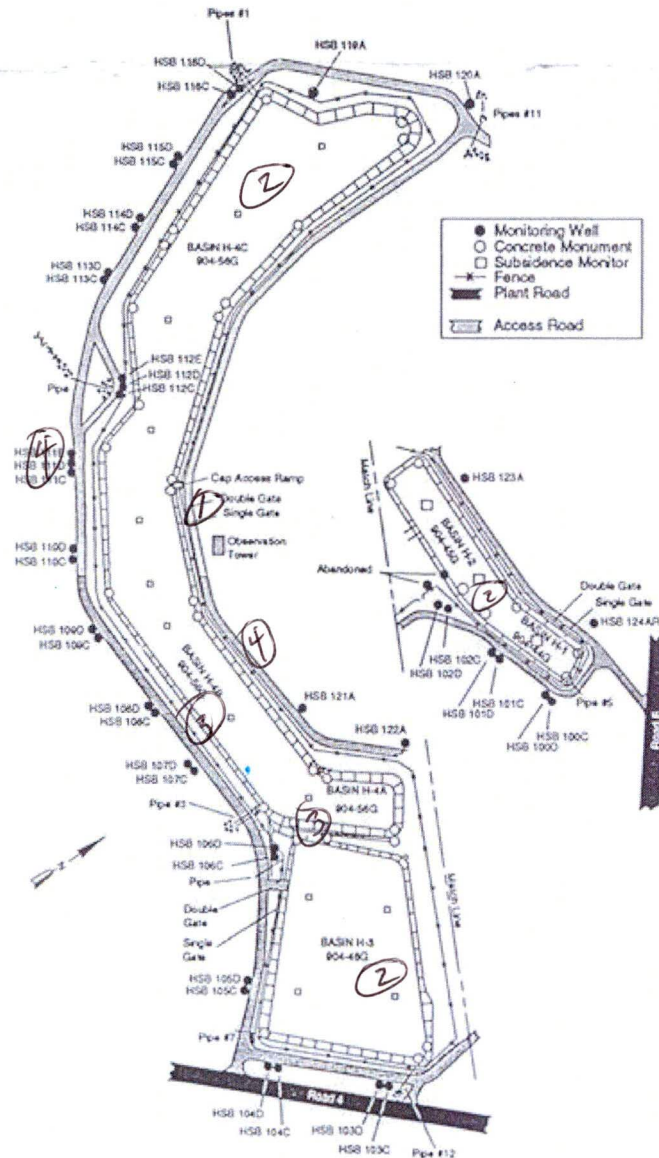
A = Satisfactory X = Unsatisfactory (Explanation required)	A or X	Observation/Corrective Action Taken
2. Verify that the waste unit signs are in acceptable condition, have correct information and are legible from a distance of 25 feet.	X	CARRY OVER ITEM: WASTE UNIT SIGN NEEDS REPAIRING. SEE MAP NOTE (1). REF MAINT. Register PL-2017-00

5. Inspect closure cover for erosion, abnormal soil cracks, depressions or ponding indicating subsidence.	A	
6. Check for signs of burrowing animals.	X	ACTIVE ANT MOUNDS ON SOIL COVER. SEE MAP NOTE (2). REF MAINT. Register PL-2017-00109

7. Check the integrity of drainage ditches inside and outside of the fence areas for excessive erosion and the presence of soil, sediment or debris restricting water flow.	X	SEDIMENT INSIDE DRAINAGE DITCHES NEEDS REMOVING. SEE MAP NOTE (3). DRAINAGE DITCHES OUTSIDE THE FENCE NEEDS BRUSH/TREES REMOVED. SEE MAP NOTE (4) REF MAINT. Register PL-2017-00110

NOTES: ① = CARRY OVER ITEM: WASTE UNIT SIGNS NEEDS REPLACING. A NEW SIGN WILL BE ORDERED FROM SHOP (SIGN SHOP) AND REPLACED.  
 ② = ACTIVE ANTS MOUNDS ON SOIL COVER. APPLIED 0.5 LBS OF EXTINGUISH ANT BAIT. ③ = SEDIMENT INSIDE DRAINAGE DITCHES NEEDS REMOVING. USFS WILL REMOVE. ④ = DRAINAGE DITCHES OUTSIDE THE FENCE NEEDS BUSH/TREES REMOVED. USFS WILL REMOVE.
