**ENVIRONMENTAL COMPLIANCE & AREA COMPLETION PROJECTS (EC&ACP) STANDARD  
OPERATING PROCEDURES, VOL. I**
**Manual:** C3  
**Procedure:** ER-IDS-019-022  
**Revision:** 3  
**Effective Date:** 06/01/2016  
**Type-Class:** Form  
**Page:** 1 of 5

**M-AREA HAZARDOUS WASTE MANAGEMENT FACILITY (BLDG. 904-51G) FIELD INSPECTION  
CHECKLIST**
**WORKING COPY**

13 M-AREA HAZARDOUS WASTE MANAGEMENT FACILITY (M-AREA SETTLING BASIN - 904-51G)

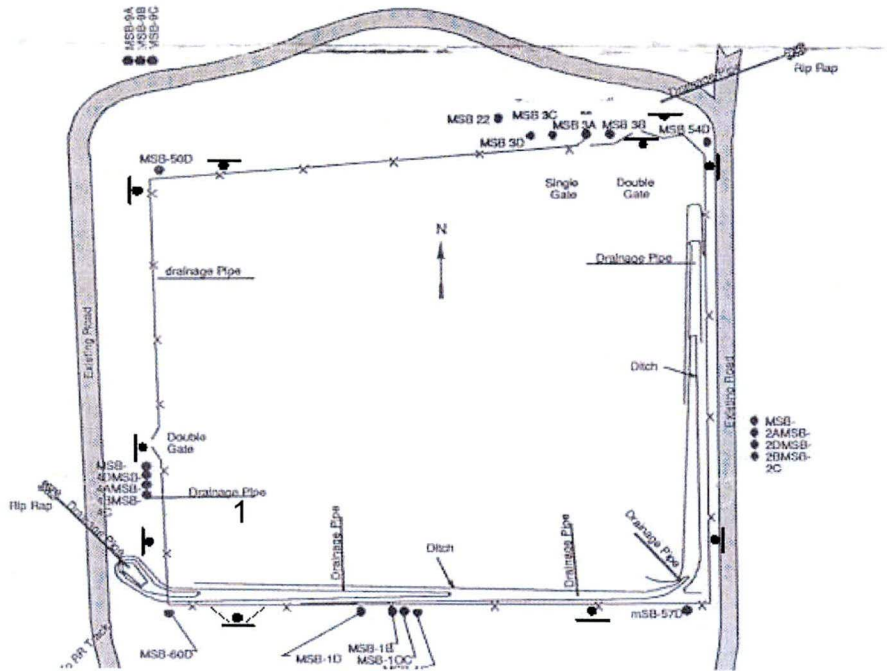
Map of M-Area Hazardous Waste Management Facility 904-51G

7. Check for excessive vegetation growing over fences, which may obstruct warning signs or visibility of inspected area.	A	
8. Check M-Settling Basin cover for signs of burrowing animals.	X	Active ant mounds on soil cover See map note:1 Ref Maint Register: PC-2019-00043

NOTES: 1=Active ant mounds on soil cover. Applied .25 lbs of extinguish and bait.

Active ant mounds on soil cover

Applied Extinguish ant bait.
