Facility Decommissioning Evaluation Building 483-3D, Electrical Control Building

This is a Simple Model Decommissioning per Facility Disposition Manual 1C

Introduction

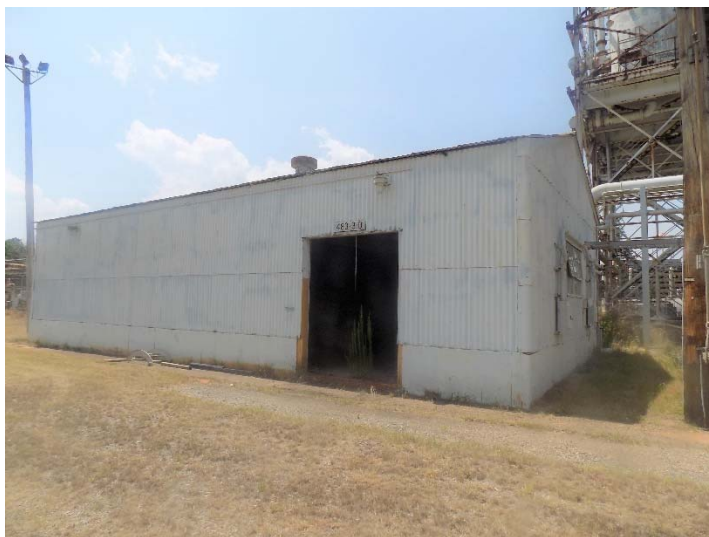
Figure 1. Building 483-3D, D-Area Electrical Control Building

Building 483-3D (Figure 1), Electrical Control Building, is at the southeast corner of the boiler and process water treatment facilities' Softener Building, 483-D, of D-Area in the Savannah River Site (SRS) (Figure 2). Note that Figure 2 shows the boundaries of the scope of this decommissioning in red dot-dash-dot outline. The blue dot-dash-dot line is a portion of the boundary for the boiler and process water treatment facilities (Buildings 483-D Softener Building, 483-1D Water Filtration and Treatment Plant, 483-2D Softener and Silica Absorber Building, and 487-D Process Water Storage Tank), another decommissioning project not within the scope of this evaluation. Construction of the building was completed and operations began circa 1952. The building is steel frame construction sitting on a concrete slab. The siding and roof are corrugated asbestos. The dimensions of the structure are 32.5' by 62.5' by 14' high (Figure 3). There is a 8.5' wide roll-up door on the south wall of the structure and a standard swinging door on the north wall of the structure. The building had electrical power supplied at 13.8 kilovolts (kV), which has been cut off and isolated. A Public Address system was present inside the structure. Heat to the structure used to be provided by overhead electric heaters inside the structure.

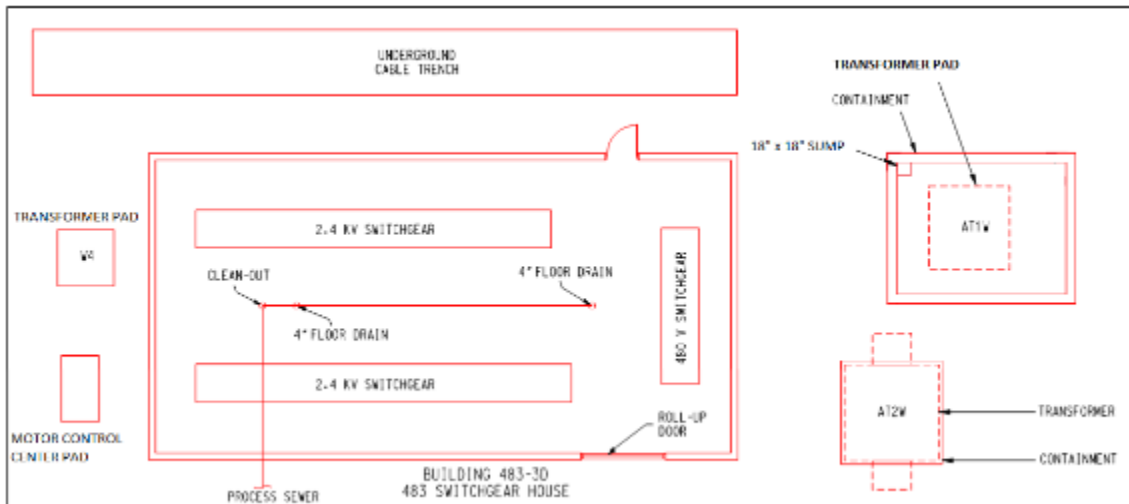
**Figure 3. Building 483-3D, D-Area Electrical Control Building Original Layout
 (The only equipment left to be removed is AT2W)**

Within the building there were three switchgear banks, all previously removed. Two switchgear banks were 2.4kV and the other was 480V. The 2.4kV switchgear banks were aligned east to west, opposite each other on the north and south sides of the structure. The 480V switchgear bank was aligned north-south on the east side of the structure. On each end of the 480V switchgear bank was an integral 2.4kV to 480V transformer. The northeast (AT1W) transformer pad has an empty cable tray that goes overhead to the west and enters Building 483-3D. Note that the scope of this decommissioning ends at the end of the north cable trench concrete slab. This is also the boundary for the conduit bridge that is mounted above the cable trench.

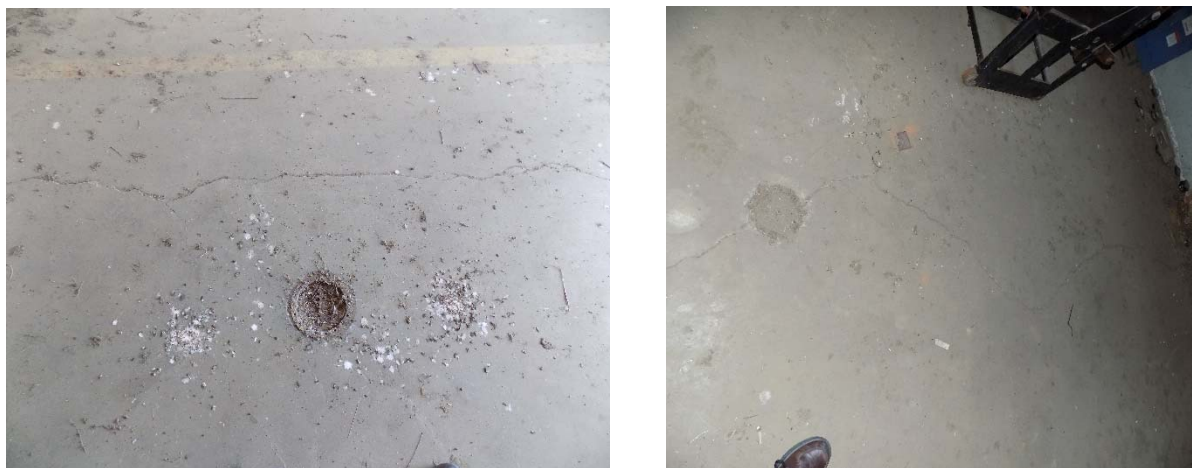
Figure 4. Floor Cracks In Proximity To Clean out And Drains

Inside the building are two floor drains and a cleanout. All are in line with the center of the building slab running east-west. The drains go to the area process sewer. It is noted that the building's concrete slab has cracks through the center of it. A crack in the slab passes within approximately 18" of the cleanout and another crack passes through the locations of both floor drains. However, the concrete cracks do not affect the structural integrity of the floor drain piping.

The liquid transformer AT1W has been removed. This is supported by process knowledge from the Facility Manager and Electrical Engineer for 400-D area, as well as the PCB database kept by SRS. There are no remaining transformers except for AT2W, which is an item of equipment still to be removed outside the decommissioning scope of this FDE. AT2W is non-PCB oil acceptable with a sticker which shows this. Holes in the slab (e.g., beneath the lighting panel) will be plugged and grouted.

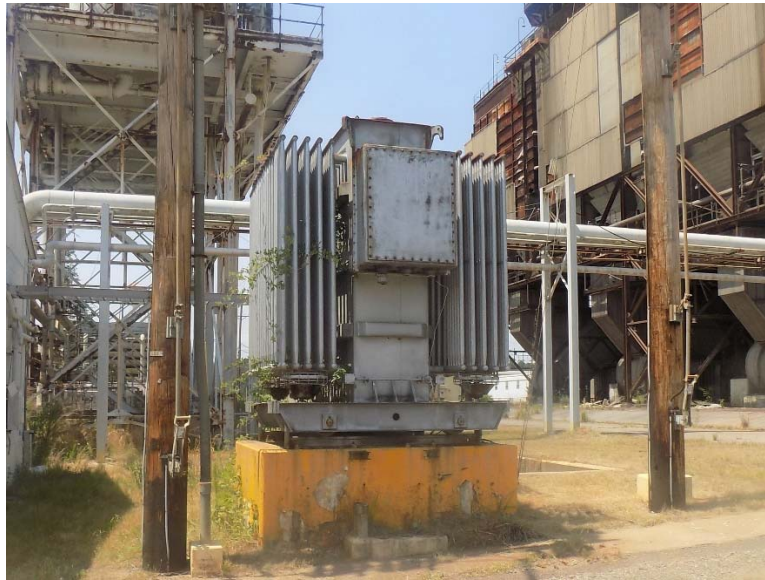
Figure 5. Transformer AT2W (Drained & Disconnected)

On the east side of the structure is one transformer, AT2W (southeast) (Figure 5), still remaining to be removed outside the decommissioning scope of this FDE. On the west side of AT1W transformer pad and containment dike is a 12" thick, 16' wide, 6' high concrete wall. The former location of transformer AT1W (Figure 6) has a 16' by 20' gravel-filled containment with an 18" x 18" x 12" deep sump in the northwest corner, while transformer AT2W is mounted on a concrete pad in an 8' by 10' gravel-filled containment. Each transformer was designed to step down 13.8 kV to 2.4 kV.

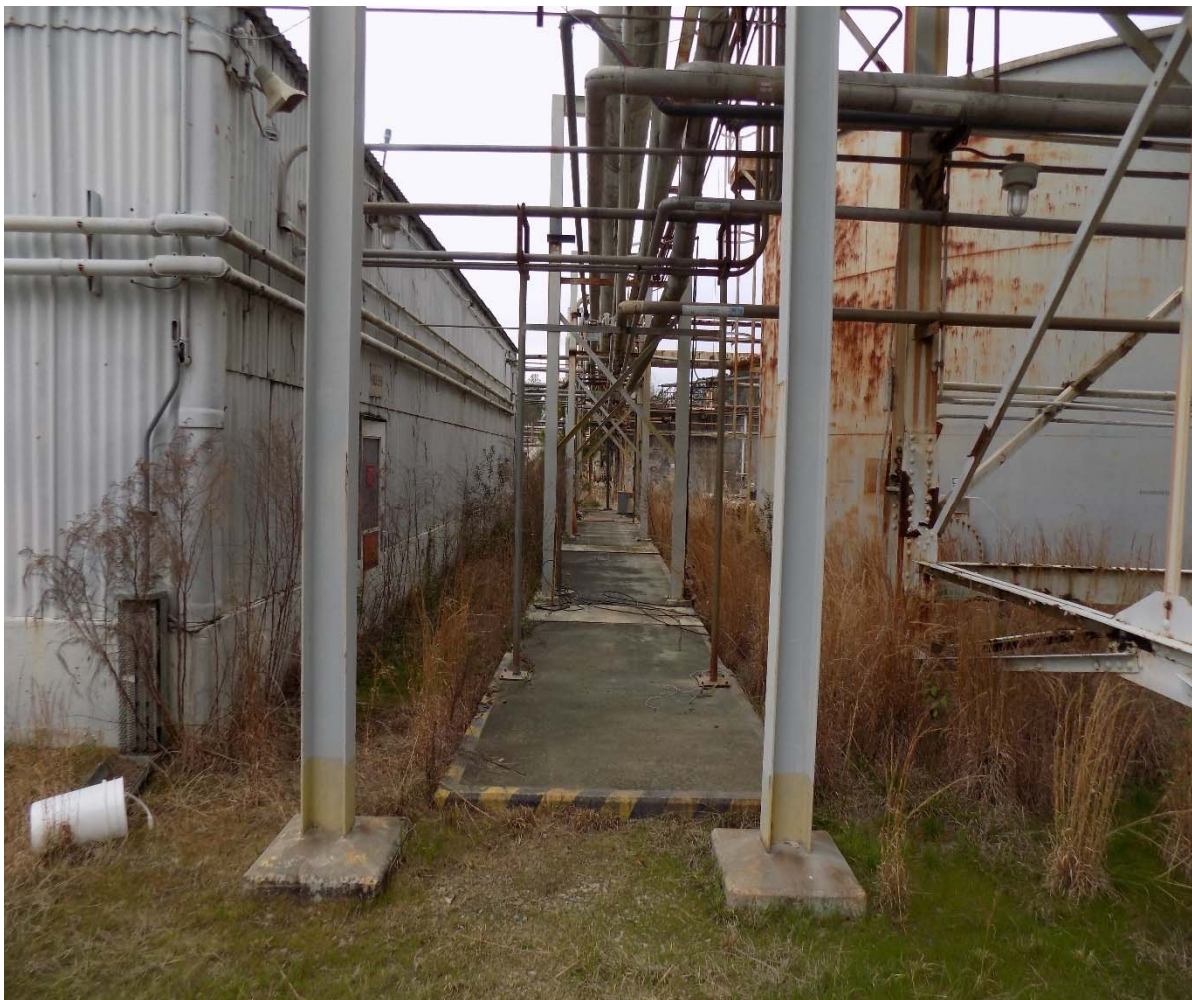
Figure 7. Building 483-3D Cable Trench

To the north of Building 483-3D is a cable trench (Figure 7). The cable trench used to contain many of the electrical cables leaving Building 483-3D to area loads. The cable trench is approximately 75' long by 6'11" wide and approximately 8' deep. There were six (6) vertically stacked cable trays running along the south wall of the trench. The cable trench is concrete and has three (3) hinged access plates. Mounted on and above the cable tray is a pipe and conduit bridge of steel construction.

The proposed decommissioning end state for the North Cable Trench is In Situ Disposal. The structure is essentially concrete and predominantly below grade. Demolition is therefore impractical, and consequently, a portion of the structure will remain intact after decommissioning. Below grade equipment and components will be removed during decommissioning. Remaining below grade structure will be filled to grade with rock, gravel, and/or soils.

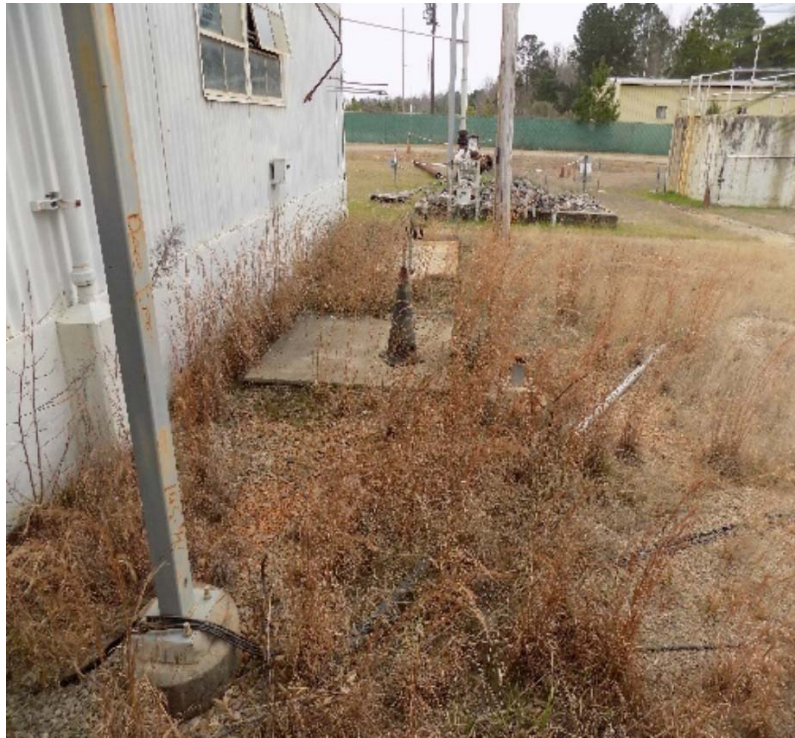
Figure 8. Old Location of Transformer W4

To the west of the building was the transformer W4. Transformer W4 was a 2.4kV to 480V step-down transformer which sat on a 4' x 4'4" concrete pad (Shown in Figure 8).

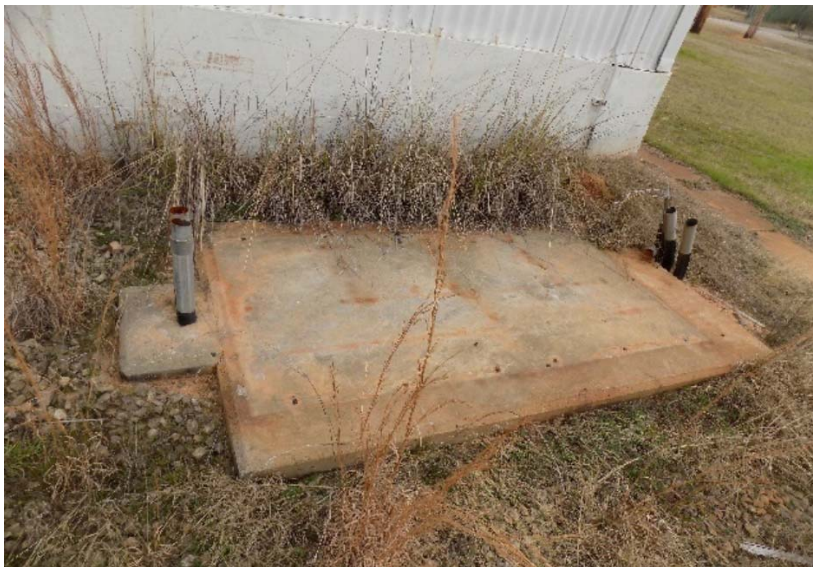
Figure 9. Old Location of Spill Control Motor Control Center

Figure 9 shows the location of the old spill control motor control center, which provided power to the spill control pump pit for the 484-D Powerhouse. The spill control pump pit is not applicable to this scope.
