## Decommissioning Project Final Report Building 607-14D, Chemical Feed Facility

The purpose of this report is to document what was done to the facility as a part of the decommissioning project, and the condition the facility was left in at the completion of the project. The requirement for this report is found in the Facility Disposition Manual 1C, Procedure 506, "Preparing a Decommissioning Project Final Report". Interactions with regulatory agencies, South Carolina Department of Health and Environmental Control (SCDHEC) and U.S. Environmental Protection Agency (EPA), for concurrence on this report are governed by SRNS-RP-2021-00120, "Core Team Protocol for Review and Concurrence on Facility Decommissioning Evaluations and Decommissioning Project Final Reports" (Reference 8.12).

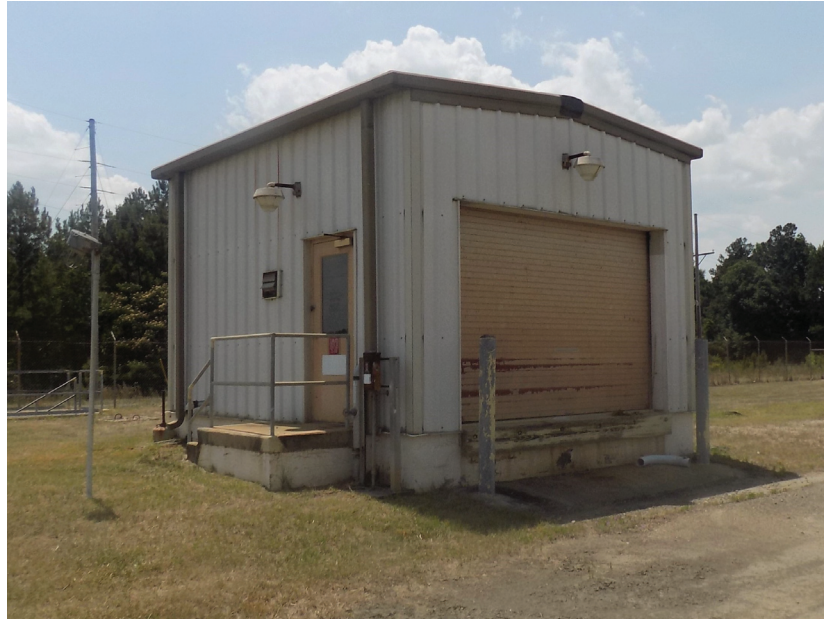
**Figure A-1. 607-14D (Looking Northwest) Before Decommissioning**

607-14D, Chemical Feed Building was built on a concrete slab. The lower portions of the walls (up to ~18" above the slab) were masonry block. The remainder of the structure was constructed of metal and composite materials. The structure was ~16' by 20' and ~13' high. There was a 10' roll-up door on the east side of the structure. Outside the roll-up door, on either side, were two bollards, 4" diameter and 30" above grade. There were concrete steps with a handrail to the south door of the building. The structure was formerly provided with electrical supply at 480 volts (V) (3-phase) and domestic water. There was a domestic water isolation valve and an electrical disconnect on the southeast corner of the structure. There was also a domestic water isolation valve to the south of the structure that is associated with the structure. The building contained a soda ash mixing tank, two soda ash transfer pumps, a lab bench and sink, one floor drain, one collection sump, and a chemical storage area. Lighting inside the structure was from fluorescent lamps, while lighting on the outside of the building (east, south, and west) was high pressure sodium lamps mounted on the structure.

607-14D was demolished down to its concrete slab. The 607-14D sump was filled to the top of sump elevation with grout. Below-grade spaces of 607-15D and the Disinfection Pit/UV Disinfection Chamber were filled to grade with gravel and/or rip-rap, followed then by placement of 6" thick concrete cap slabs. Slab protrusions were cut flush with the slab and floor openings were filled to grade with gravel and/or rip-rap. All interfacing utilities are isolated, disconnected, and plugged. The 607-12D lift station was filled with gravel to the top of the lift station. The 607-2D lift station #2 was filled with gravel under the IWT Permit interim closure plan. The junction box located between the Disinfection Pit and 607-15D had its cover removed and was grouted to the top of its curb. The 483-6D platform handrails were left in place following decommissioning of the Surge Basin remnants due to the height of the platform above the surrounding grade.

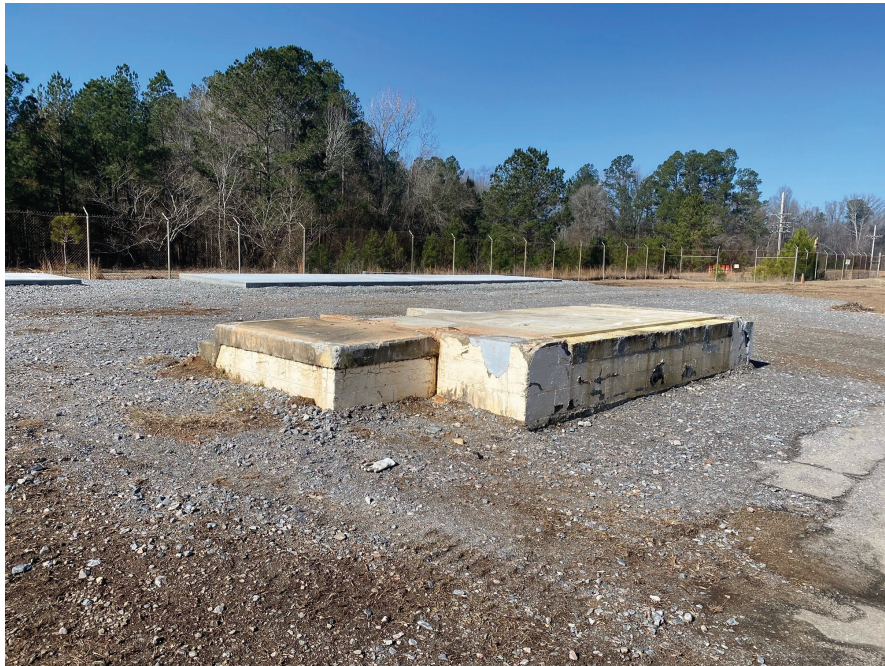
**Figure A-2. 607-14D (Looking Northwest) After Decommissioning**

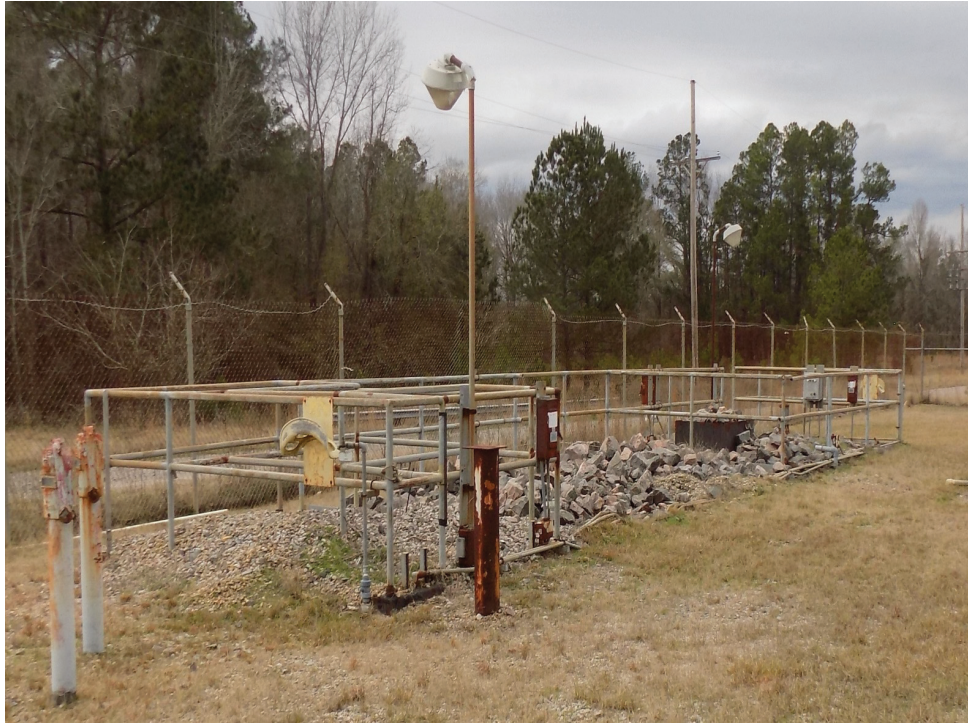
**Figure A-3. 607-15D (Looking Northwest) Before Decommissioning**

607-15D, Sanitary Waste Treatment Plant was a package treatment plant that was installed, placed into operation in 1993, and since closed under an IWT Permit interim closure plan. The structure was ~50' by 16' and 12' high, disregarding handrail and equipment height atop the structure. The majority of the 12' high structure was below grade. The structure was primarily epoxy-coated carbon steel. The walkway gratings atop the structure were made of aluminum. The top of the structure was within 4" to 6" inches of being level with grade. The more visible portions of the structure were the handrails and above grade equipment.

The treatment plant had four (4) major sections: (1) the chlorine diffuser, (2) the clarifier, (3) the aeration tank, and (4) the surge tank. The sewage inlet to the structure was via a 4" pipe at the north end of the structure. The treated effluent was discharged via a 6" pipe at the outlet of the weir on the south end of the structure. There was a 4" air inlet below grade on the east side of the surge tank from the surge tank blowers. There was another 4" air inlet below grade in the aeration tank from the aeration blowers.

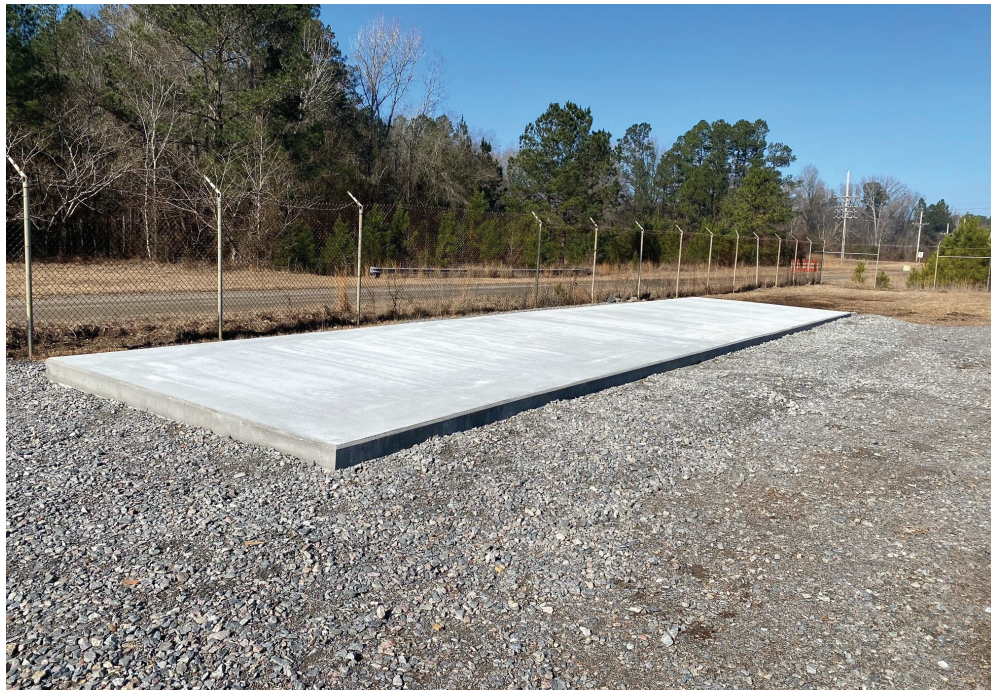
**Figure A-4. 607-15D (Looking Southwest) After Decommissioning**

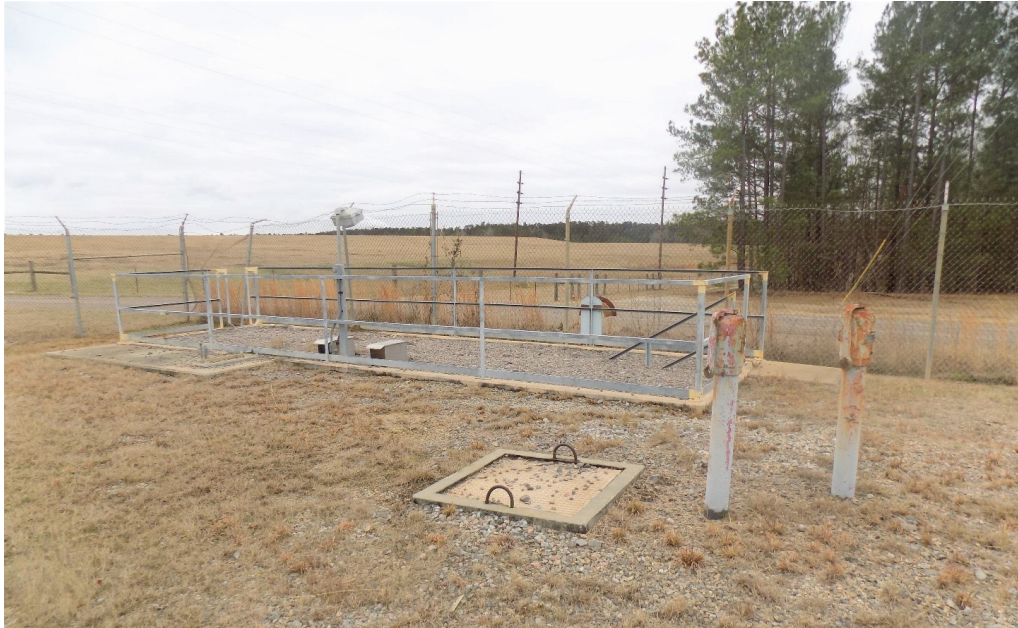
**Figure A-5. Disinfestation Pit (Looking Southwest) Before Decommissioning**

To the south of 607-15D was the disinfection pit. The disinfection pit was an open, concrete, below-grade structure. It had been filled in with gravel under the IWT Permit interim closure plan. The pit was ~6 feet below grade and was ~8' by 28'. Along the east side of the pit was the UV disinfection chamber. Effluent sewage passed through the chamber while being exposed to UV light for disinfection and was discharged to outfall D-01. There were metal steps leading down into the pit. There was a sump in the bottom of the pit that was covered with a galvanized metal grate. The sump was equipped with a 120V sump pump that discharged to the treatment plant, 607-15D. Handrails surrounded the entirety of the pit, with an opening at the steps.

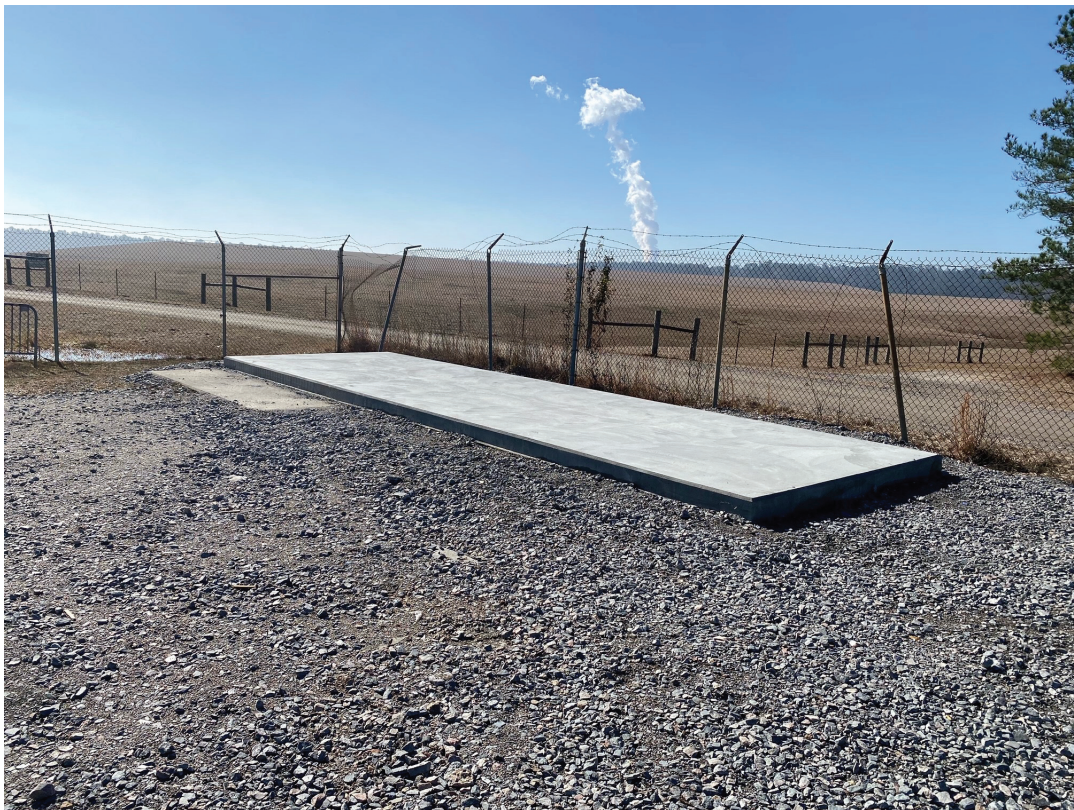
**Figure A-6. Disinfestation Pit (Looking Southwest) After Decommissioning**

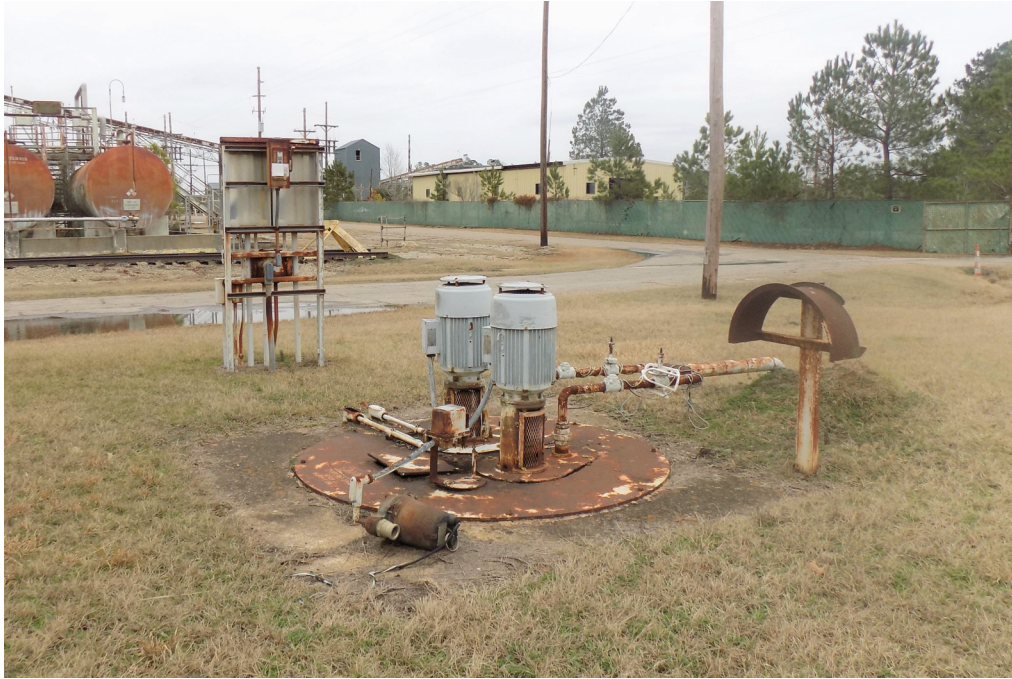
**Figure A-7. 607-12D (Looking Southwest) Before Decommissioning**

607-12D was an abandoned-in-place sanitary sewage lift station located to the south of 607-14D. The station was in use until 1993, when 607-2D was brought online to replace it. 607-12D was then abandoned. The concrete pad for the 607-12D station is 10' by 10'. The interior pit was 6' in diameter and 6'6" deep. The shell of the pit was 6" thick reinforced concrete. Located above grade at 607-12D were two motors and pumps (with oil removed), a hose rack, pipes, and conduit. The lift station pumps were 480V, 3-phase pumps. On the electrical panel were two combination starters for the pumps, two junction boxes, and a receptacle.

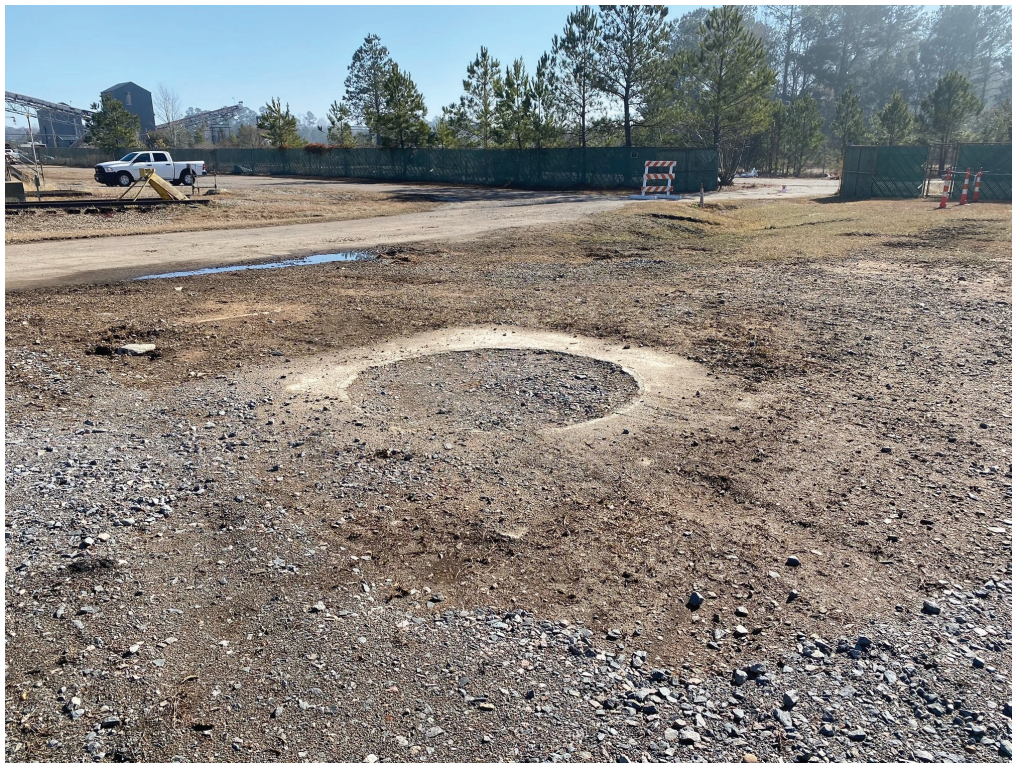
**Figure A-8. 607-12D (Looking Southwest) After Decommissioning**

placement of 6” thick concrete cap slabs. The 607-12D lift station was filled with gravel to the top of the lift station. The 607-2D lift station #2 was filled with gravel under the IWT Permit interim closure plan. All interfacing utilities were isolated, disconnected, and plugged. All appurtenances (i.e., handrail, conduits, hose rack, piping, lighting poles, diverter valve operators, etc.) were removed to grade. Resulting holes were plugged and grouted. The junction box located between the Disinfection Pit and 607-15D had its cover removed and was grouted to the top of its curb. For safety reasons, the 483-6D platform handrails were left in place following decommissioning of the Surge Basin remnants due to the height of the platform above the surrounding grade. It was confirmed complete in the FAI-51 Final Acceptance Inspection walkdown performed on 2/3/2021 (Reference 8.11).

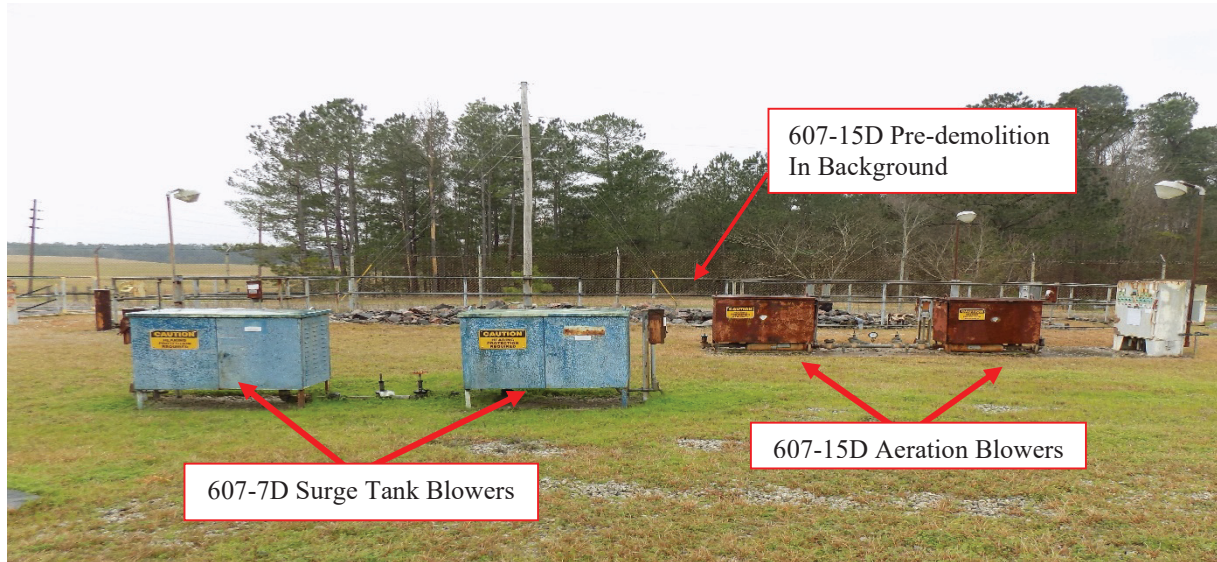
Figure A-9. 607-7D and 607-15D Blowers (Looking West) Before Decommissioning

On the east side of 607-15D were the blowers for the aeration and surge tanks. There were two blowers for each. The two easternmost blowers, the surge tank blowers, were remnants of the 607-7D sanitary waste treatment plant. Prior to installation of the 607-15D Sanitary Waste Treatment Plant, 607-7D was the operational sewage treatment plant. 607-7D was removed from service and decommissioned in 1993. The aeration blowers were closer to 607-15D. Each of the blowers was a 5 horsepower (hp), 480V, 3-phase blower. The electrical control panel for the blowers was located to the north end of the aeration blower equipment pad. The only remnants of 607-7D of concern for the decommissioning were the blowers associated with 607-7D. Nothing else remained of 607-7D.

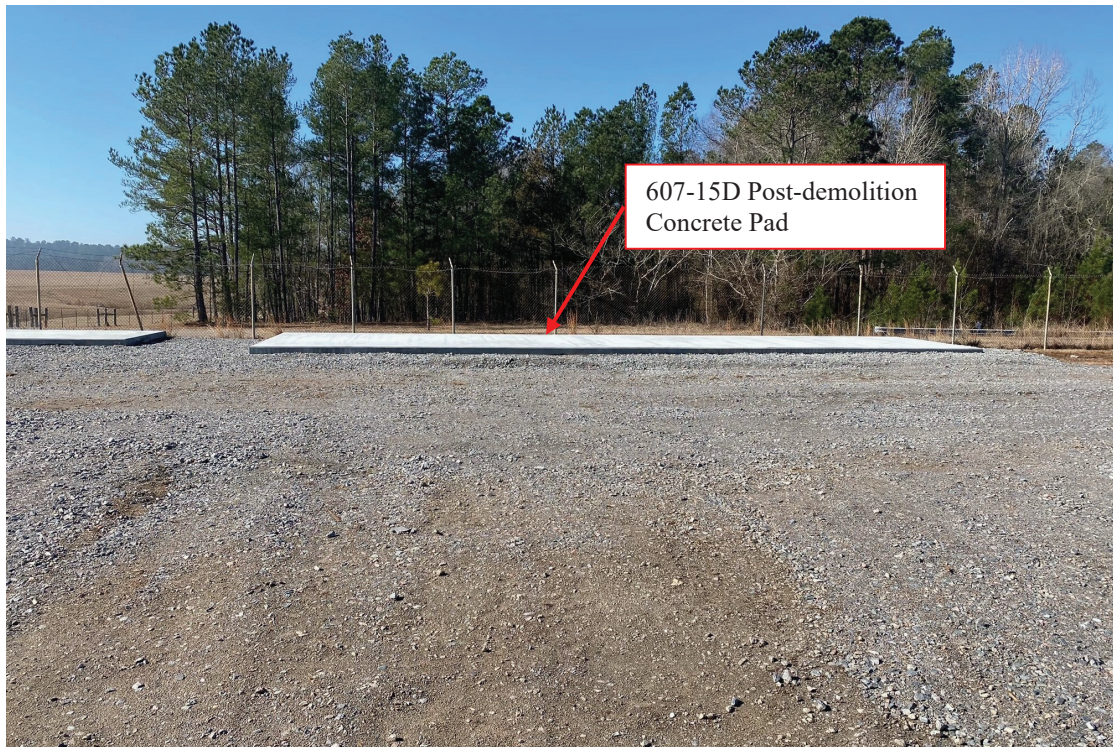
Figure A-10. 607-7D and 607-15D Blowers (Looking West) After Decommissioning

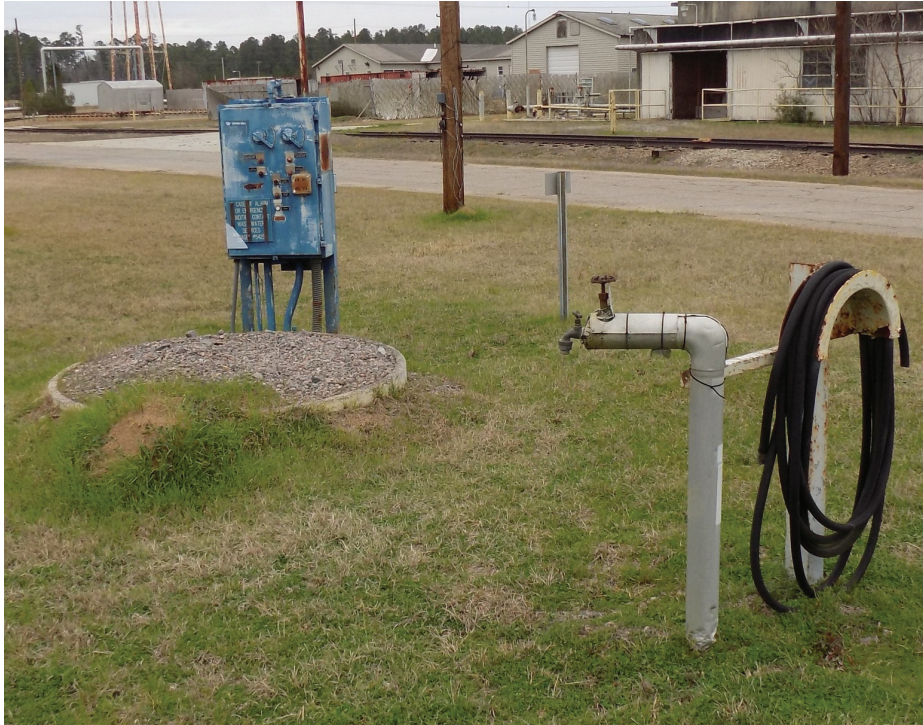
**Figure A-11. 607-2D (Looking Southwest) Before Decommissioning**

607-2D was the operational lift station for the sanitary sewage waste treatment plant. The lift station contained two lifting pumps (with oil removed) for transfer of the sanitary wastewater to the 607-15D treatment plant. The basin of the lift station was constructed of reinforced concrete and located mostly below grade. The upper rim of the lift station extended to about 9" above ground level (previously decommissioned under the IWT Permit interim closure plan). The lift station pumps were located below grade inside the lift station. The pumps were 3 hp, 480V, 3-phase centrifugal pumps. The lift station control panel was located adjacent to the lift station on the northeast and was above grade. A process water connection and a hose rack were ~8' to the south of the lift station.

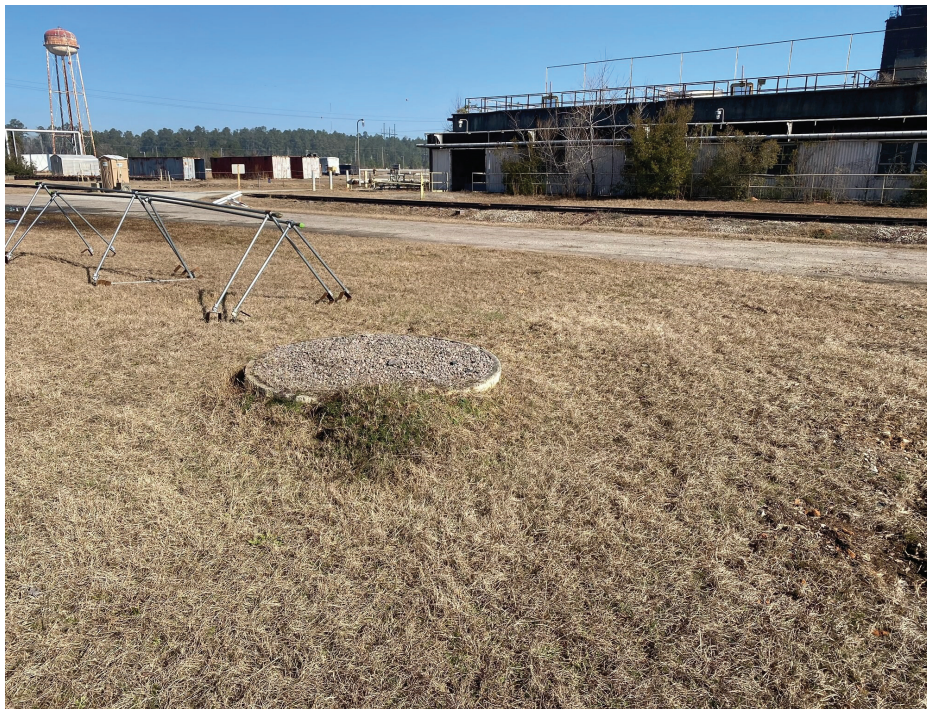
**Figure A-12. Building 607-2D (Looking Southwest) After Decommissioning**

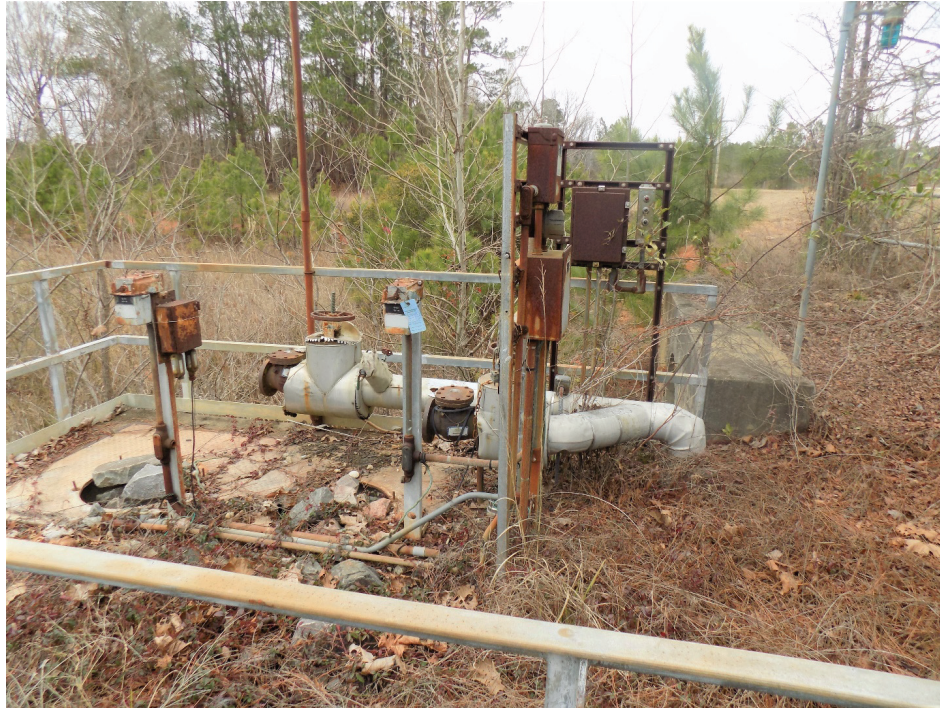
**Figure A-13. 483-6D Surge Basin (Looking Northwest) Before Decommissioning**

The 483-6D Surge Basin was permitted under SCDHEC IWT Permit No. 18078-IW. The Surge Basin was a 400,000-gallon capacity water plant surge basin located on the west side of the Savannah River Site's D-Area. The 483-6D Surge Basin was placed into service in 1976 with a projected service life of 50 years. The basin provided a buffer from the large flow rates required to backwash the filtration systems from the 483-D Surface Water Treatment and the 483-7D Domestic Water Treatment Plants. It also provided short-term storage of the wastewaters and residual sludge generated as by-products of the filtration processes. The Surge Basin's original Hypalon liner was later replaced when it deteriorated. The new liner consisted of a bentonite mat and a 60 mil High Density Polyethylene Liner, placed atop the original bentonite liner. The liner

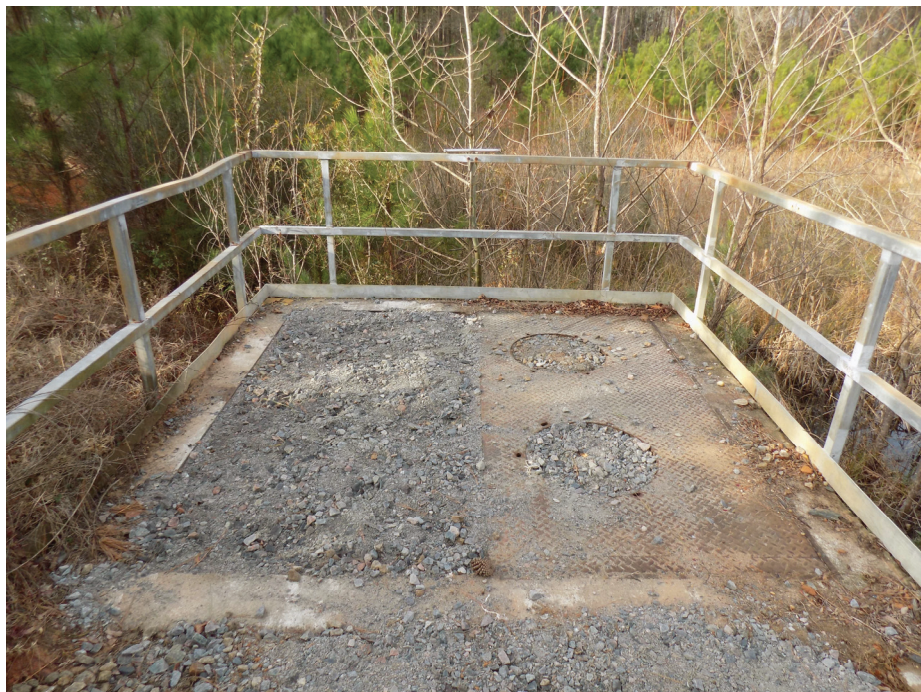
**Figure A-14. 483-6D Surge Basin (Looking West) After Decommissioning**
