ENVIRONMENTAL COMPLIANCE & AREA COMPLETION PROJECTS (EC&ACP) STANDARD OPERATING PROCEDURES, VOL. I

Manual: C3
Procedure: ER-IDS-019-003
Revision: 8
Effective Date: 06/02/2016
Type-Class: Form
Page: 1 of 3

D-AREA BURNING/RUBBLE PITS (BLDGS. 431-D AND 431-1D) FIELD INSPECTION CHECKLIST

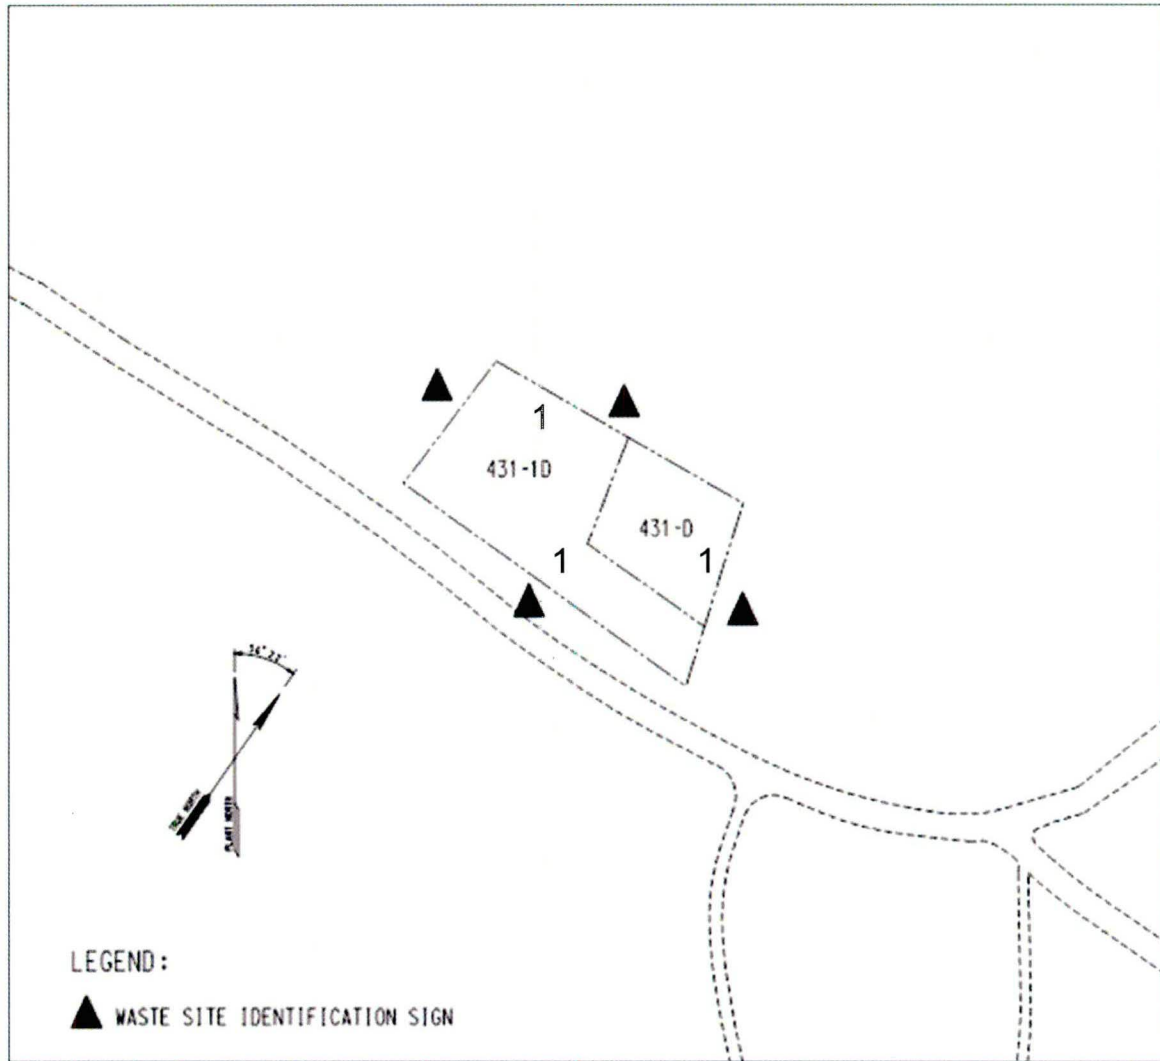
MAP OF D-AREA BURNING/RUBBLE PITS (BLDG. 431-D & 431-1D)

NOTES: 1=Old hog damage (rooting) on the soil cover. USFS will repair with topsoil, grass seed and straw.
