**ENVIRONMENTAL COMPLIANCE & AREA COMPLETION PROJECTS (EC&ACP) STANDARD
OPERATING PROCEDURES, VOL. I**
**M-AREA HAZARDOUS WASTE MANAGEMENT FACILITY (BLDG. 904-51G) FIELD INSPECTION
CHECKLIST**

M-Area Hazardous Waste Management Facility (Bldg. 904-51G) Field Inspection Checklist

Map of M-Area Hazardous Waste Management Facility 904-51G

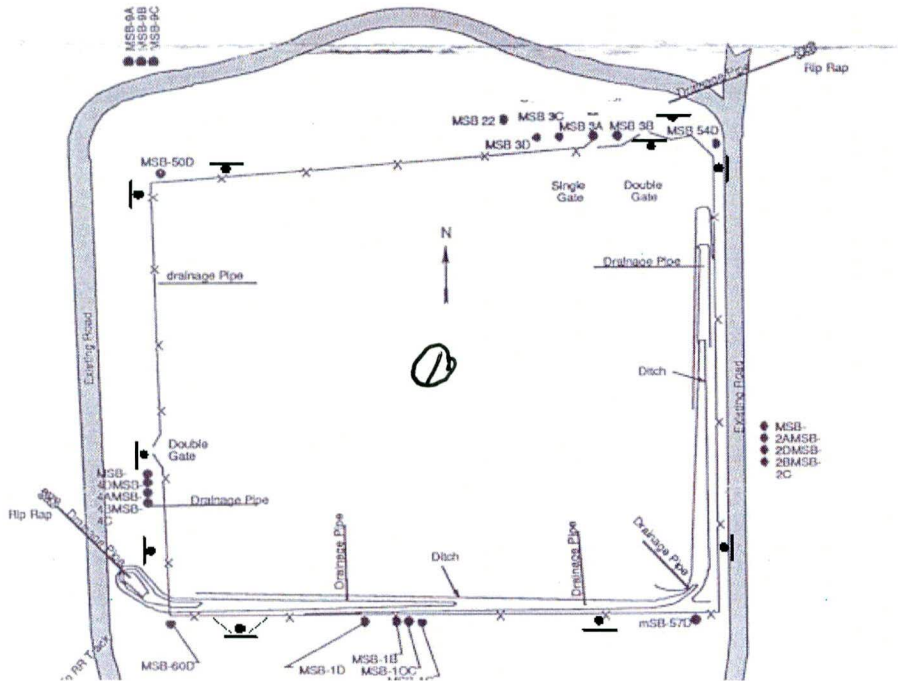
7. Check for excessive vegetation growing over fences, which may obstruct warning signs or visibility of inspected area.	A	
8. Check M-Settling Basin cover for signs of burrowing animals.	X	Active ANT Mounds on soil cover. See MAP Note ① Ref. Maint. Register PC-2018-00013

NOTES: D = Active Ant Mounds on soil cover. Applied 1.0 lbs. of Extinguish Ant Bait.

Active ant mounds on soil cover

Applied Extinguish ant bait.
