**ENVIRONMENTAL COMPLIANCE & AREA COMPLETION PROJECTS (EC&ACP) STANDARD
OPERATING PROCEDURES, VOL. I**
Manual: C3
Procedure: ER-IDS-019-022
Revision: 3
Effective Date: 06/01/2016
Type-Class: Form
Page: 1 of 5
**M-AREA HAZARDOUS WASTE MANAGEMENT FACILITY (BLDG. 904-51G) FIELD INSPECTION
CHECKLIST**
WORKING COPY

M-Area Hazardous Waste Management Facility (Bldg. 904-51G) Field Inspection Checklist

Map of M-Area Hazardous Waste Management Facility 904-51G

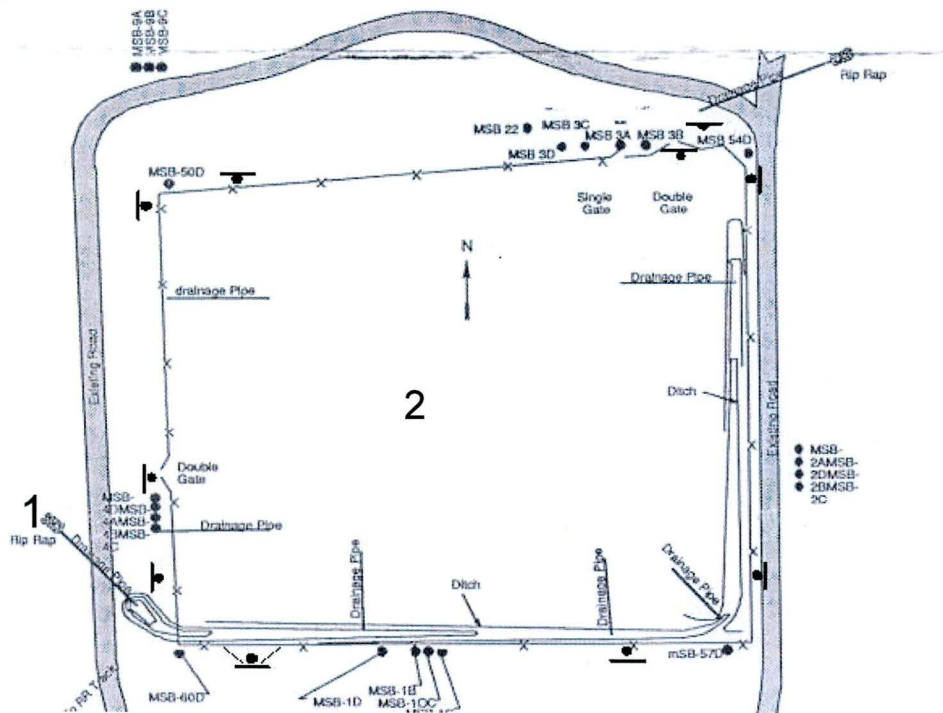
4. Check integrity of drainage ditches, drain pipes and general area (including the drainage ditch to Lost Lake) for presence excessive erosion, sediment buildups any debris restricting water flow.	X	Vegetation restricting water flow in drainage ditch to Lost Lake. See Map Note: 1 Reference Maintenance Register: PC-2021-00068

7. Check for excessive vegetation growing over fences, which may obstruct warning signs or visibility of inspected area.	A	
8. Check M-Settling Basin cover for signs of burrowing animals.	X	Active ant mounds on soil cover. See Map Note: 2 Reference Maintenance Register: PC-2021-00069

NOTES: 1=Vegetation restricting water flow in drainage ditch to Lost Lake. The USFS will cut and remove vegetation.
 2=Active ant mounds on soil cover. Applied 1.0 lb. of Extinguish ant bait.

The USFS cut and removed vegetation.

Maintenance Item Corrected
Applied Extinguish ant bait.
