ENVIRONMENTAL COMPLIANCE & AREA COMPLETION PROJECTS (EC&ACP) STANDARD OPERATING PROCEDURES, VOL. I

Manual: C3
 Procedure: ER-IDS-019-077
 Revision: 1
 Effective Date: 03/27/2018
 Type-Class: Checklist
 Page: 1 of 3

D-AREA ASH BASIN (488-2D) AND ASH LANDFILL (488-4D) INTERIM FIELD INSPECTION CHECKLIST

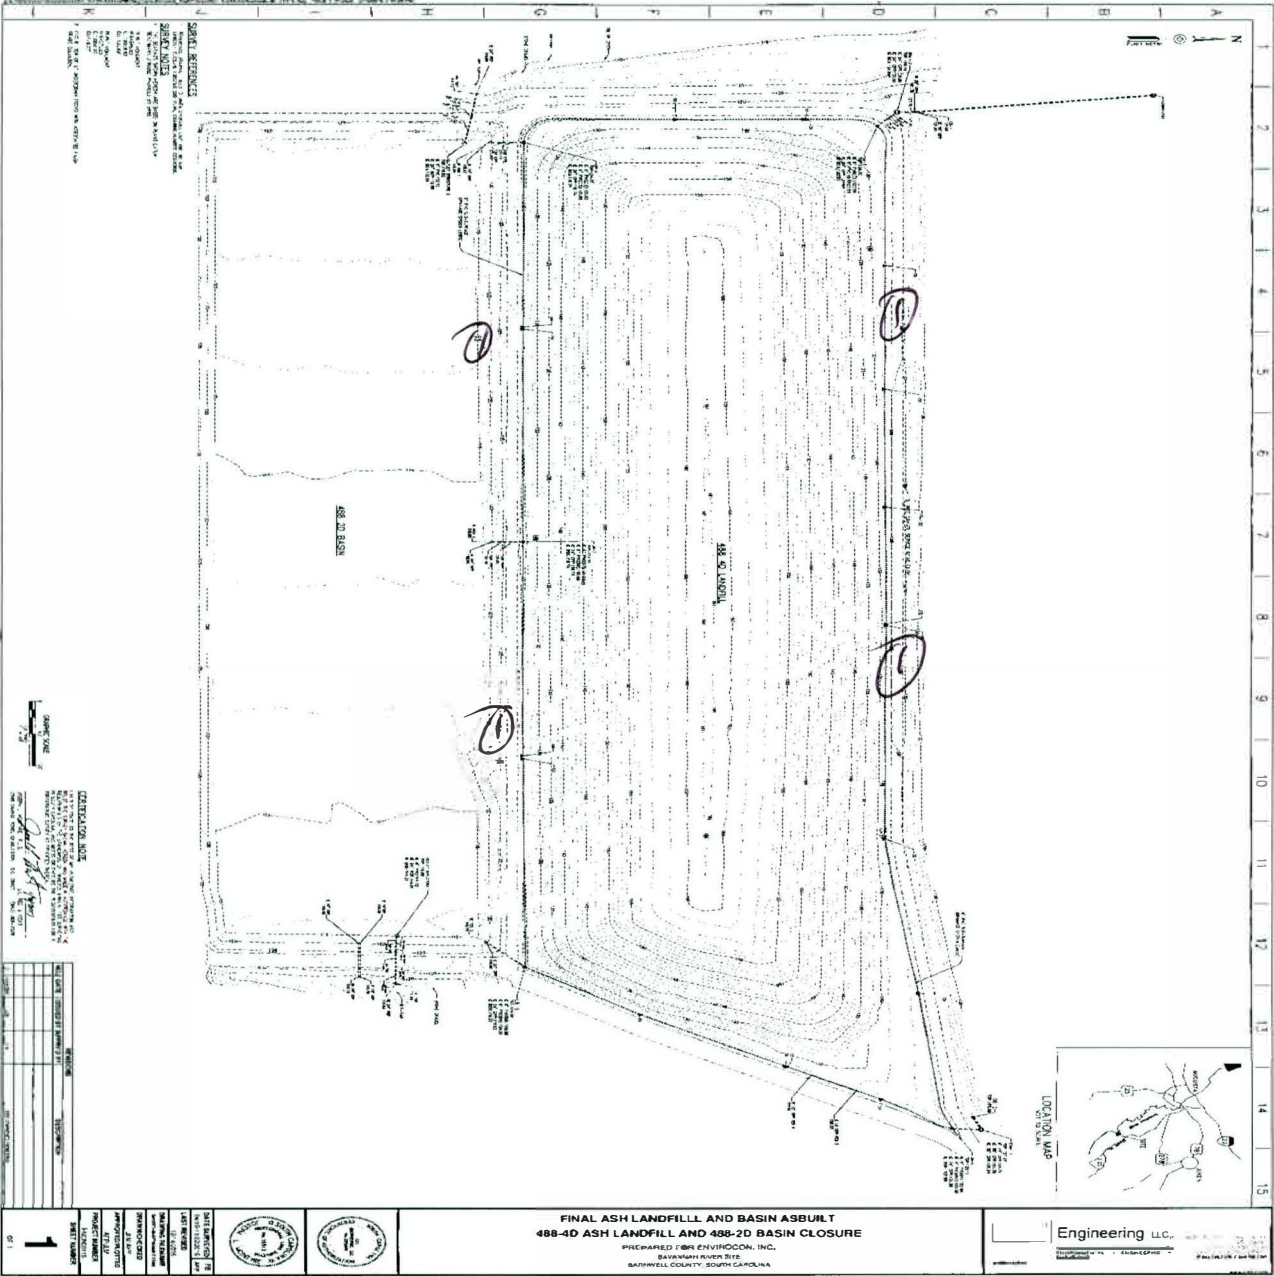
D-Area Ash Basin (488-2D) and Ash Landfill (488-4D) Map

6. Verify the soil cover at D-Area Ash Basin (488-2D) and Ash Landfill (488-4D) has no signs of unacceptable erosion or depressions (subsidence).	X	CARRY OVER ITEM; SPOTS OF EROSION ON THE SIDE SLOPES OF 488-4D. SEE MAP NOTE (D). REF. MAINT. REGISTER PC-2017-00094

NOTE: (D) = CARRY OVER ITEM: SPOTS OF EROSION ON THE SIDE SLOPES OF 488-4D. USFS WILL MAKE REPAIRS.
