Decommissioning Project Final Report Building 483-3D, Electrical Control Building

1.0 SUMMARY

2.01 Facility Description

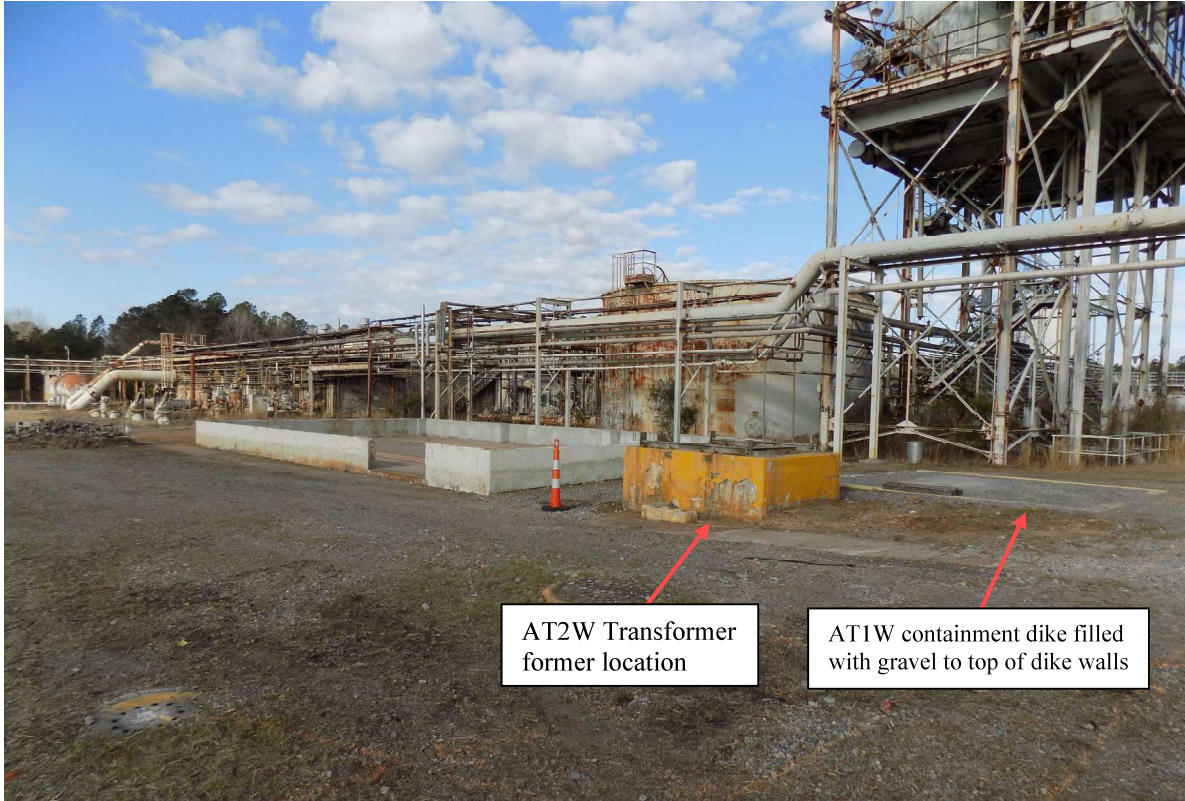
Figure 2: Building 483-3D (Looking Northwest) After Decommissioning

AT2W Transformer
former location

AT1W containment dike filled
with gravel to top of dike walls

483-3D was demolished down to the concrete slab and low concrete support walls. Only the piping and conduits associated with Building 483-3D were removed from the Pipe and Conduit Bridge. The below-grade structure of the Exterior North Cable Trench was filled to grade with CLSM. The concrete barrier wall along the west side of the AT1W Transformer Pad and Containment Dike was demolished down to the top of dike elevation, the sump inside the dike area was filled to the top of sump elevation with CLSM, and additional gravel fill was placed in the dike area to the top of dike walls. Slab protrusions were cut flush with the slab and floor openings filled to achieve a uniform surface.
