Decommissioning Project Final Report Building 484-15D, D-Area Storage Building

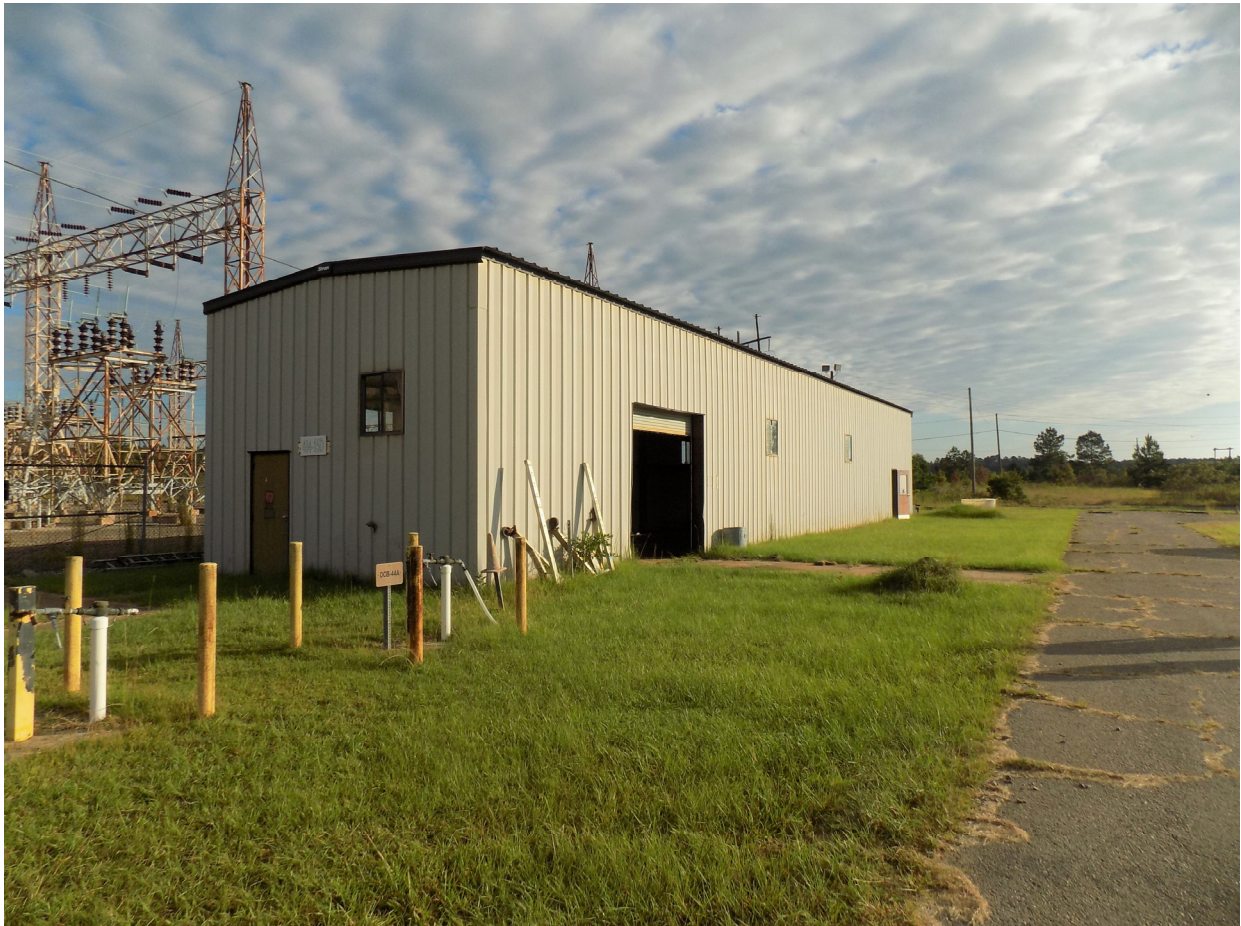
Figure 1: Building 484-15D (Looking East) Before

Building 484-15D was an approximately (~) 34-year old 2,000 square foot metal frame structure with metal skin. The building was used primarily for receiving D-Area Materials. The interior was non-partitioned and had aluminum walls. There were no sumps or drains associated with the structure. To the east of the building was a lay-down yard without a concrete slab. An asbestos inspection survey of the building (Q-APG-D-00011) was conducted on November 6, 2019 10, 2019) with the results being there was no Asbestos Containing Material ((ACM) or Presumed Asbestos Containing Material (PACM) found in the building or its components. See Appendix A, Figure 1 for a photo of the building prior to D&R and Figure 2 for a photo of the area after D&R.

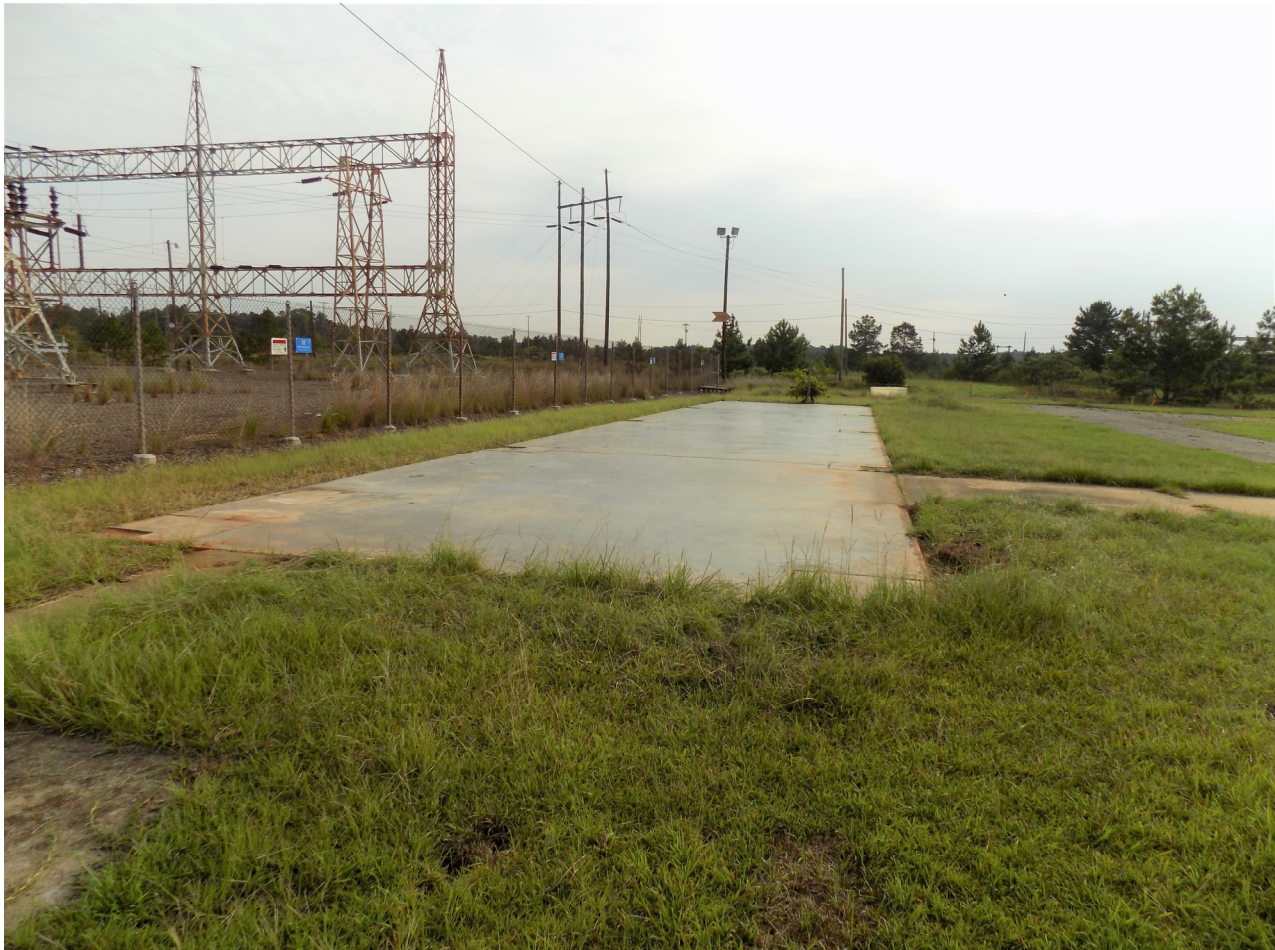
Figure 2: 484-15D (Looking East) After

484-15D was dismantled and removed down to the concrete slab. No ancillary structures were associated with this facility and there were no projections or resulting holes left in the slab or surrounding area. The slab was completely cleaned, including a suspect oil stain that had been identified in the FDE which was cleaned with BioSolve®.
