Decommissioning Project Final Report Building 484-9D, D-Area Valve House

Building 484-9D, D-Area Valve House, was located on the SRS in South Carolina in the southeast portion of 400-D Area, near the northeast corner of the D-Area coal yard. The structure was constructed circa 1988.

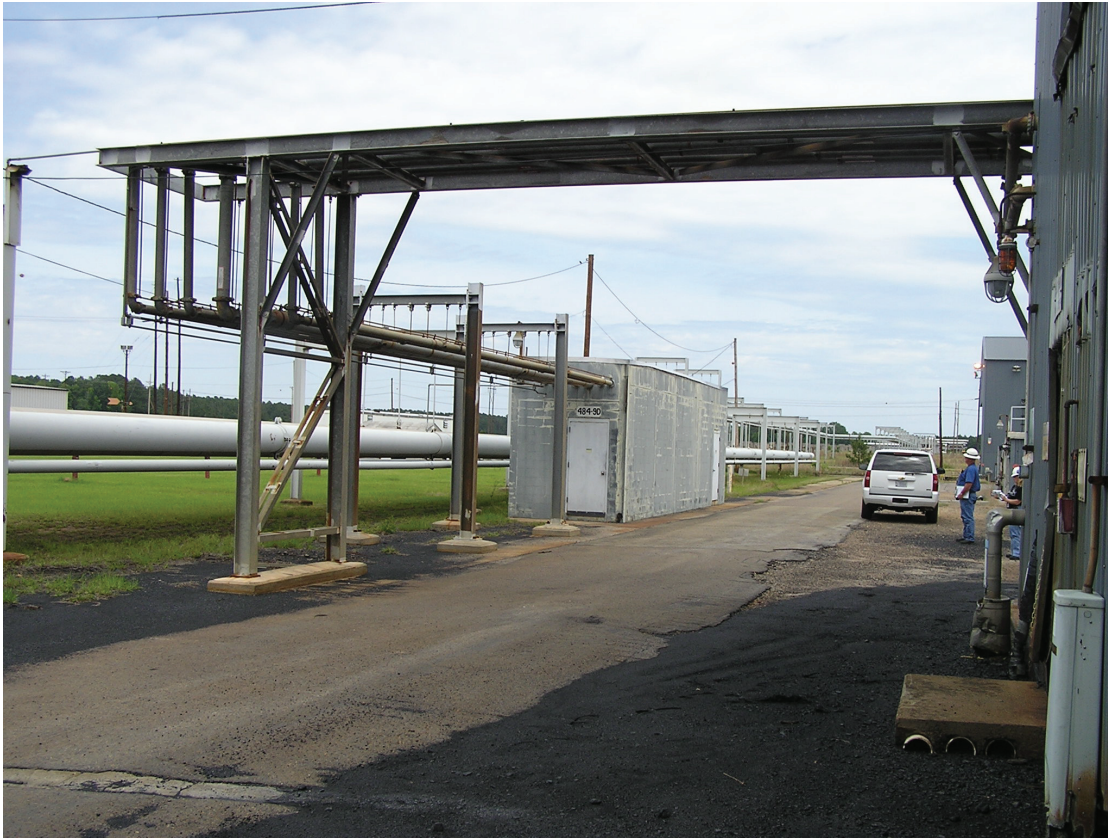
Figure 1: Building 484-9D (Looking East) Before Decommissioning

See Appendix A, Figure 1 for a photo of the building prior to decommissioning and Figure 2 for a photo of the area after decommissioning.

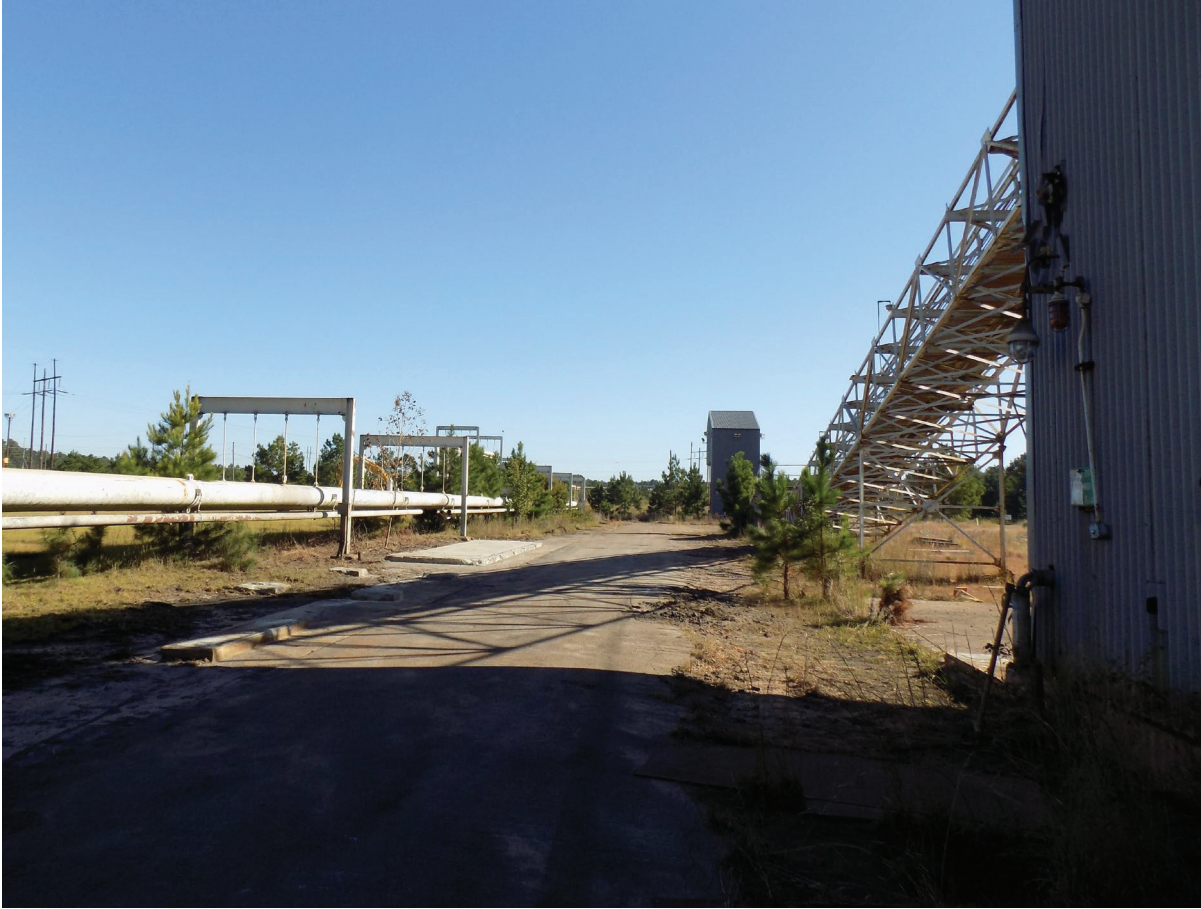
484-9D was demolished down to the concrete slab. All concrete slab penetrations greater than 2” were cut off flush to the slab and grouted. The pipe bridge was demolished down to the bridge foundations. The fire hydrant, fire hose box supports, and bollards east of Building 484-9D were demolished to grade. All slab/foundation protrusions (i.e., anchor bolts, rebar, etc.) were cut off flush with the top of slab.

Figure 2: Building 484-9D (Looking East) After Decommissioning
