ENVIRONMENTAL COMPLIANCE & AREA COMPLETION PROJECTS (EC&ACP) STANDARD OPERATING PROCEDURES, VOL. I

Manual: C3
Procedure: ER-IDS-019-023
Revision: 8
Effective Date: 11/11/2020
Type-Class: Checklist
Page: 1 of 4

INTERIM SANITARY LANDFILL (BLDG. 740-10G) FIELD INSPECTION CHECKLIST

Map Interim Sanitary Landfill (Bldg. 740-10G)

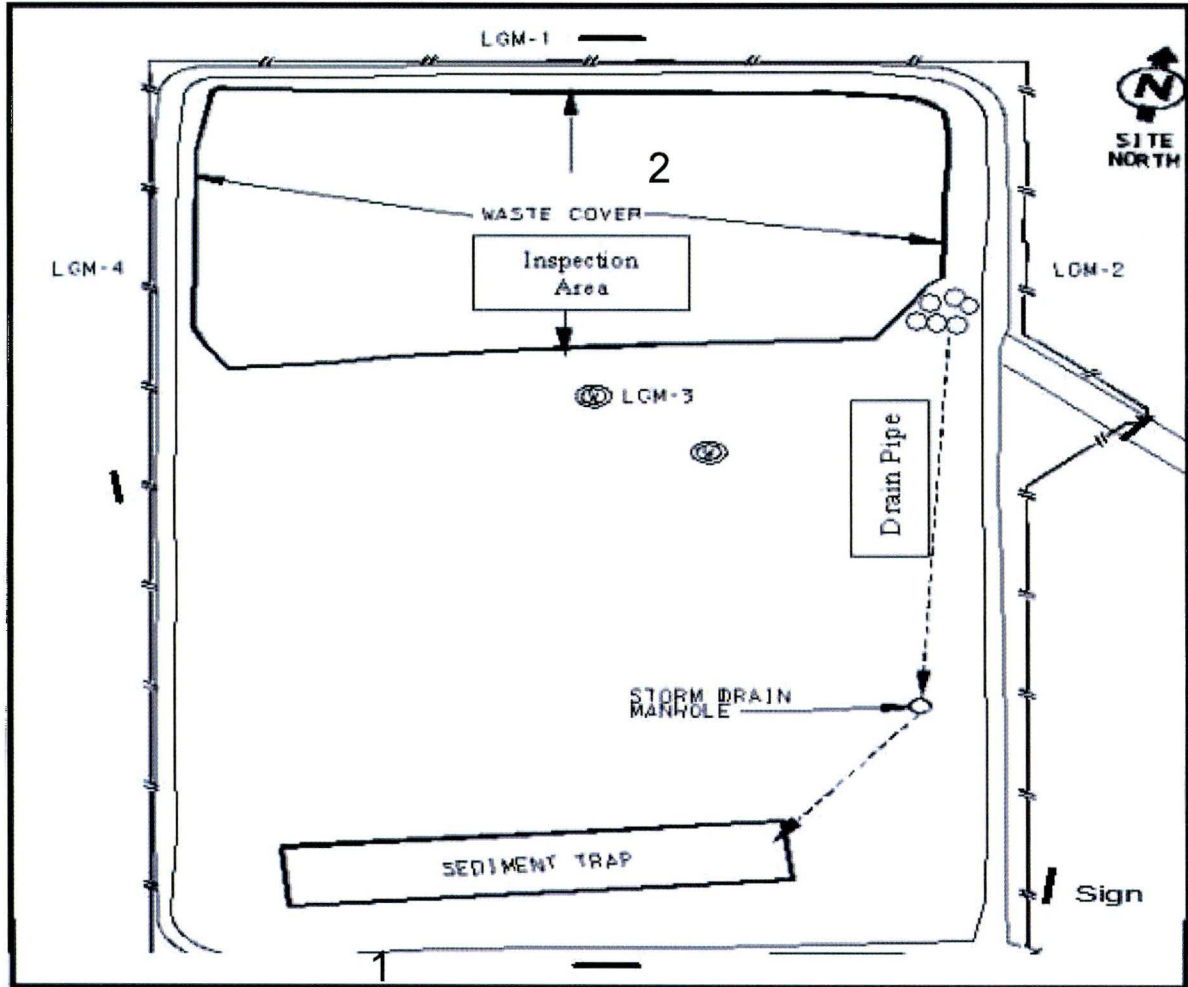
8.	CHECK the soil cover for signs of erosion or depressions (subsidence).	A	
9.	CHECK for evidence of burrowing animals.	X	Hog damage(rooting) on side slope of South drainage ditch. Outside of fence. See Map Note: 1 Reference Maintenance Register PC-2022-00036

A = Satisfactory X = Unsatisfactory (Explanation required)		A or X	Observation/Corrective Action Taken
10.	INSPECT Gas Monitoring Wells for signs of damage.	A	
11.	CHECK the survey benchmarks for damage and visibility, AND VERIFY the annual topographic/ subsidence survey has been performed by the end of June for the current calendar year, and the results have been submitted to the EC&ACP Document Control Center.	A	Completed on 04/11/2022
12.	Other Active Ant Mounds	X	Active Ant Mounds on Soil Cover See Map Note: 1 Reference Maintenance Register PC-2022-00037

NOTES: 1=Hog damage(rooting) on side slope of South drainage ditch. Outside of fence. USFS will repair with topsoil, grass seed and straw. 2= Active ant mounds on soil cover. Applied .25 lb. of Extinguish ant bait.

Maintenance Item Corrected
Applied Extinguish pesticide

USFS repaired with topsoil, straw matting with grass seed.
