Decommissioning Project Final Report

Building 484-4D, Powerhouse Maintenance Facility

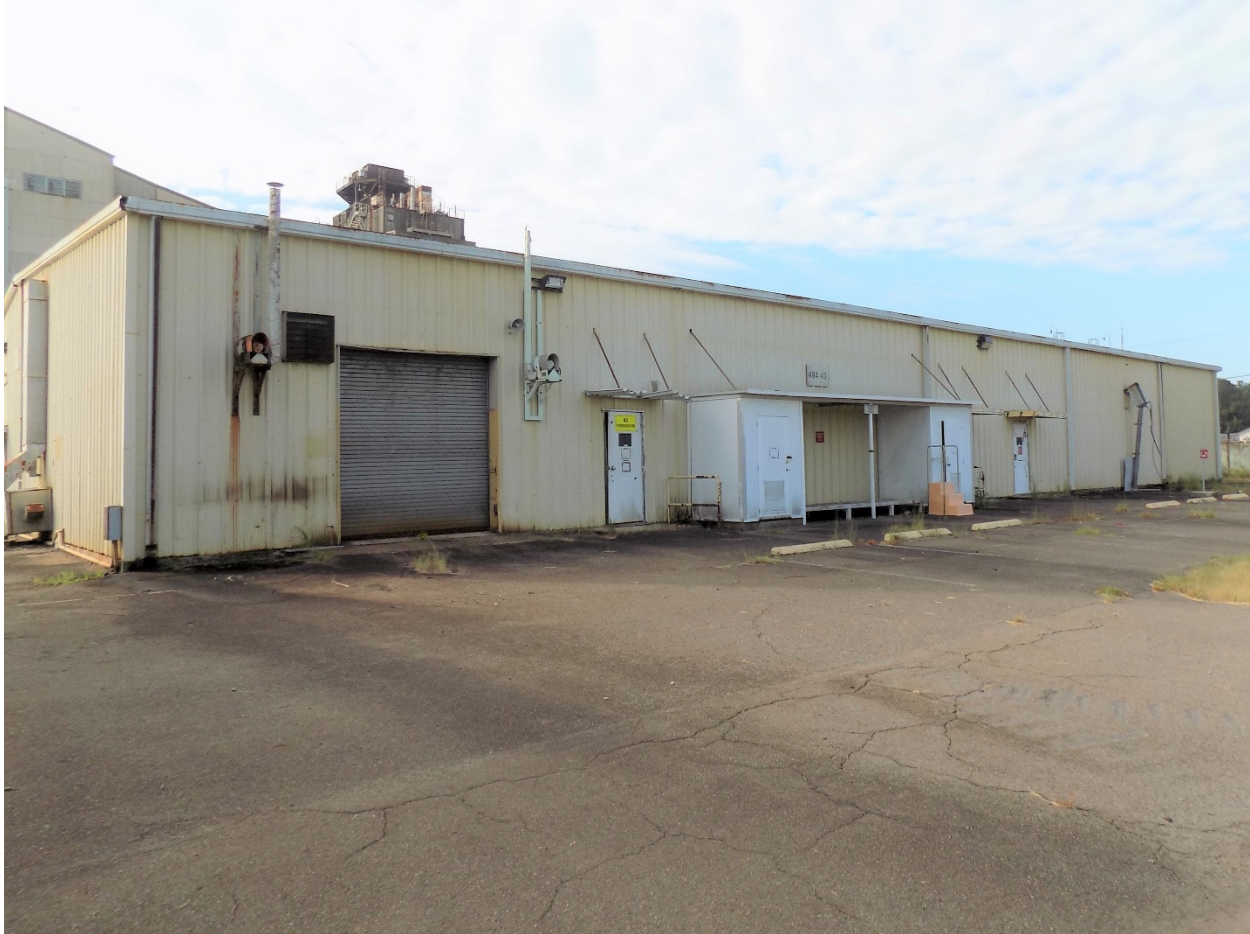
Figure 1: Building 484-4D Before

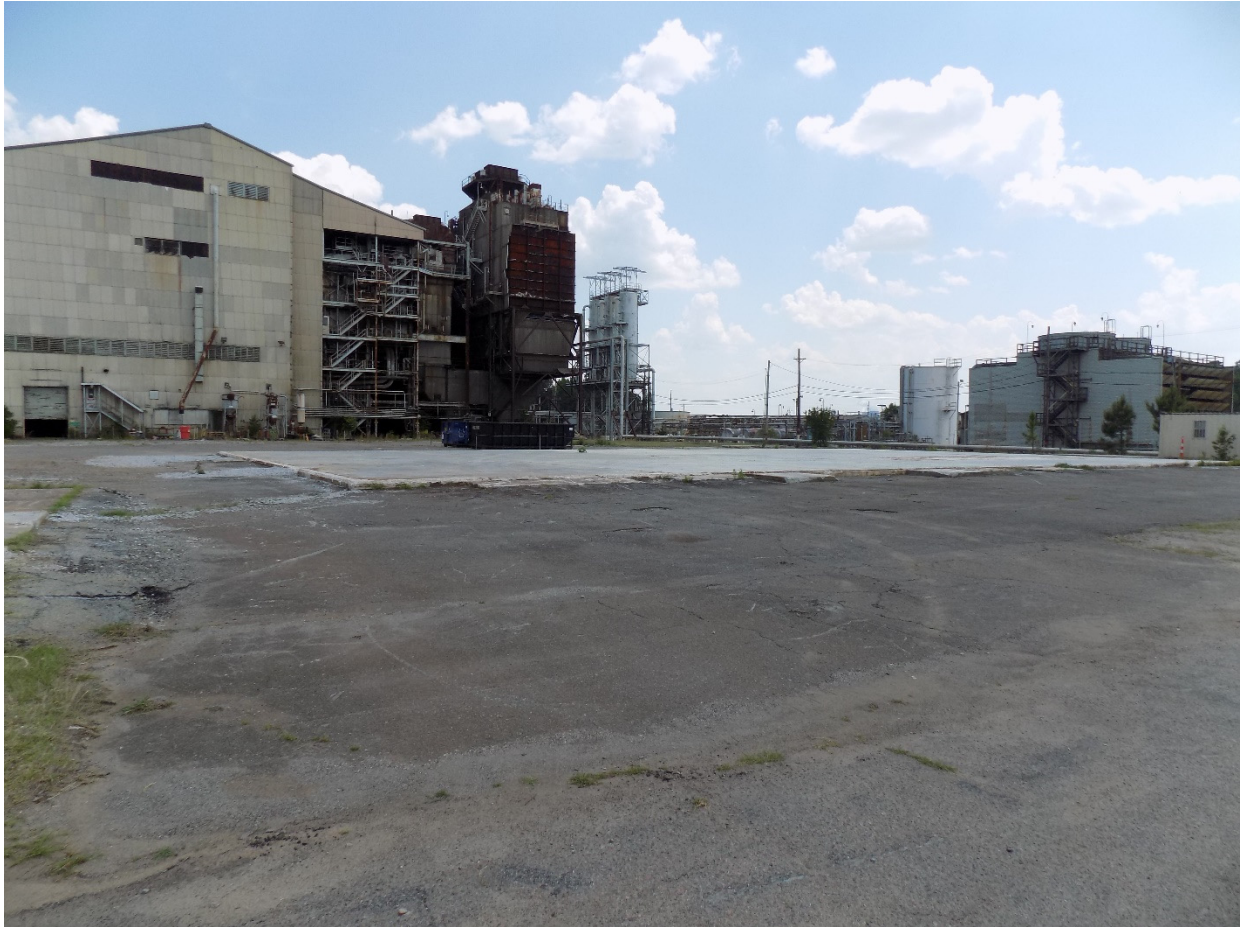
Figure 2: 484-4D After

484-4D was dismantled and removed down to the concrete slab. The gas cylinder shed, two small storage buildings with a covered area between them along with

the lay-down area and fence were all demolished and removed. Any remaining projections were cut off flush with the surrounding surface and resulting holes filled with grout. The slab was completely cleaned, including a few suspected oil stains that had been identified in the FDE which were cleaned with BioSolve®.
