Decommissioning Project Final Report (DPFR) Building 728-N, Shipping Cask and Railroad Car Repair Facility

1.0 SUMMARY

Appendix A - Photographs

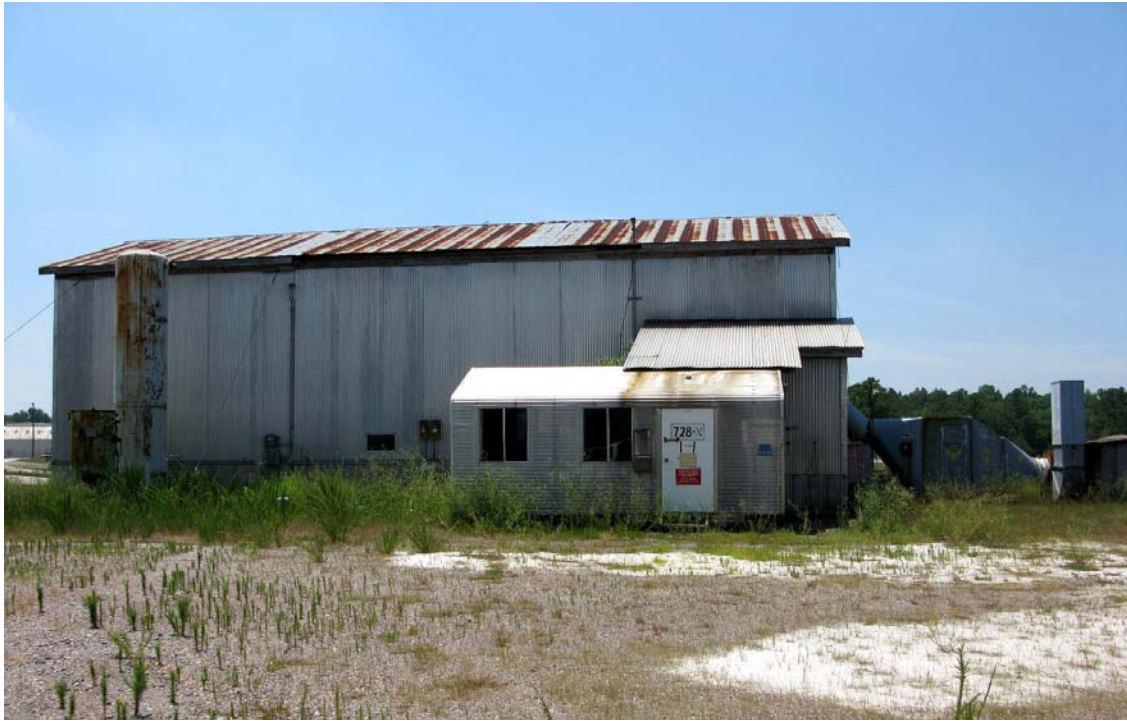
**Photo 1 – Building 728-N, Shipping Cask and Railroad Car Repair Facility - Before
(Looking Southwest)**

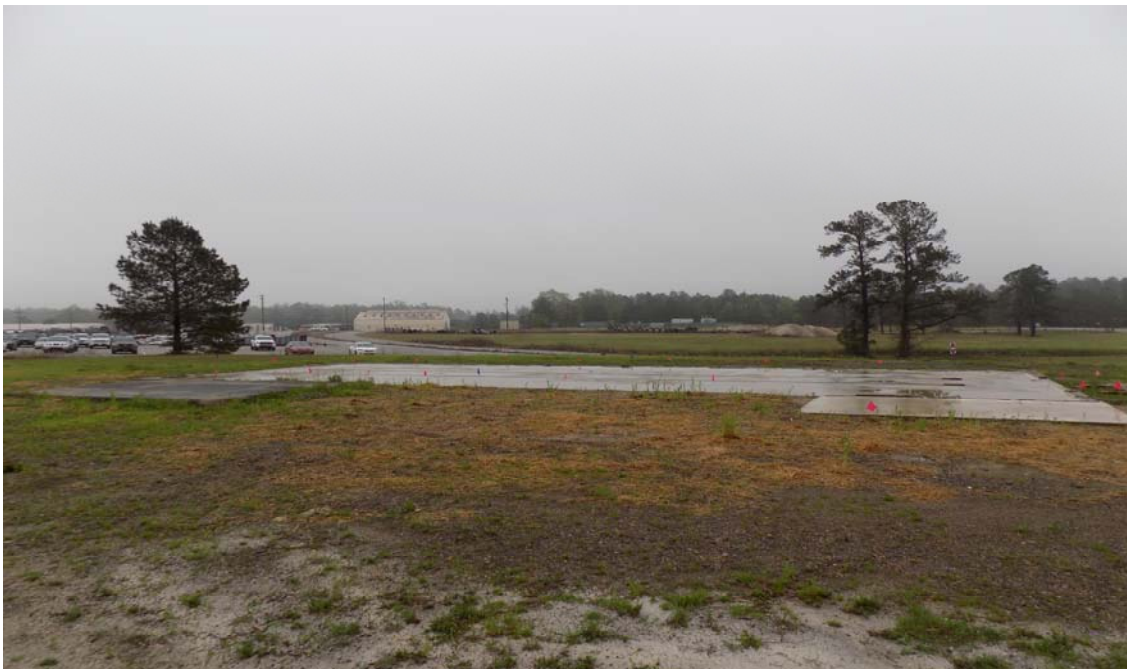
**Photo 2 – Building 728-N, Shipping Cask and Railroad Car Repair Facility - After
(Looking Southwest)**

Demolition of the 728-N Shipping Cask and Railroad Car Repair Facility to its concrete floor slab is complete. With the exception of normal surface disruption caused by construction equipment, the surrounding areas remain undisturbed. All interfacing utilities (e.g., electrical power and communications circuitry) were isolated, disconnected, and plugged/capped prior to demolition/decommissioning, as documented in References 8.06 and 8.07.

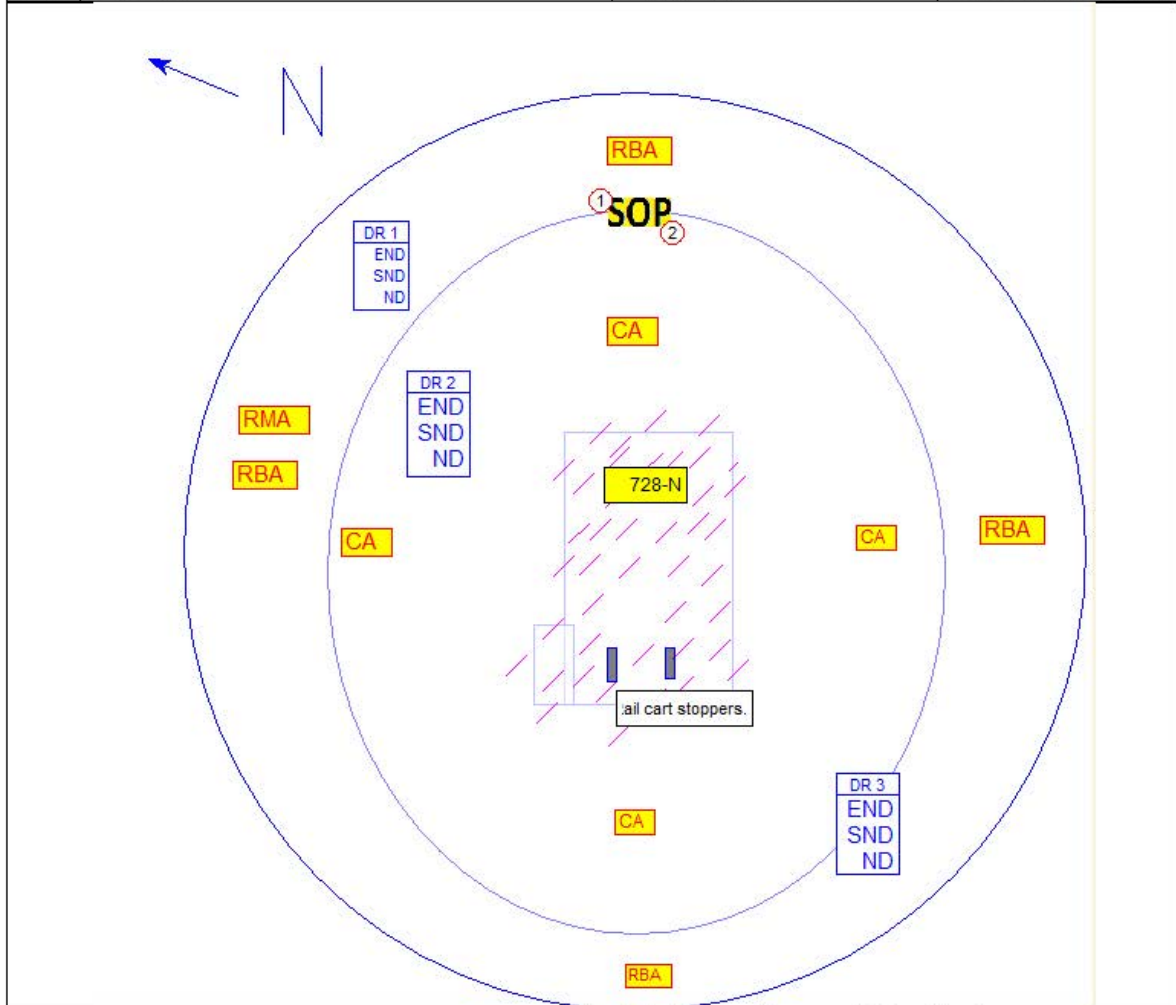
Map: 1	BLANK MAP	Survey #: DDSG-M-20191120-1	Date/Time: 11/20/2019 06:38
--------	-----------	-----------------------------	-----------------------------

Comments:	Summary of Highest Readings (All available values may not be listed)	
	Smears	Air Samples & Wipes
	2) <20 DPM/100 cm ² α	
	2) <200 DPM/100 cm ² β/γ	
Type: Job Coverage	RWP #: 19-SGP-102	
Symbol Legend (for example only)		
DR 1 DOSE RATE	○ SMEAR	▨ WIPE
E15 EXTREMITY	◇ DIRECT	
S10 SKIN	△ AIR SAMPLE	
3 WHOLEBODY		
Unless otherwise noted, dose rates in mrem/hr.		
Lead Inspector: PRICE, SOLOMON JERRY	Status: Approved by: CROY, EVAN JOHN, 3/5/2020 07:48:30	
Location Code: COMMON	Bldg/Area Name: BLANK MAP	
Location Description: BLANK MAP
